December 2023
FL973 A-D
NHTSA #23V-333
Transport Canada #2023-276

Subject: TBB C2 Interior Side Sheet Joint

**Models Affected: Specific model years 2021-2024 Thomas Built
Buses Saf-T-Liner C2 school buses manufactured
January 24, 2020,through April 18, 2023.**

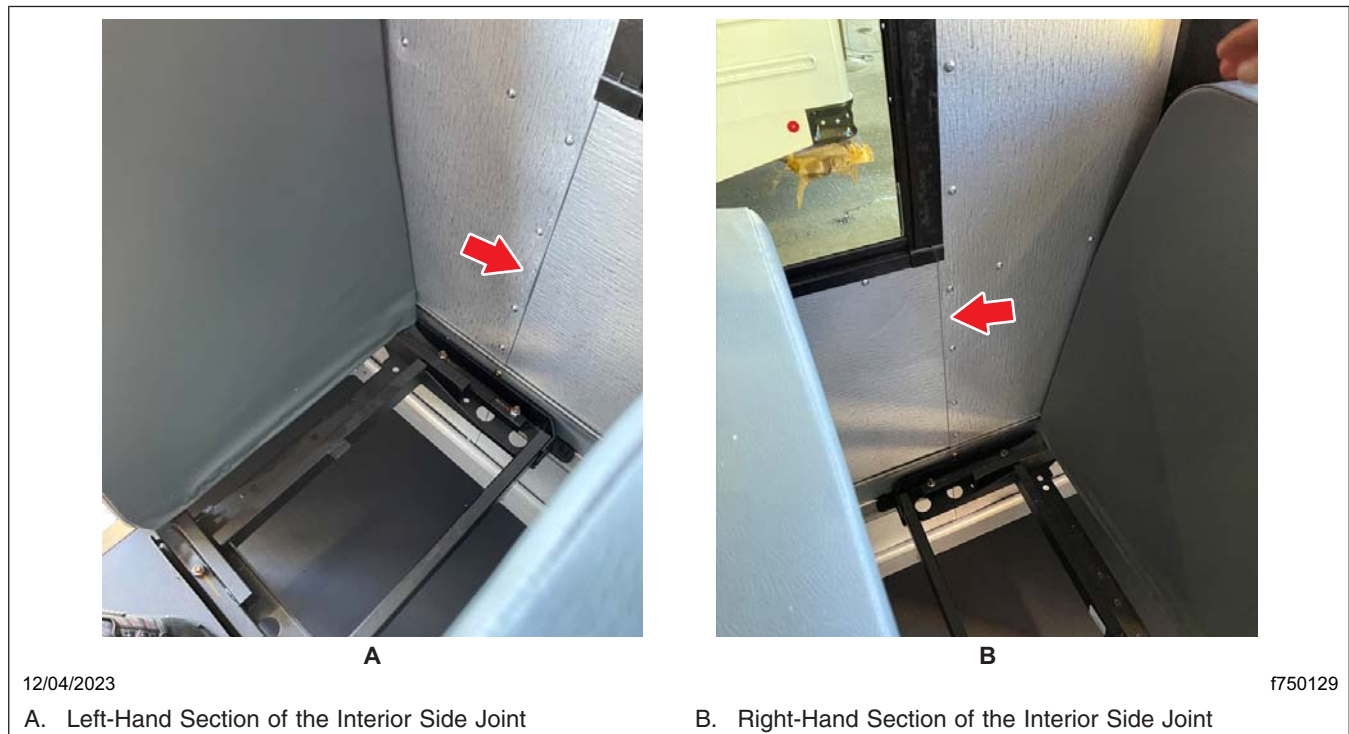
Fig. 1, Left-Hand and Right-Hand Sections of the Interior Side Joint

4. Remove the bottom seat cushion to gain access to the entire interior joint. **Figure 1** shows the left-hand and right-hand sections of the interior side joint.

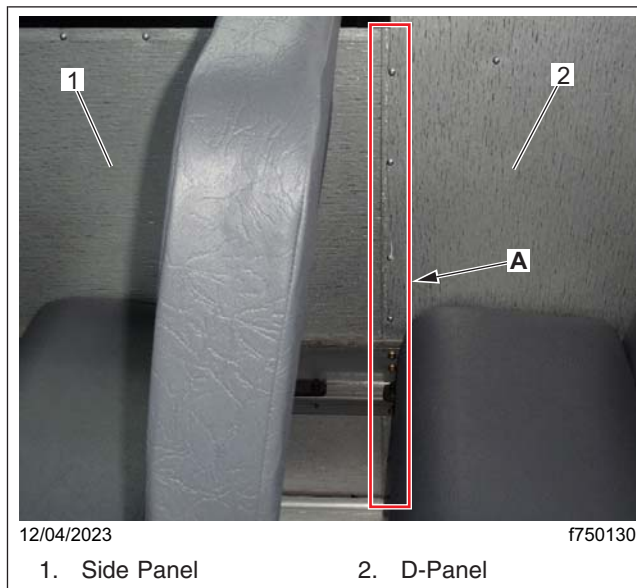
Fig. 2, Location of the Lap Joint

5. To identify the correct installation location for the new fasteners, locate the rear interior joint formed when the D-panel overlaps with the side-sheet at the last rafter as shown in **Fig. 2**, and mark the fastener locations as follows.
