November 7, 2023

SUBJECT: NEW VEHICLE DEMONSTRATION / DELIVERY HOLD -Safety Recall 23S23 - Supplement #4 Certain 2020-2023 Explorer and Aviator, and 2020-2022 Corsair Model Year Vehicles Inoperative Rear / 360 Degree Camera with A Blue or Black Screen

Safety Recall 23S23 - Supplement #4

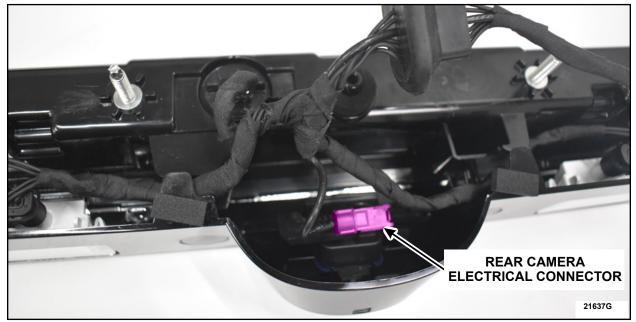
FIGURE 1

2. Disconnect the rear view camera electrical connector. See Figure 1.

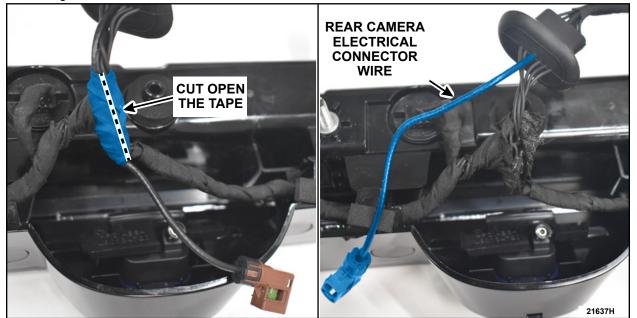
FIGURE 2

3. Cut open the tape and isolate the rear camera electrical connector wire from the taped up bundle. See Figure 2.

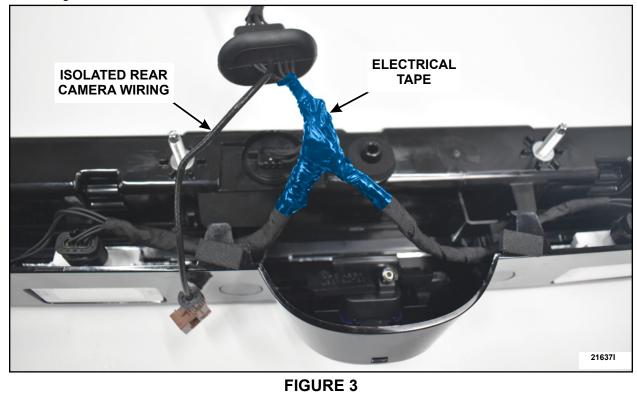
4. Wrap up the exposed wire harness using electrical tape keeping the rear camera wiring isolated. See Figure 3.

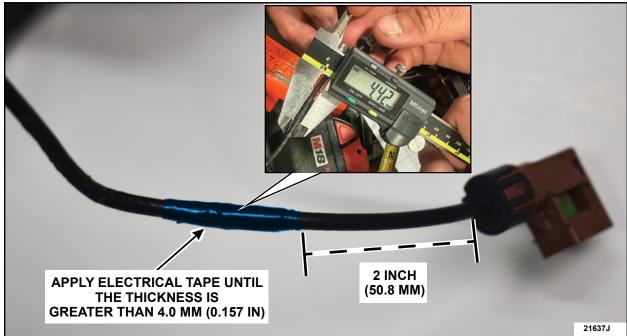
FIGURE 4

5. Measure 2 inch (50.8 mm) from the back of the rear camera electrical connector. Apply wraps of electrical tape and measure using a caliper until the thickness is 4.0 mm (0.157 in) or greater. See Figure 4.

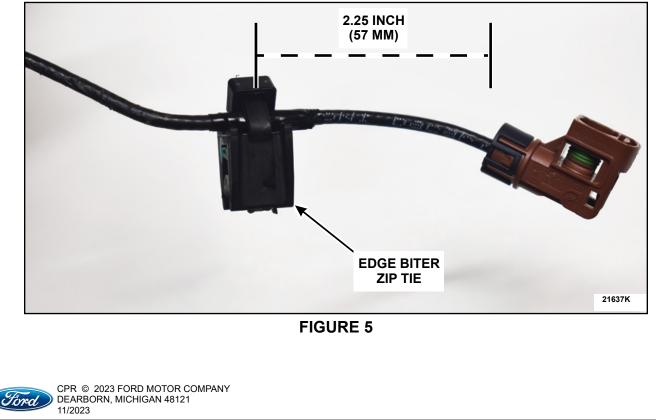
6. Measure 2.25 inch (57 mm) from the back of the rear camera electrical connector and install the edge biter zip tie. Trim any excess length of zip tie. See Figure 5.

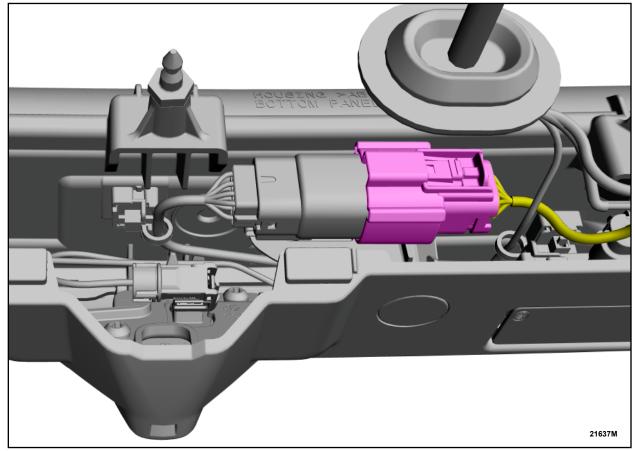
FIGURE 8

2. Disconnect the electrical connector on the back of the lif and position the harness aside. See Figure 8.

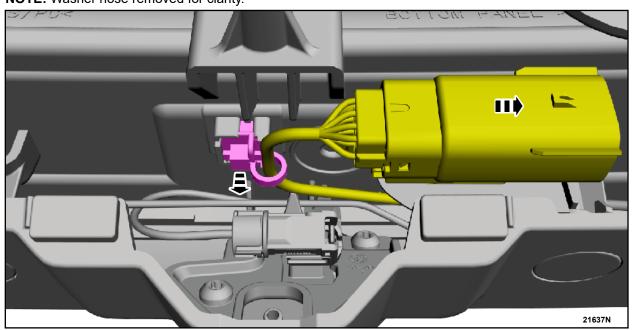
FIGURE 9

3. Disconnect the wiring guide and position the electrical connector aside. See Figure 9.

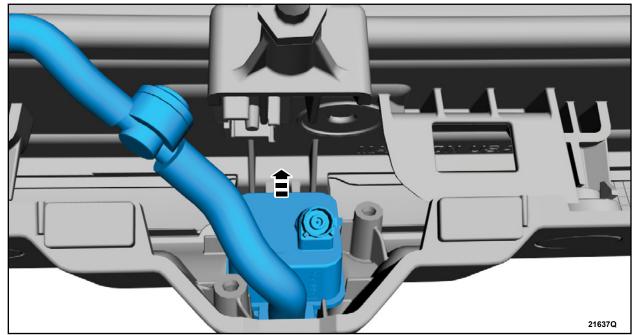
FIGURE 12

6. Remove the rear camera and washer tube as an assembly. See Figure 12.

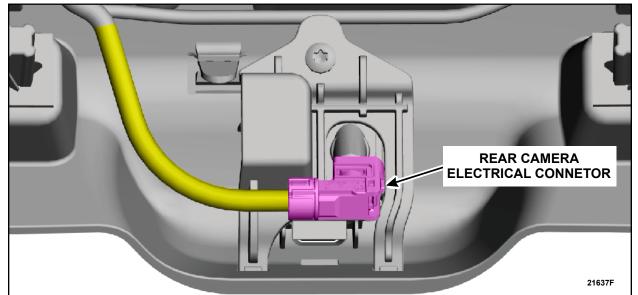
FIGURE 14

- 1. Remove the liftgate moulding. Follow the WSM procedures in Section 501-08.
- 2. Disconnect the rear view camera electrical connector. See Figure 14.

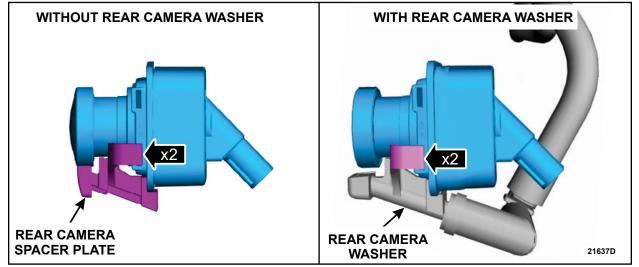
FIGURE 17

4. Release the tabs and remove the rear view camera from the washer nozzle or spacer plate. See Figure 17.

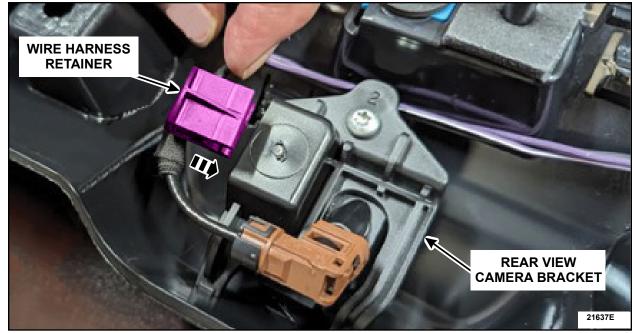
FIGURE 19

7. Attach the wire harness retaining clip to the rear view camera bracket. See Figure 19.

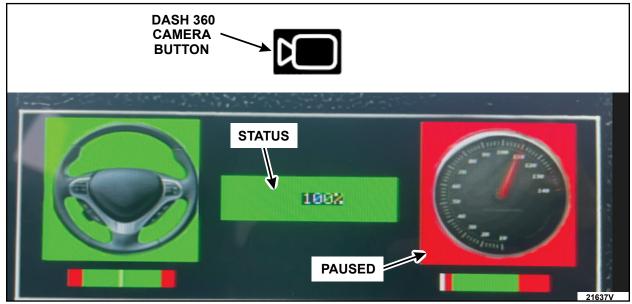
FIGURE 23

- e. To access the calibration status screen, press the 360 camera button located on the center of the dash and maintain a speed of 5 Miles Per Hour (MPH) (8 Kilometer Per Hour (KPH) or lower. See Figure 23. The status screen will disappear at speeds greater than 5 MPH (8 KPH).
- **NOTE:** It is recommended to keep the vehicle speed at 5 MPH (8 KPH) or lower to be able to view the status screen.
- **NOTE:** If the steering wheel is turned too sharp or speed is over 15 MPH (24 KPH), progress will pause (turn red). It will resume (turn green) once the steering wheel is straightened or you have reached the appropriate speed. See Figure 23.
