Recall Campaign Bulletin

Campaign No. 2023070015, August 2023
Revision A 8/18/2023

SUBJECT: **Model C-Class (206 platform)**
Model Year 2022-2023

Inspect Transmission Wiring Harness Routing

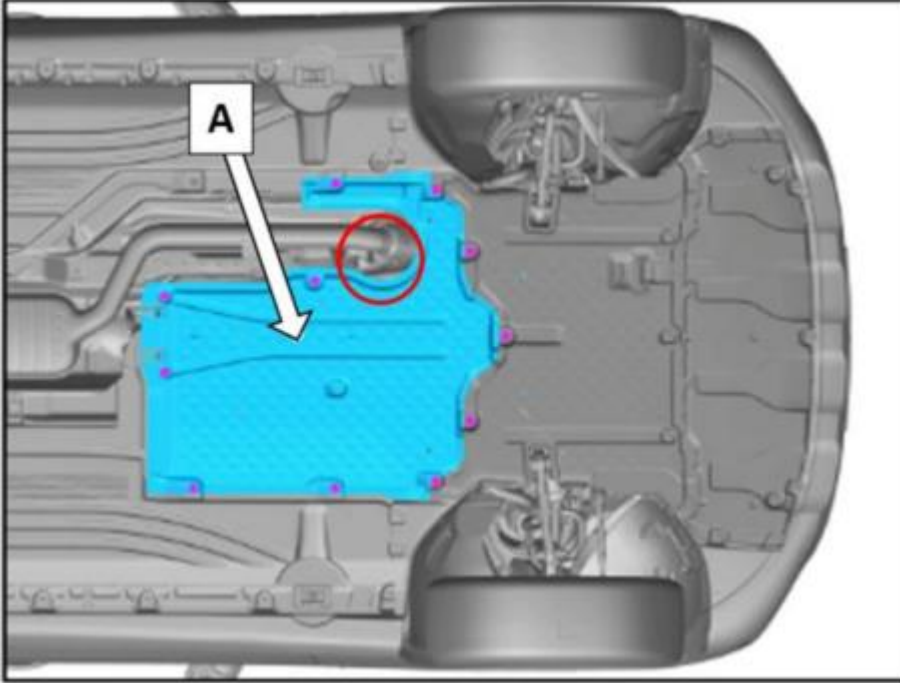
Figure 1

1. Remove rear engine compartment lining (A, Figure 1).

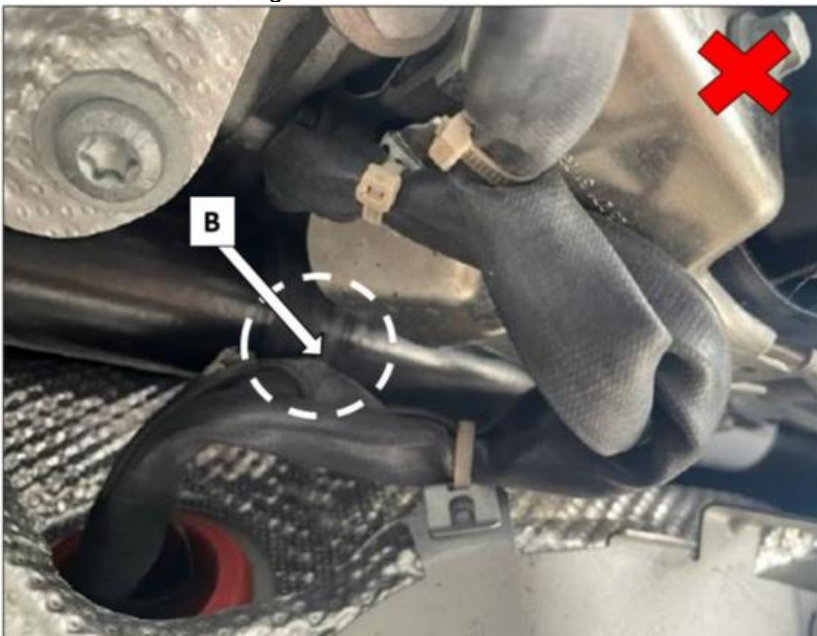
Figure 2, condition not OK

2. Check routing and clearance (B, Figure 2) between the electrical wiring harnesses and the transmission tunnel/drive shaft, and the transfer case for the front axle differential.

i The electrical wiring harnesses **must not** contact the drive shaft or the transfer case for the front axle differential!

- a. If the electrical wiring harness is in contact but **not damaged**:
Carry out **Work Procedure 1**.
- b. If the electrical wiring harness is in contact and **is damaged**:
Carry out **Work Procedure 2**.
- c. If the electrical **power supply line (3, Figure 3)**
(Cable cross section 10 mm²) is damaged:
Carry out **Work Procedure 3**.
- d. If the electrical wiring harness is **routed correctly**.
End measure.

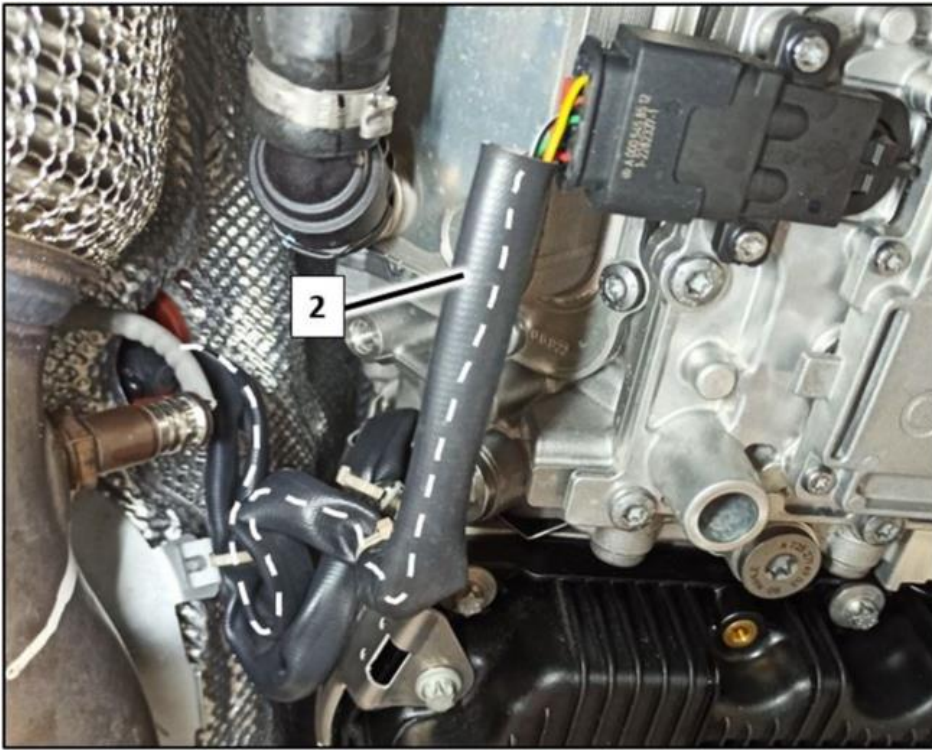
Figure 5

i **If only the protective hose is slightly damaged:**

i If one or more of the electrical signal lines (**cable cross section 0.35 mm² or 0.75 mm²**) in the electrical wiring harness (**2, Figure 5**) are damaged:

1. Wrap fabric tape around affected area.
2. Route the electrical wiring harness (2, Figure 5) correctly as shown.
 - i** The electrical wiring harness (2, Figure 5) may not be in contact at **any point!**

1. Repair the affected electrical signal line (**cable cross section 0.35 mm² or 0.75 mm²**) in the electrical wiring harness (**2, Figure 5**) using a line connector.

2. Route electrical wiring harness (**2, Figure 5**) correctly as shown.

i The electrical wiring harness (**2, Figure 5**) may not be in contact at **any point!**
