Recall Campaign Bulletin

Campaign No. 2024070016, August 2024

SUBJECT: **Model C-Class (206 platform)**
Model Year 2022 – 2023

Inspect 12V and 48V Ground Connections

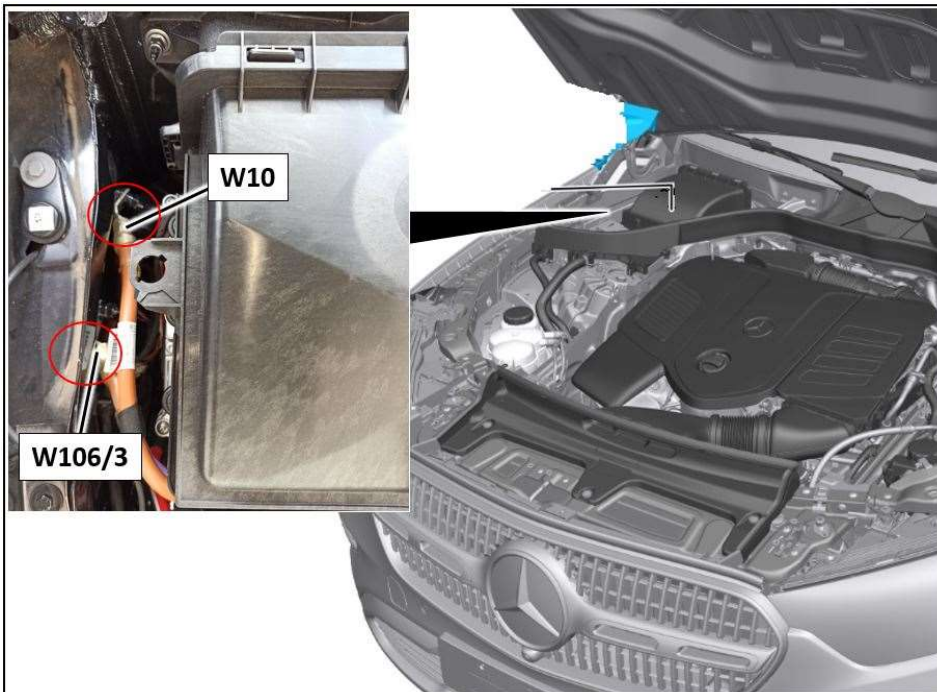
Figure 2

3. Check connections of ground points (Figure 2, W10 & W106/3) for correct tightening torque.

Nm 48 V battery ground point (W106/3) (see BA00.19-P-1039-01O) = **16 Nm**

Nm On-board electrical system battery ground point (W10) (see BA00.19-P-1012-01O) = **16 Nm**

1. Replace respective nut and tighten with specified tightening torque.

Nm 48 V battery ground point (**W106/3**) (see BA00.19-P-1039-01O) = **16 Nm**

Nm On-board electrical system battery ground point (**W10**) (see BA00.19-P-1012-01O) = **16 Nm**

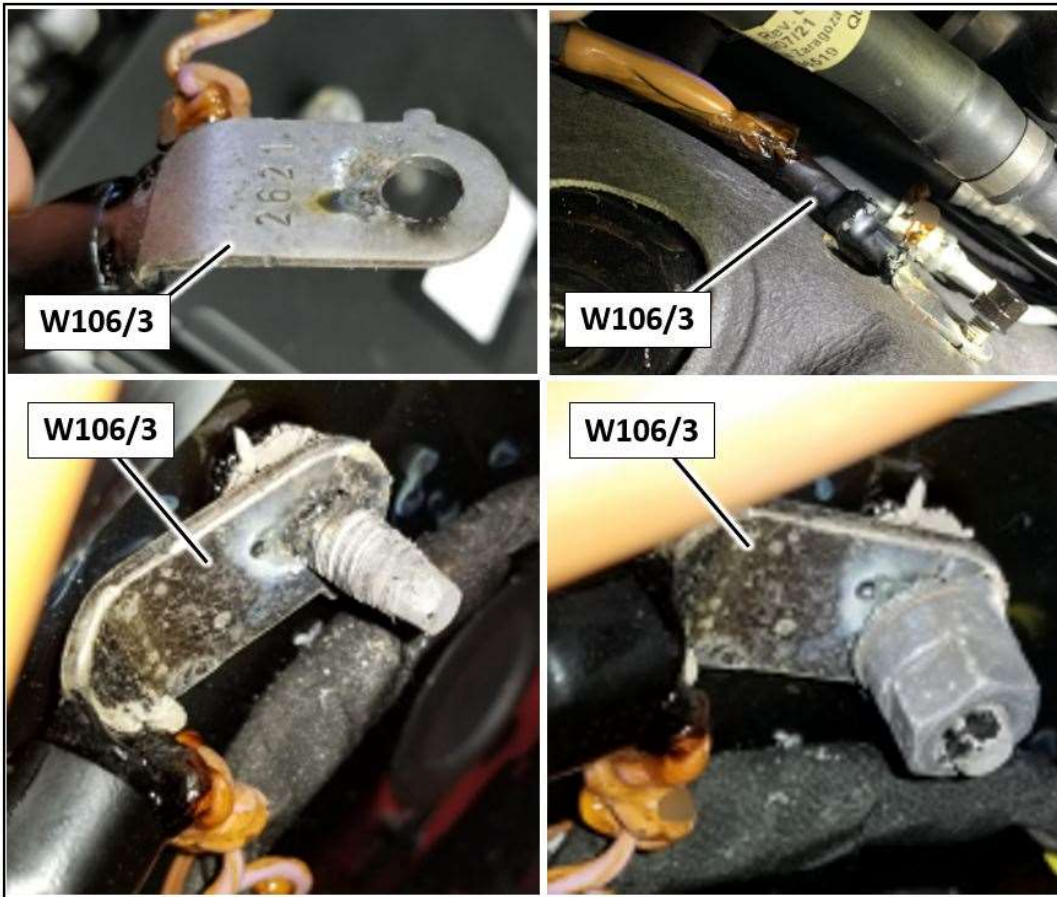
3. Remove respective affected cable lug from weld stud.
4. Check respective affected electric line, contact areas, and weld stud for **damage, such as arcing, scorch marks and/or melting**.

i See examples of the damage profiles (**Figures 5 and 6**).

Figure 5, Examples of potential damage profiles of a 48 V battery ground point (W106/3)

2. Replace damaged weld stud if necessary.

3. Replace damaged electric line and nut if necessary and tighten with specified tightening torque.

Nm 48 V battery ground point (**W106/3**) (see BA00.19-P-1039-01O) = **16 Nm**

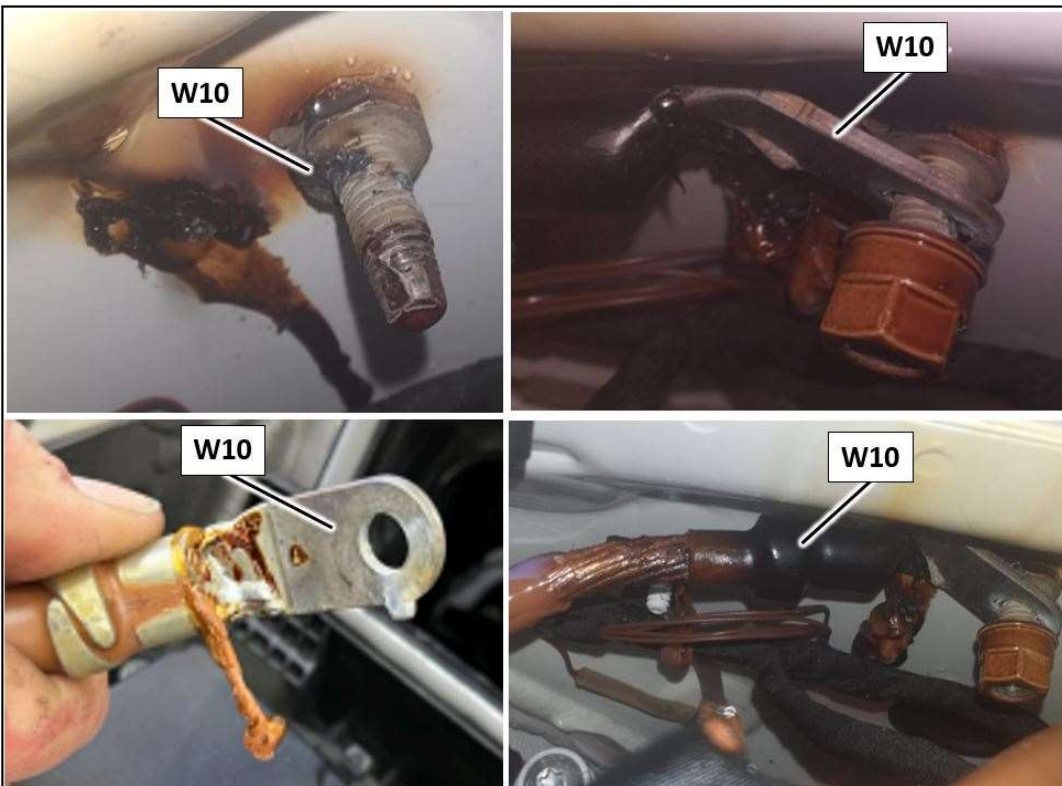
Figure 6, Examples of potential damage profiles of an on-board electrical system battery ground point (W10)

Nm On-board electrical system battery ground point (**W10**) (see BA00.19-P-1012-01O) = **16 Nm**

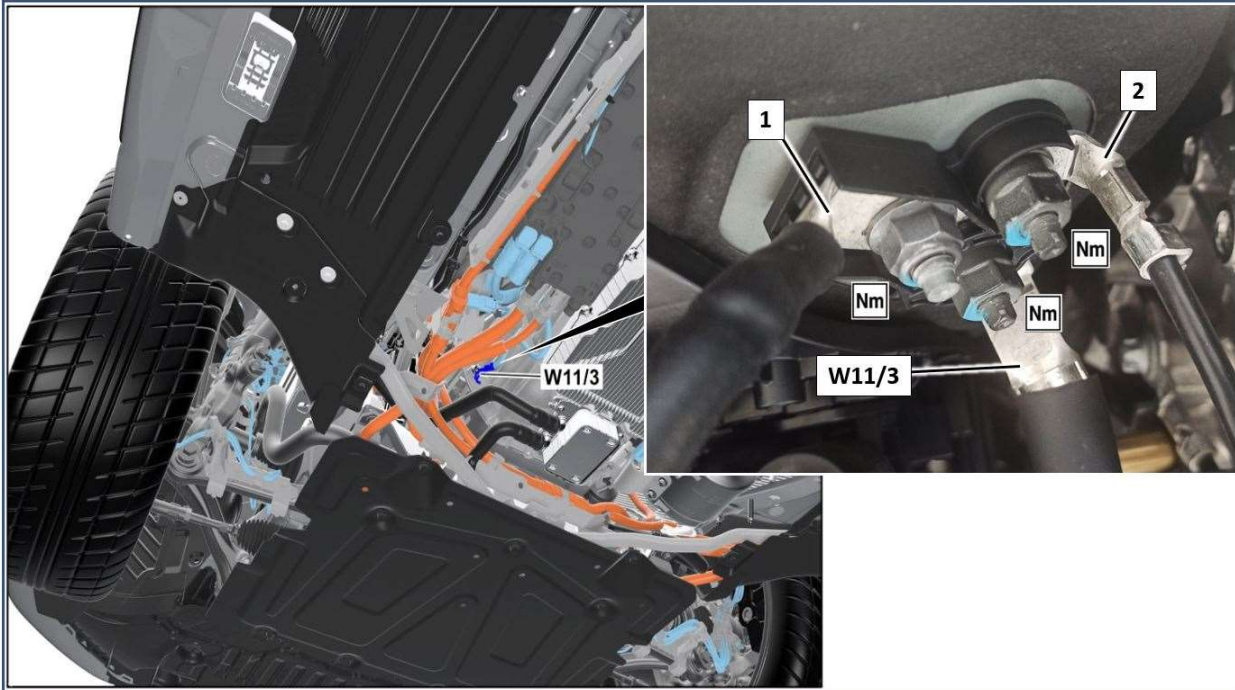
Figure 7

2. Check threaded connections at ground points (**Figure 7, 1, 2, & W11/3**) for correct tightening torque.

Left combustion engine ground point (**Figure 7, W11/3**) = 20 Nm

**Circuit 31 ground point with code B01 (Figure 7, 2) = 20 Nm**

**Circuit 41 ground point, with engine 654 and code B01 (Figure 7, 1) = 16 Nm**

1. Replace respective nut at ground point (**Figure 7, W11/3, 1, or 2**) and tighten with specified tightening torque.

Nm Left combustion engine ground point (**Figure 7, W11/3**) = 20 Nm

Nm Circuit 31 ground point with code B01 (**Figure 7, 2**) = 20 Nm

Nm Circuit 41 ground point, with engine 654 and with code B01 (**Figure 7, 1**) = 16 Nm

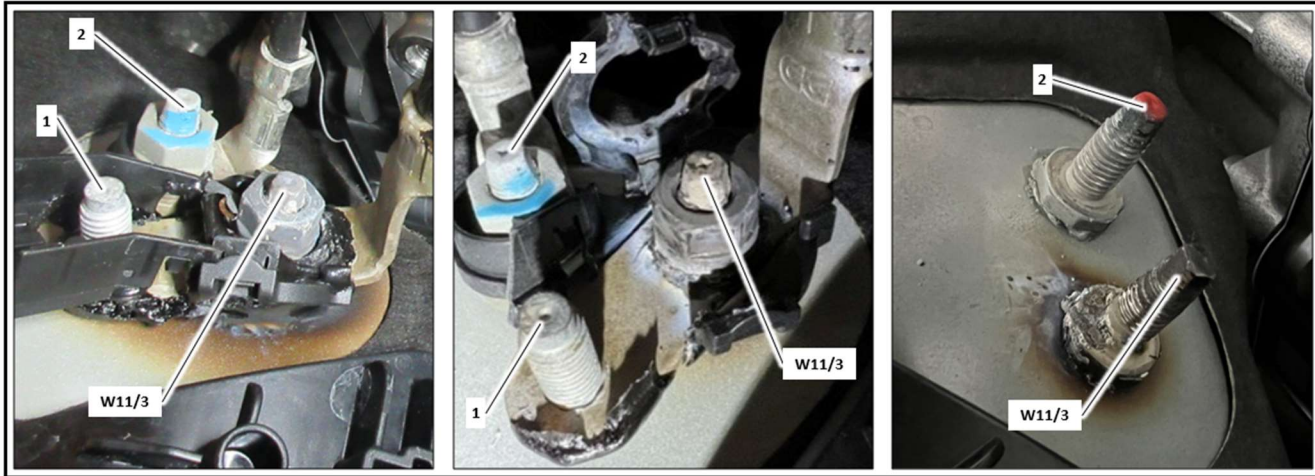
1. Remove respective affected nut from ground point (**Figure 7, W11/3, 1, or 2**) and perform a visual check of the affected electric line, contact area, and weld stud.

i See examples of damage profiles (**Figure 8**).

Figure 8, example of potential ground point damage profiles (1, 2, W11/3)

1. Replace damaged weld stud if necessary.

2. Replace damaged electric line and nut if necessary and tighten with specified tightening torque.

Nm Left combustion engine ground point (**Figure 7, W11/3**) = 20 Nm

Nm Circuit 31 ground point with code B01 (**Figure 7, 2**) = 20 Nm

Nm Circuit 41 ground point, with engine 654 and with code B01 (**Figure 7, 1**) = 16 Nm
