Recall Campaign Bulletin

Campaign No. 2023070009, July 2023

SUBJECT: Model EQS (297 platform) Model Year 2022-2023

Inspect Rear Seat Belt Buckle Bolts

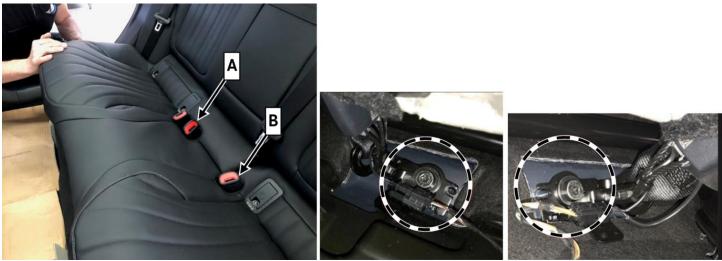
Figure 1

Mercedes-Benz AG ("MBAG"), the manufacturer of Mercedes-Benz vehicles, has determined that on certain Model Year ("MY") 2022-2023 EQS (297 platform) vehicles, the bolts that secure the rear seat belt buckles to the body might not meet current torque specifications. In this case, the bolts might loosen due to vibrations while driving, or in the event of a crash. As a result, the restraining effect of the rear seat belts might be impaired, which could increase the risk of injury for vehicle occupants. An authorized Mercedes-Benz dealer will inspect the rear seat belt buckle bolts on the affected vehicles and rework the bolts, if necessary.

For basic data, see AR91.12-P-1022EQS.
- 2. Check the torque (1 35) of both bolts on the right and left of the rear seat belt buckles (A and B, Figure 1) and correct if necessary.
