Recall Campaign Bulletin

Campaign No.2023080008, September 2023
Revision A 9/12/2023

SUBJECT: **Model S-Class (223 platform)**
Model Year 2022-2023

Inspect 12V Ground Connection

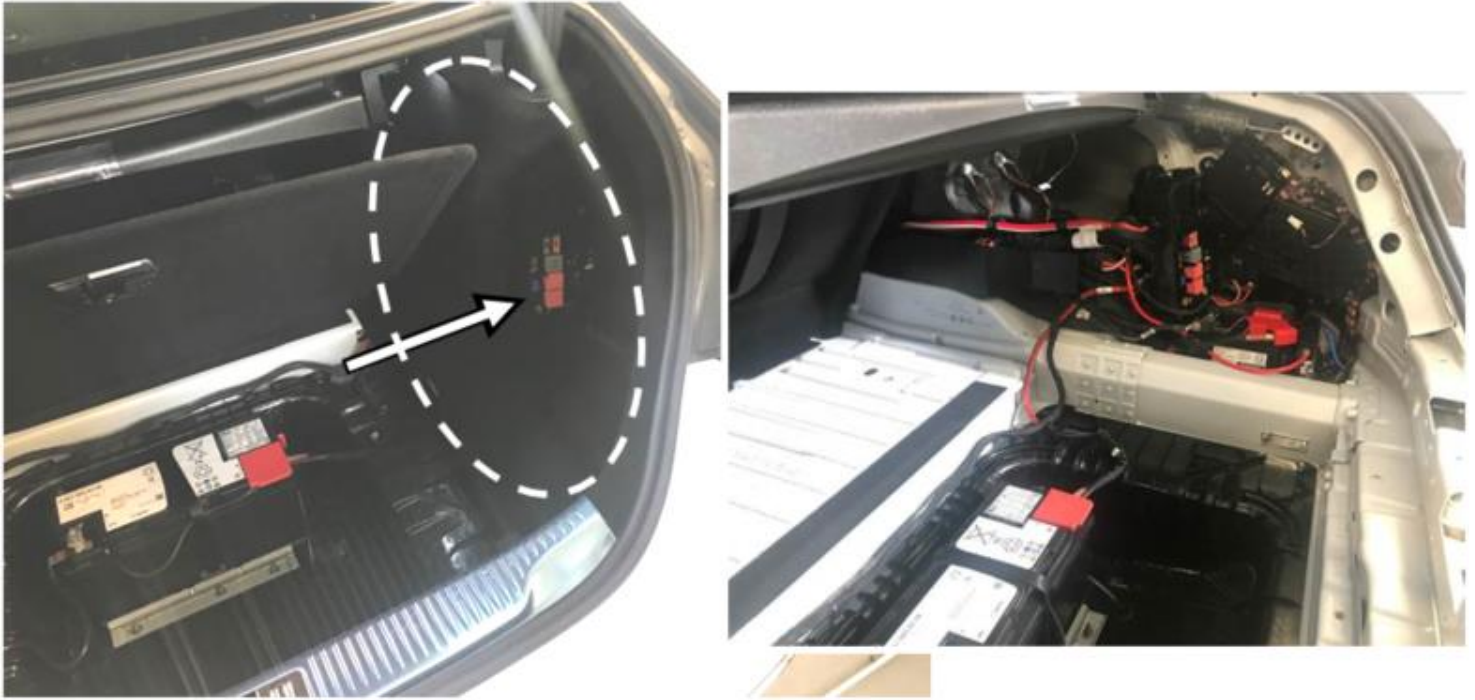
Figure 1

1. Switch off ignition and keep transmitter keys outside of transmitting range (at least 6 m).
2. Remove right side trim in trunk (**Figure 1**).

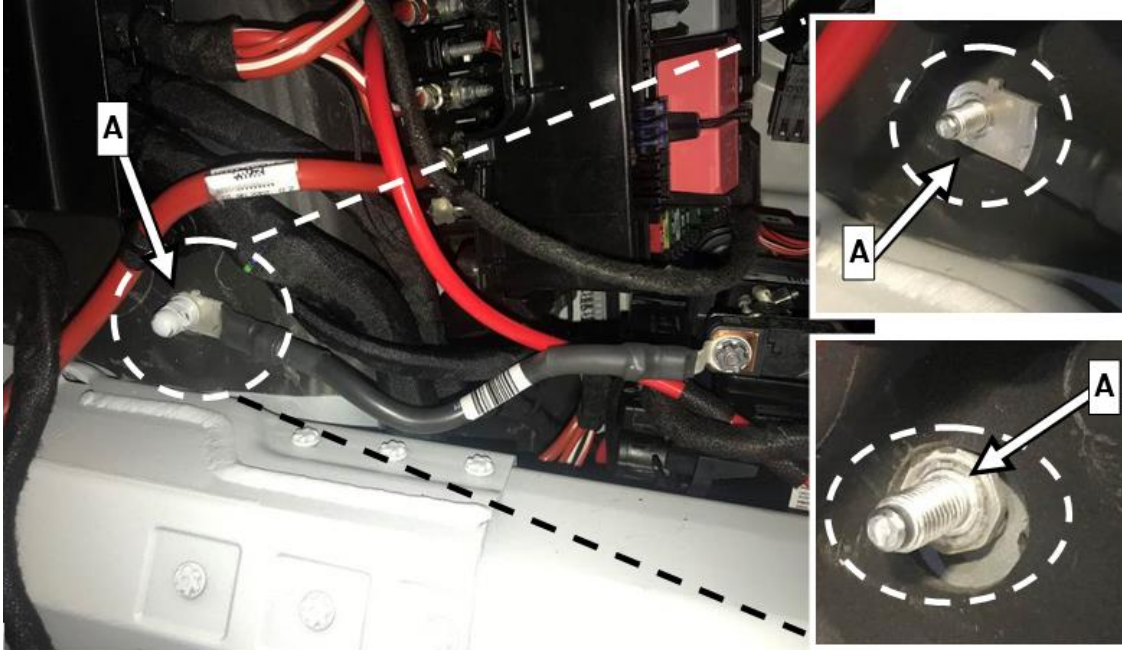
Figure 2, shown on vehicles without code ME 10 (Hybrid vehicle (plug-in, PHEV))

3. Remove ground line (A, Figure 2) of battery sensor (B95/3) of auxiliary battery from body.

i For vehicles **without** code ME 10 (Hybrid vehicle (plug-in, PHEV)), the ground line runs from the secondary 12 V on-board electrical system battery to the ground point (A, Figure 2).

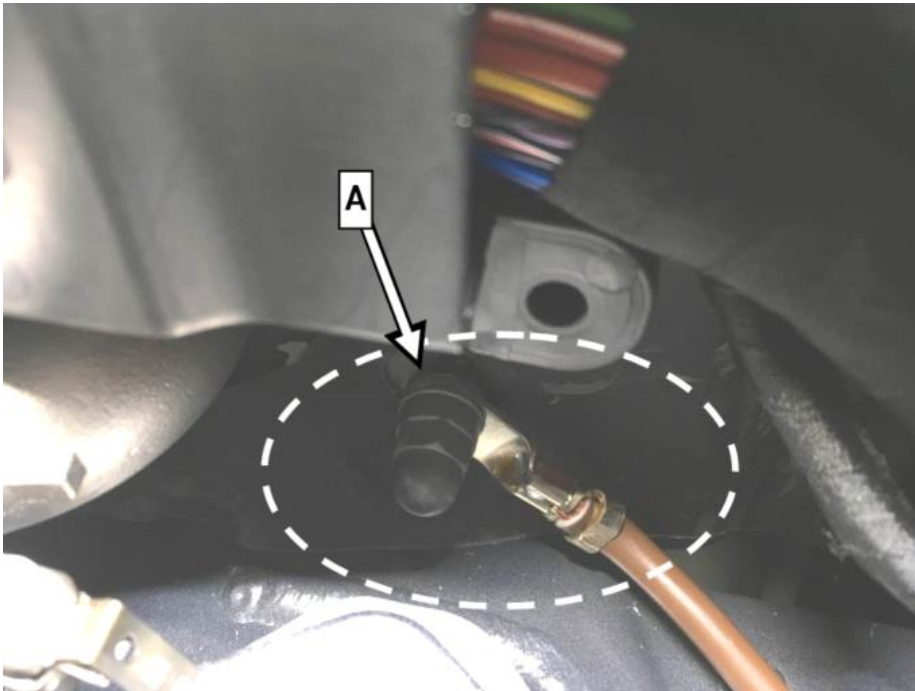
Figure 3, shown on vehicles with code ME 10 (Hybrid vehicle (plug-in, PHEV))

i For vehicles **with** code ME 10 (Hybrid vehicle (plug-in, PHEV)), the ground line runs from the windshield heater control unit to the ground point (A, Figure 3).

4. Check contact surfaces at lug of ground line and weld stud for damage (**Figure 3**).

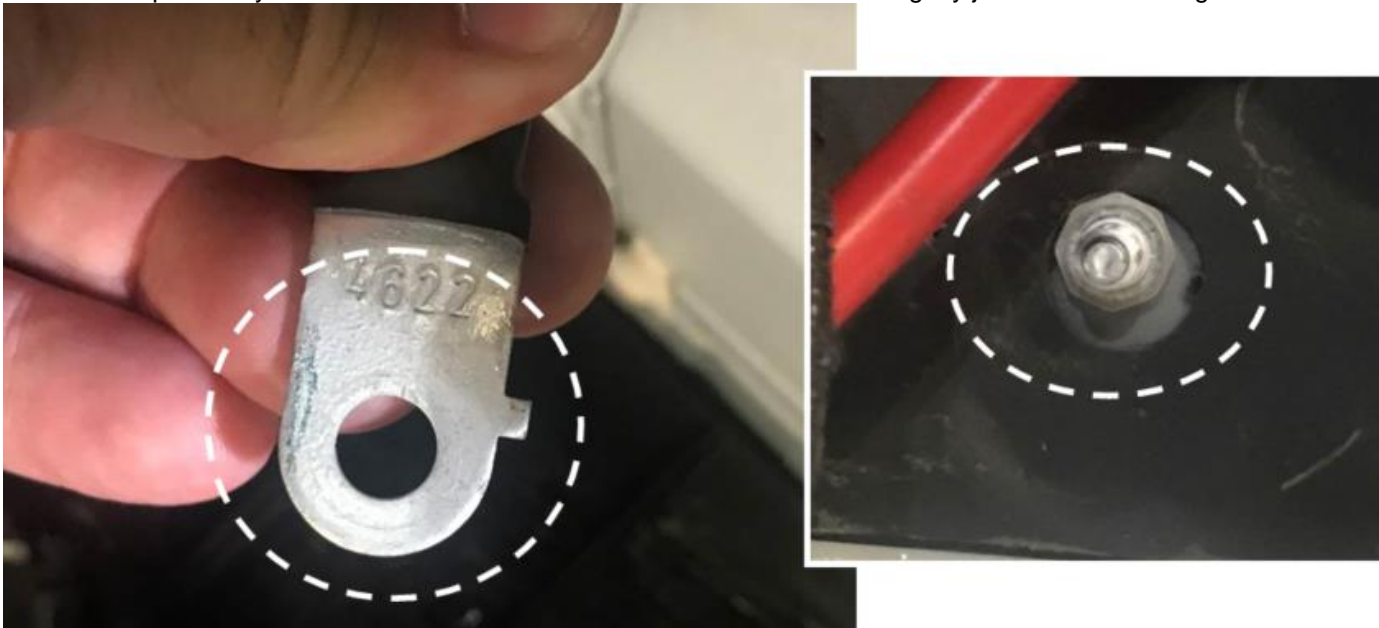
Figure 4

i The possibility exists that the insulation mat at the wheel arch was slightly jammed under the ground line.

- a. Lug of ground line and ground bolt **not** damaged: Carry out **Work Procedure A**.
- b. Lug of ground line or weld stud damaged: Carry out **Work Procedure B**.

1. Slide the lug of ground line onto the weld stud and tighten it.

i **Ensure that the insulation mat is not jammed between the lug and contact surface of the weld stud!**

i After tightening, check insulation mat again for clearance around the weld stud.

i **Attention: Weld stud is made from aluminum, observe tightening torque!**

Nm Ground line to body weld stud **7 Nm**

1. Replace damaged ground line with battery sensor and/or weld stud.
-
