TO: Mercedes-Benz Dealer Principals, General Managers,	FROM: Gregory Gunther, Senior Manager, Vehicle	
Sales Managers, Service Managers, Parts Managers	Compliance and Analysis, Engineering Services	
RE: Recall Campaign Launch Notification		
Replace the Absorbers in the Roof Frame	DATE: August 25, 2023	
MY23 EQE (295 platform)

Campaign No. 2023080004, August 2023

SUBJECT: Model EQE (295 platform)

Replace the Absorbers in the Roof Frame

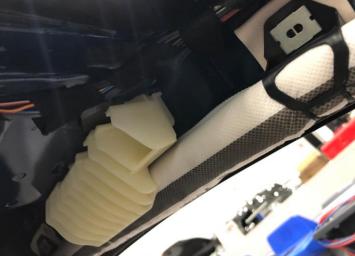
Figure 1

- 1. Partially remove and lower headliner. (Avoid bending the headliner, it will leave permanent kinks)
 - i The windshield does not need to be removed.
 - i For basic data, see AR68.30-P-4300EQS.
- 2. Replace front absorbers on the left and right sides (A, Figure 1).
 - The absorbers are clipped into the body-in-white under the headliner (Figure 2).

Figure 2 (Installed absorber on the left side)

3. Assemble in reverse order.
