October 2023
FL981AB
NHTSA #23V-621

Subject: TBB Loose AC Ground Stud

Models Affected: Specific model year 2024 Thomas Built Buses (TBB) Saf-T-Liner C2 buses manufactured May 1, 2023, through August 31, 2023.

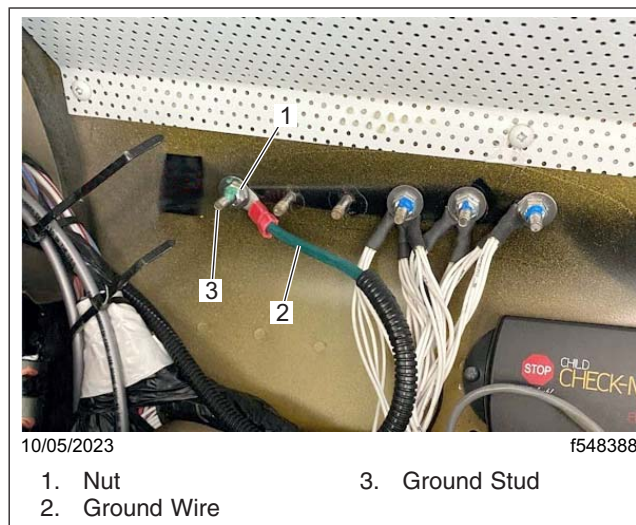
Fig. 1, Location of the A/C Ground Connection

4. Locate the glove box on the left-hand side of the driver's overhead compartment. Locate and remove the two square-head screws that hold the inner liner of the glove box in place.
5. Inspect the nut on the grounding stud to make sure it is securely fastened. See [Fig. 1](#).

6. If found loose, tighten the fastener 95 lbf-in (1073 N-cm).
7. If the ground stud breaks, connect the ground to a different stud.
8. If the nut is not fastened securely, inspect the wiring for any damage. If the ground wire is damaged, contact TBB for further guidance.

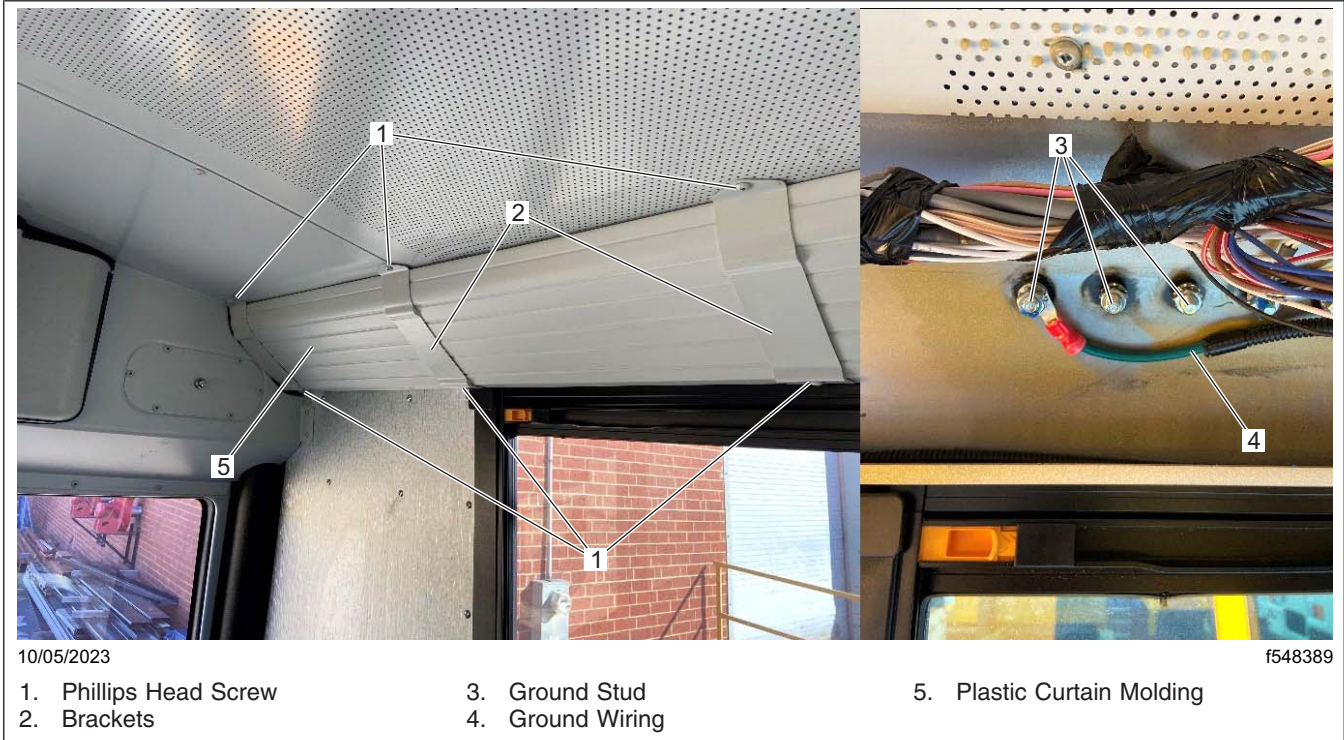
Fig. 2, Ground Stud Referencing Rear A/C Evaporator

9. Remove the Phillips head screws from the brackets that hold the plastic curtain molding. This allows to pull the curtain molding away enough to see the metal header with the ground studs. See [Fig. 2](#).

10. Inspect the nut on the grounding stud for tightness.
11. If found loose, tighten the fastener 95 lbf-in (1073 N-cm).
12. If the ground stud breaks, connect the ground to a different stud.
13. If the nut is not fastened securely, inspect the wiring for any damage. If the ground wire is damaged, contact TBB for further guidance.

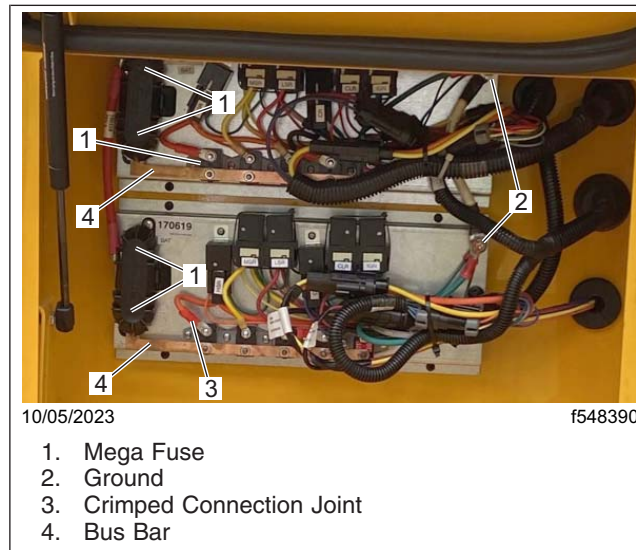
Fig. 3, BCC Module

15. Check if the nuts that attach the cables to the bus climate control (BCC) modules are properly tightened. Tighten the B (+) connectors between the cables and the mega fuses 95 lbf-in (1073 N-cm). See **Fig. 3**.

16. Inspect all the wires and connections on the control module that are connected to the bus bar. The joints should not be loose. If found loose, tighten the nuts that connect the wires to the bus bar 24 to 32 lbf-in (271 to 362 N-cm).
17. Check all the crimped connection joints so that the wires are firmly connected.
18. Connect the negative terminals to the battery.
19. Turn the MPDS to the ON position.
