TO: Mercedes-Benz Dealer Principals, General Managers, Sales Managers, Service Managers, Parts Managers	FROM: Gregory Gunther, Senior Manager, Vehicle Compliance and Analysis, Engineering Services
RE: Recall Campaign Launch Notification Revision A Inspect Front Tow Eye Receiver MY23 GLC (254 platform)	DATE: January 12, 2024

Campaign No. 2023090010, October
2023 Revision A 01/12/2024

SUBJECT: **Model GLC (254 platform)**
Model Year 2023

Inspect Front Tow Eye Receiver and Replace Front Crossmember, if necessary

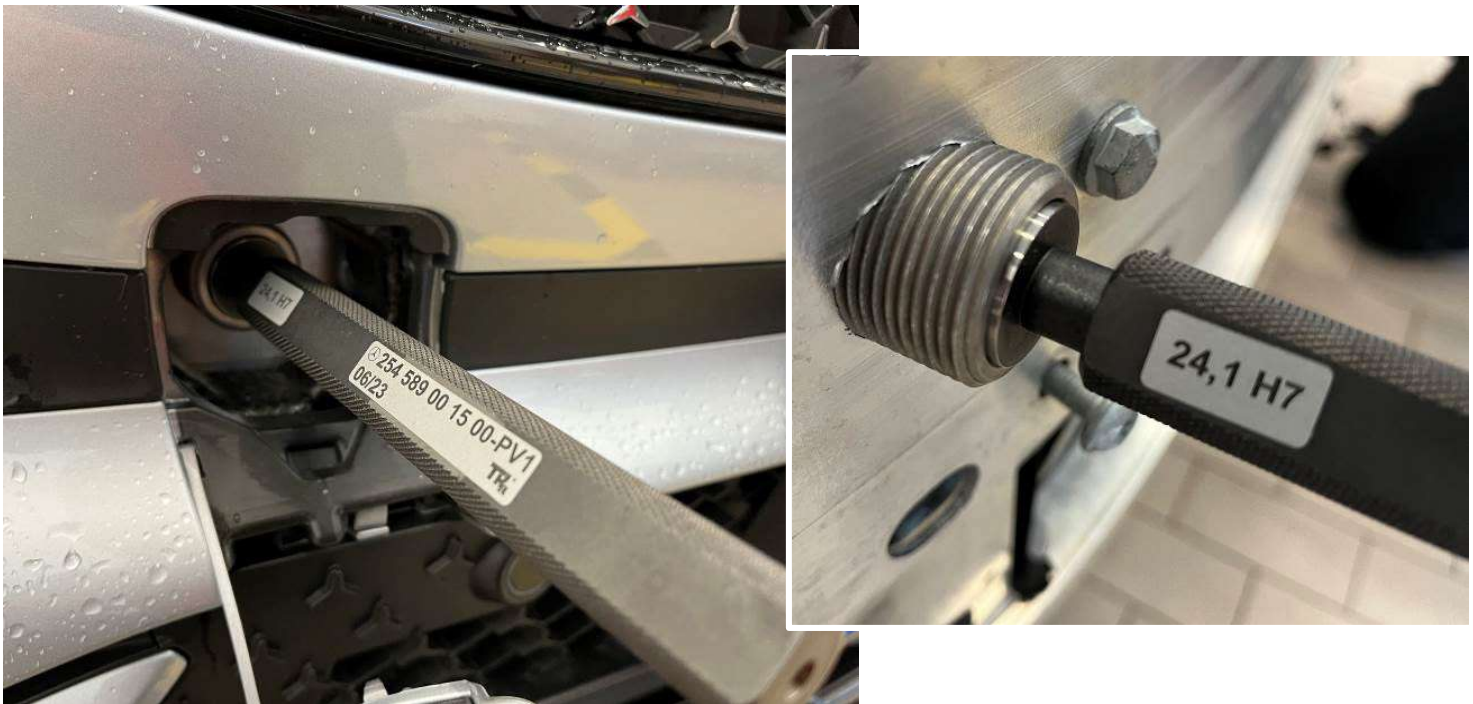
Figure 1, with and without bumper for a clearer illustration

i If the Limit check mandrel can be inserted almost completely with a slight protrusion, this is an “OK” result.
Note: Approx. 1 to 2 mm of threads may be remaining.

i If the Limit check mandrel tool cannot be threaded into the towing eye receiver on the crossmember, the towing eye receiver may be too narrow. This is a “Not OK” result.

- a. Limit check mandrel can be inserted into bush of towing eye: **End measure.**
- b. Limit check mandrel **cannot** be inserted into bush of towing eye: Carry out **Work procedure.**
