Service Engineering Operations
Ford Customer Service Division

SUBJECT: **NEW VEHICLE DEMONSTRATION / DELIVERY HOLD –
Safety Recall 23S55 - *Supplement # 4***
Certain 2020-2022 Model Year Explorer Vehicles
Rear Axle Bolt Fractures

CERTAIN 2020-2022 MODEL YEAR EXPLORER VEHICLES — REAR AXLE BOLT FRACTURES

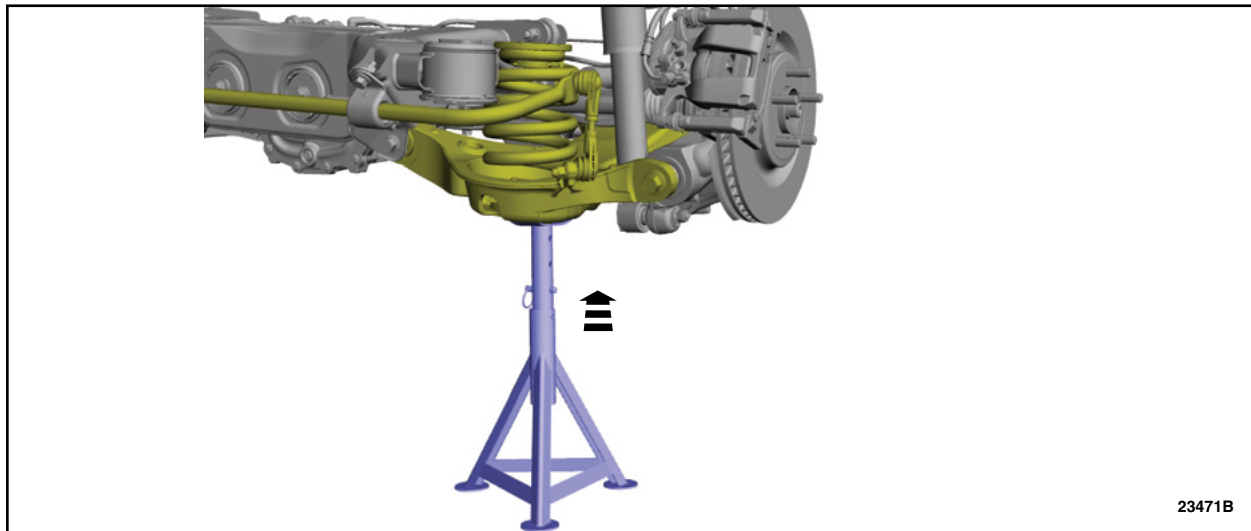
FIGURE 3

6. On the rear LH side of the vehicle, use a suitable jack to raise the suspension until the distance between the center of the hub and the lip of the fender is equal to the measurement taken in Step 3, (curb height). See Figure 3.

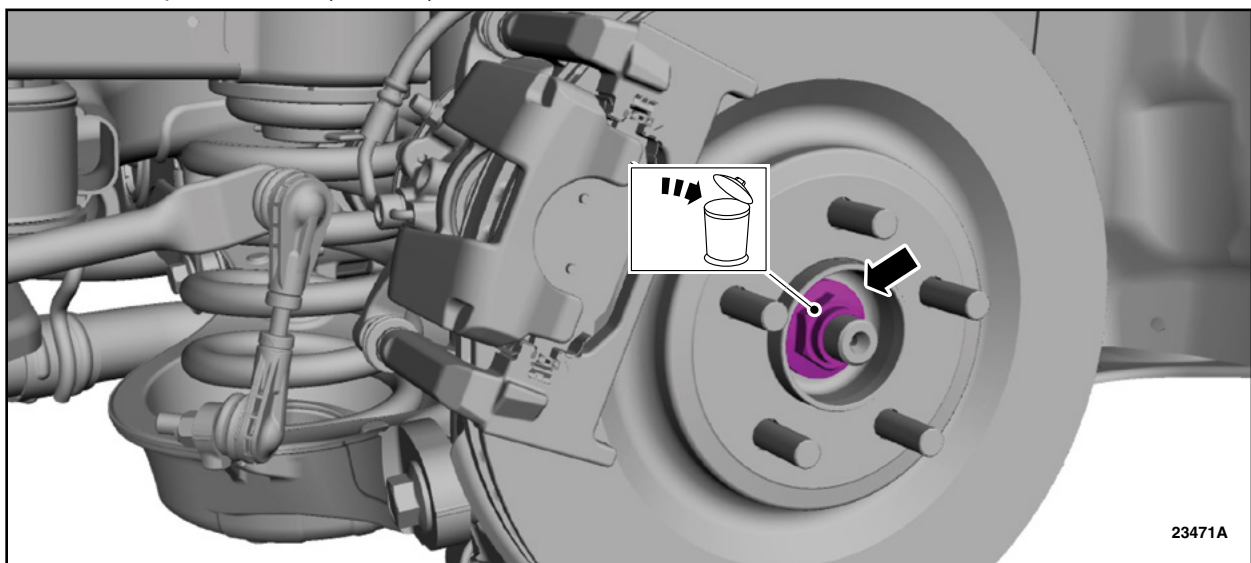
FIGURE 4

7. Remove and discard the LH rear wheel hub nut. See Figure 4.

• Torque: 221 lb.ft (300 Nm).

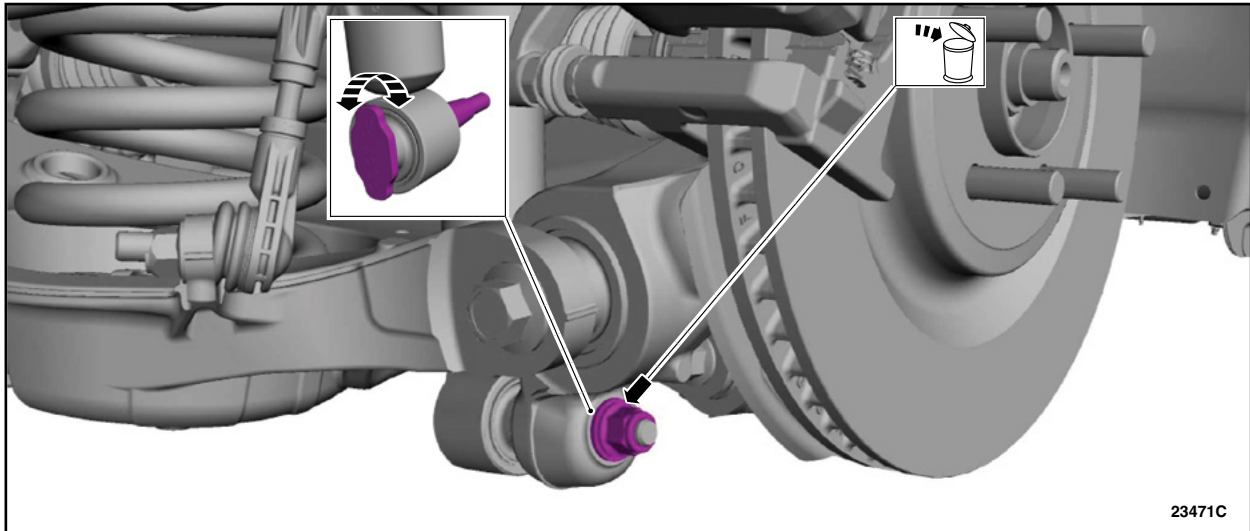
FIGURE 5

9. Remove and discard the LH rear shock absorber lower nut. See Figure 5.

- Torque: 59 lb.ft (80 Nm).

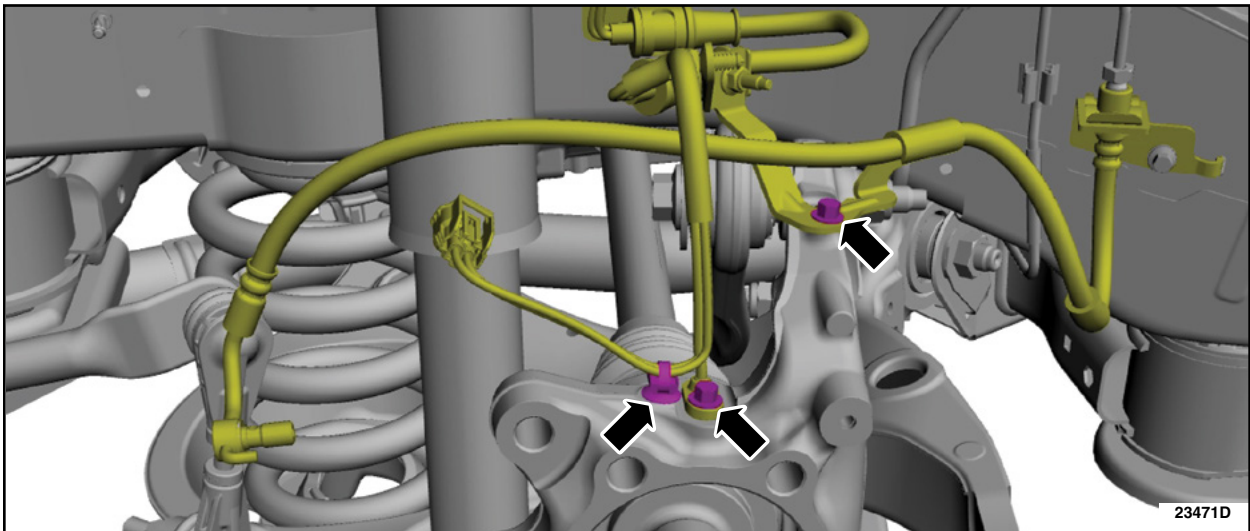
FIGURE 6

10. Remove the LH rear wheel speed sensor bolt and position the wheel speed sensor aside. Then, remove the brake hose bracket bolt and position the brake hose bracket aside. See Figure 6.

- Brake hose bracket bolt torque: 133 lb.in (15 Nm).
- Wheel speed sensor bolt torque: 133 lb.in (15 Nm).

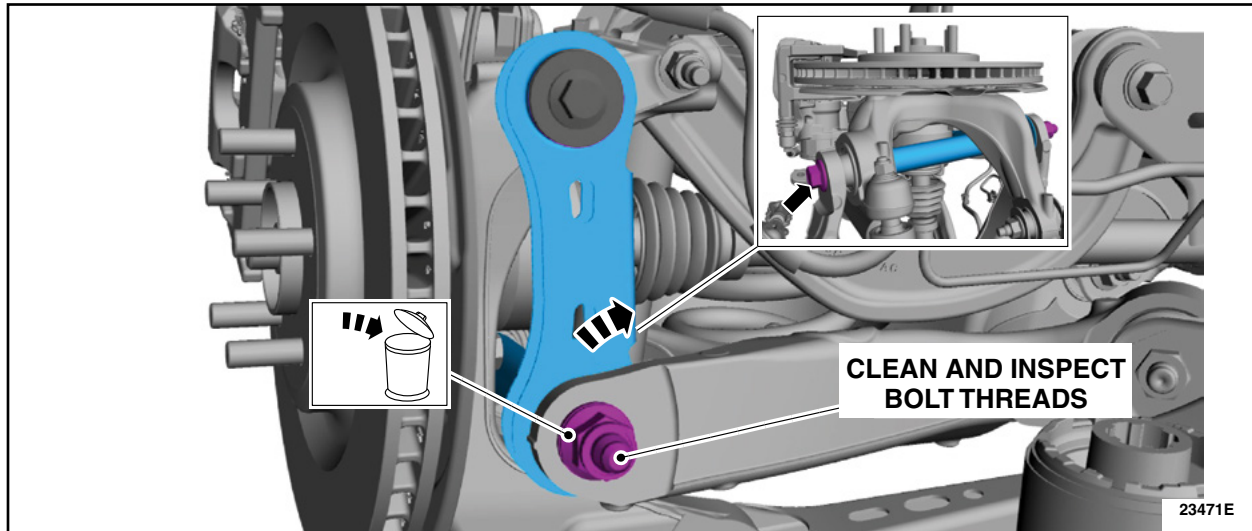
FIGURE 7

11. Remove and discard the LH rear lower arm vertical link lower nut. Then, remove, clean and inspect the LH rear lower arm vertical link lower bolt threads. If the threads are not damaged, apply LOCTITE® 263™, or equivalent (Obtain locally), and reuse the bolt and order a *new* nut. If the threads are damaged order a *new* nut and bolt. See Figure 7.

• Torque: 258 lb.ft (350 Nm).

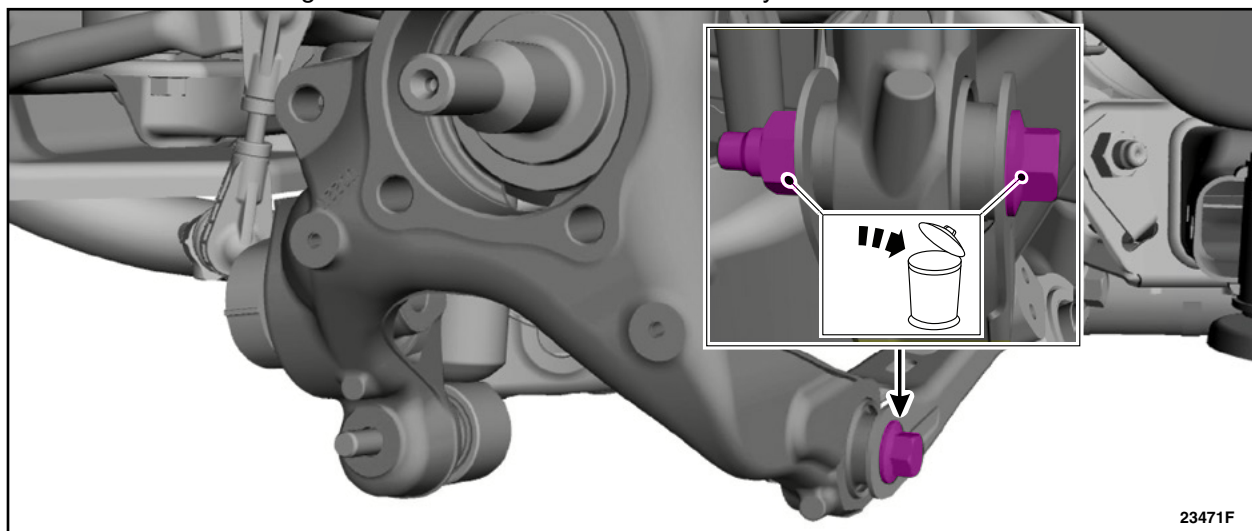
FIGURE 8

12. Remove and discard the LH rear toe link-to-wheel knuckle bolt and nut. See Figure 8.

• Torque: 129 lb.ft (175 Nm).

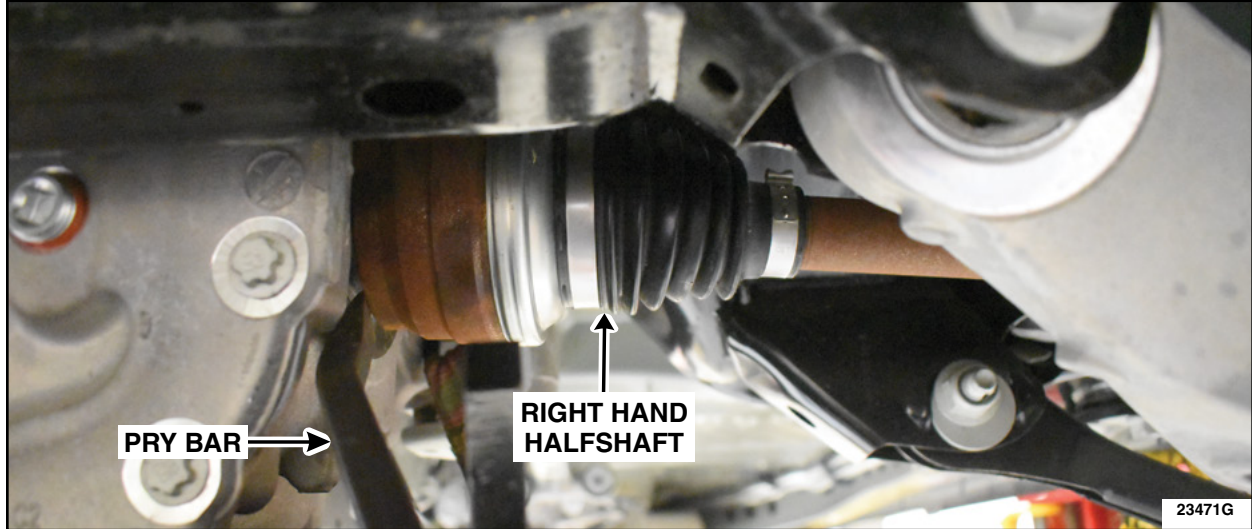
FIGURE 9

15. Using a pry bar, disengage the RH rear halfshaft inner cir-clip from the rear axle assembly.
See Figure 9.

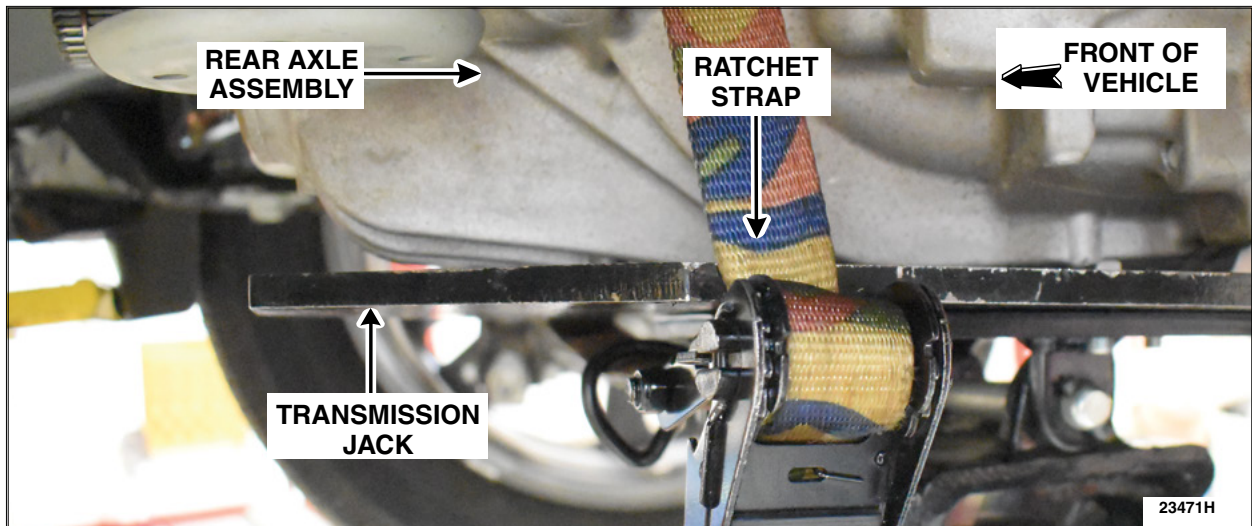
FIGURE 10

16. Secure the rear axle assembly to the transmission jack using a ratchet strap. See Figure 10.

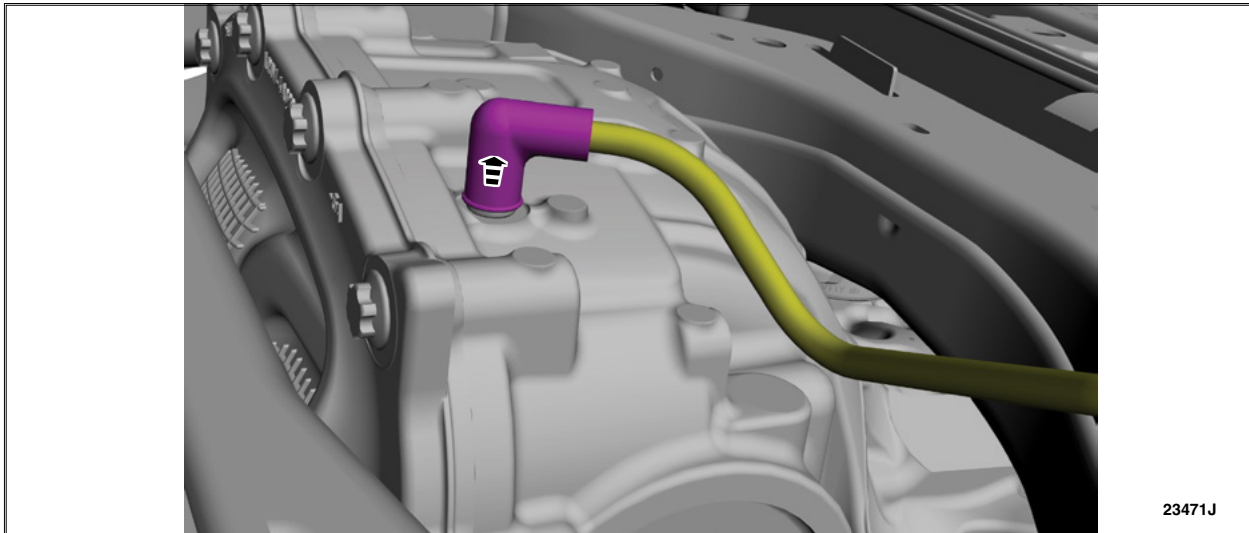
FIGURE 11

18. Disconnect and position the axle assembly vent hose aside. See Figure 11.

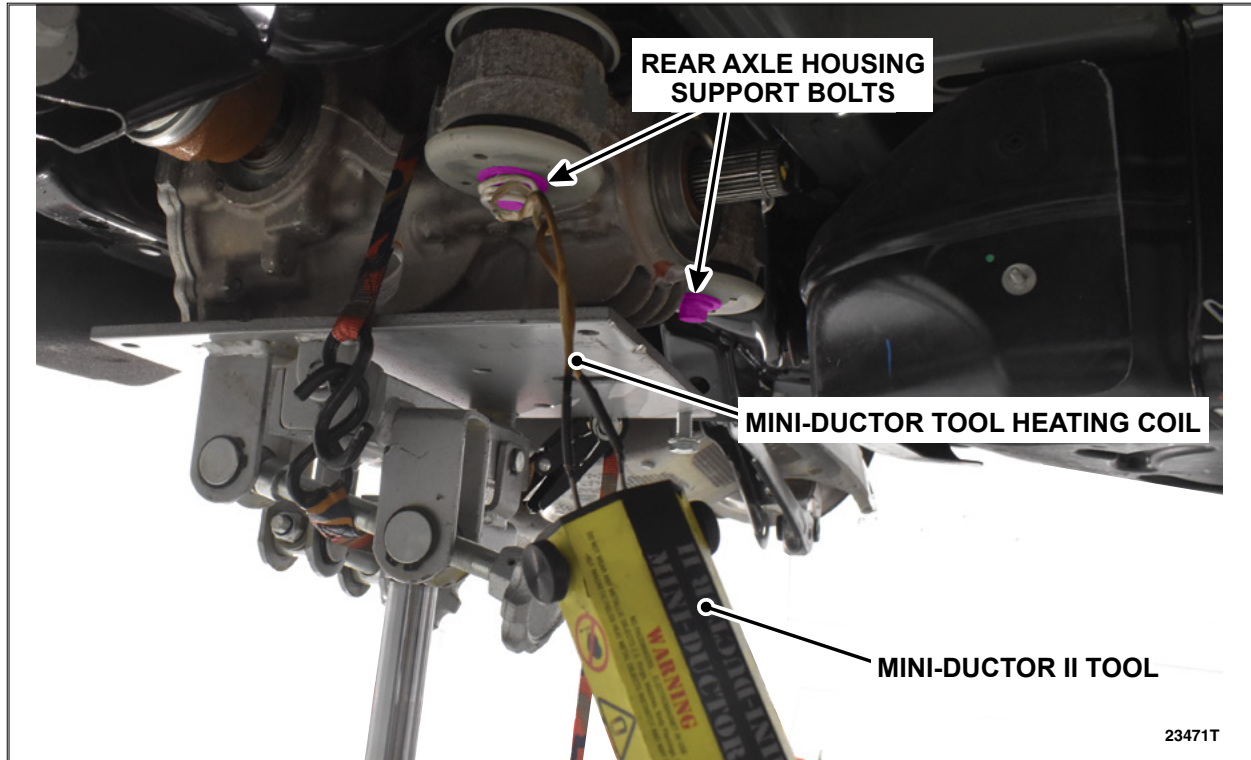
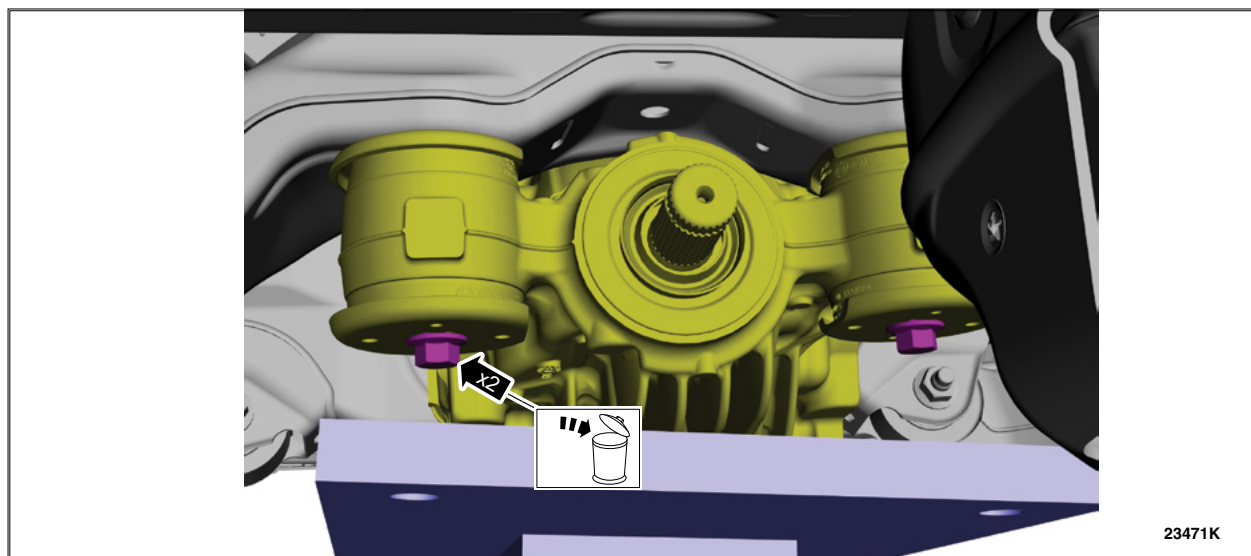
19. Using a flameless heat tool, such as the Rotunda Mini-Ductor II (part number IDIMD-700) or equivalent, heat up both front rear axle housing support bolts, as shown in Figure 12. Using a breaker bar, loosen both bolts. Then remove and discard both rear axle housing support bolts. See Figure 13.

- Torque: 129 lb.ft (175 Nm).

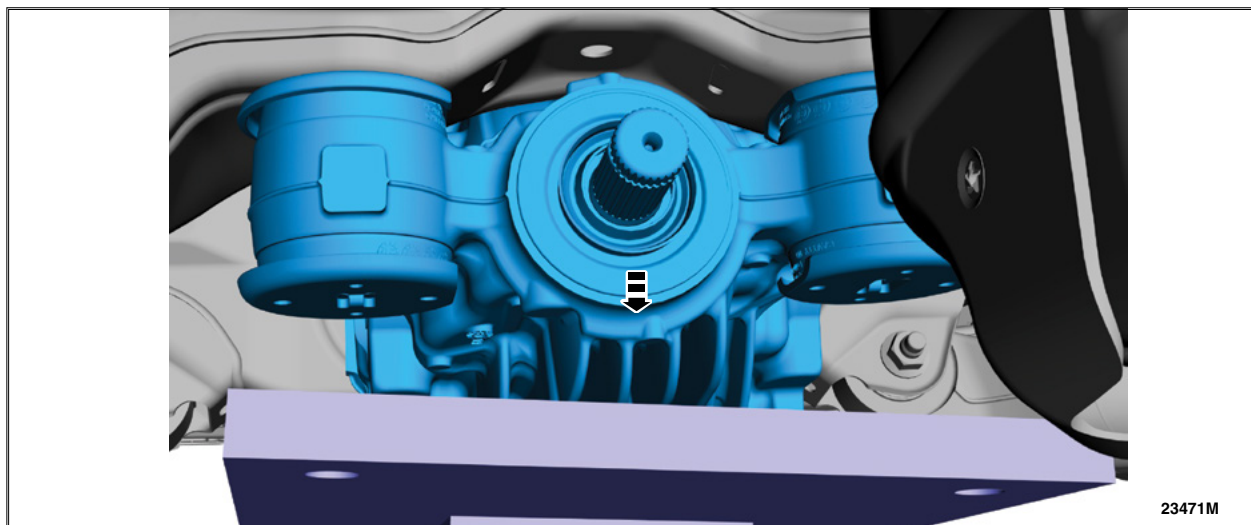
FIGURE 15

21. Gently lower down the transmission jack and remove the rear axle assembly. See Figure 15.
Use the General Equipment: Transmission Jack.

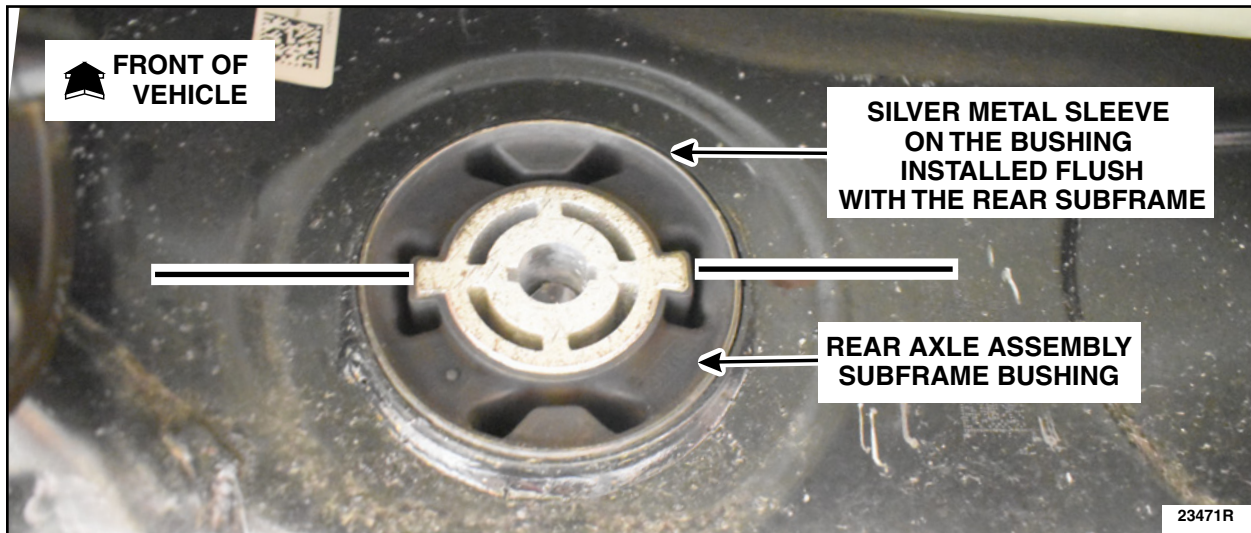
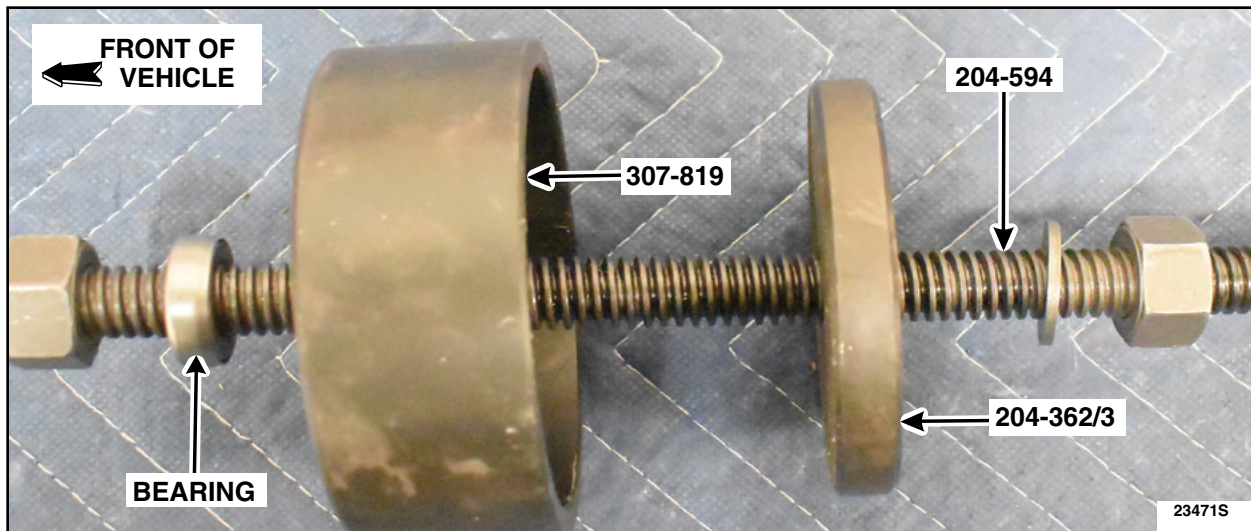
25. Using the ESST tools listed below, install the *new* rear axle assembly subframe bushing. See Figures 18 and 19.

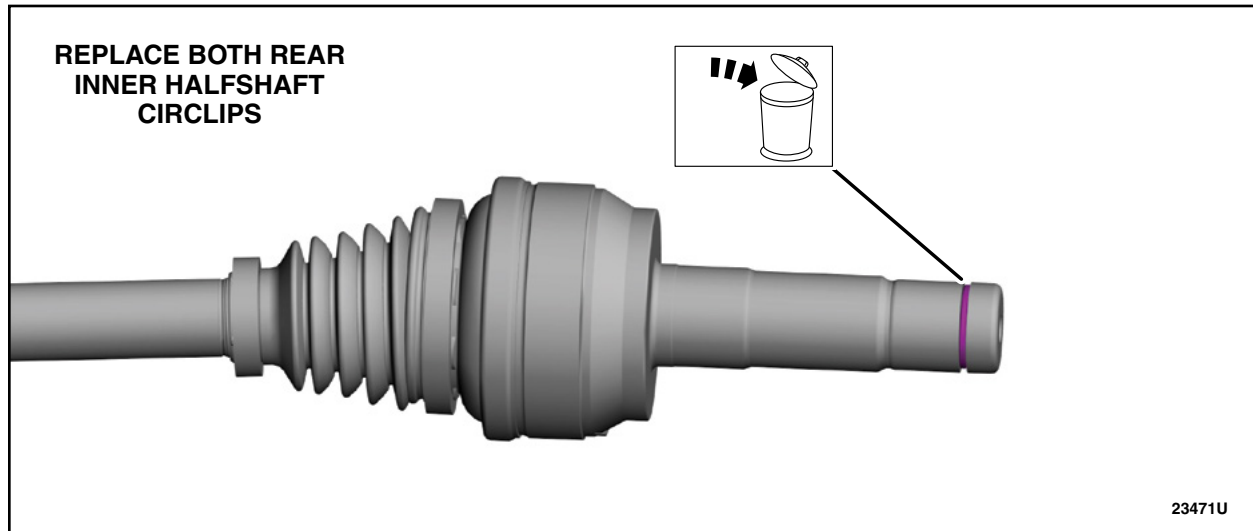
FIGURE 20

27. Remove and discard both rear inner halfshaft circlips. Then, install *new* circlips onto both rear inner halfshafts. See Figure 20. Then, proceed to the next Step.
