Stacy L. Balzer
 Director
 Service Engineering Operations
 Ford Customer Service Division

SUBJECT: **NEW VEHICLE DEMONSTRATION / DELIVERY HOLD – *Supplement # 1***
Safety Recall 23S55

Certain 2020-2022 Model Year Explorer Vehicles
 Rear Axle Bolt Fractures

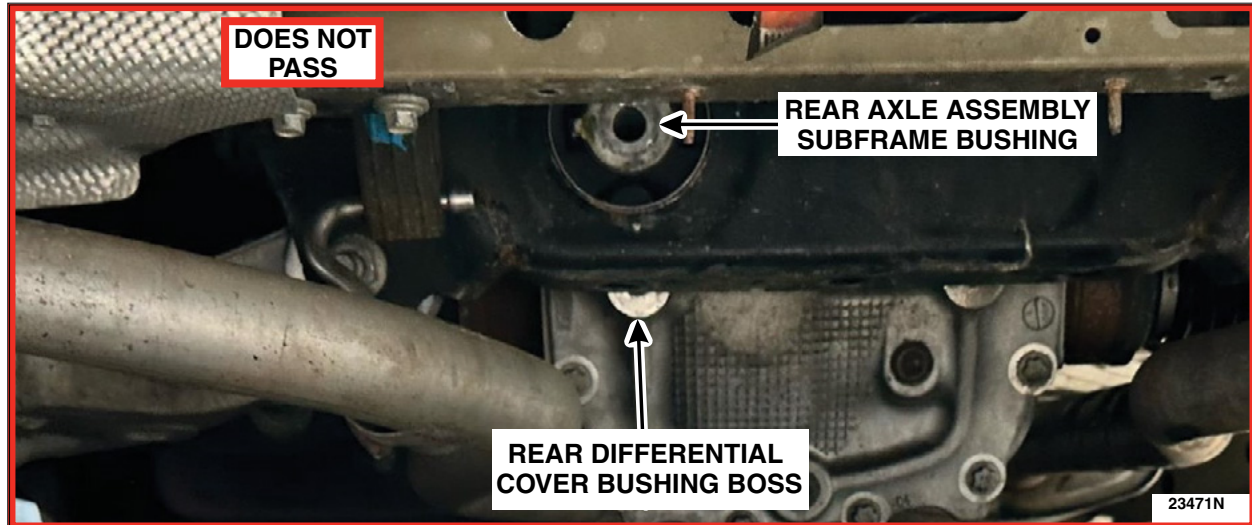
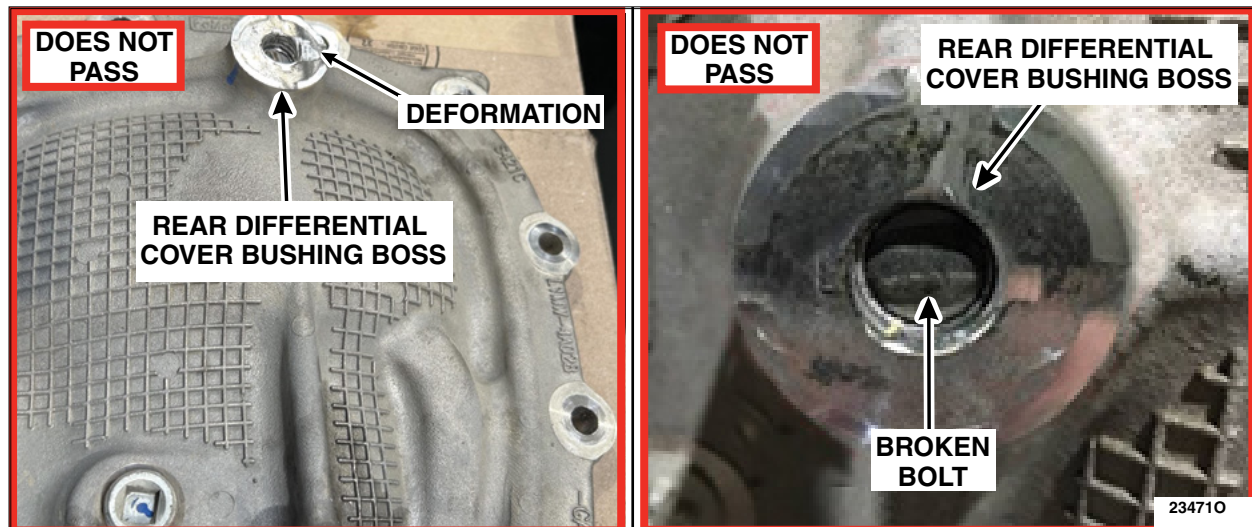
20. Visually inspect the rear differential cover bushing boss for damage (broken fastener, scoring, cracks and/or deformation and damaged threads). Is the rear differential cover bushing boss damaged?
See Figures 13 and 14.

YES - Does not pass inspection. Install a *new* differential housing cover. Follow the WSM procedures in Section 205-02. Proceed to Step 23.
