TO: Mercedes-Benz Dealer Principals, General Managers, Sales Managers, Service Managers, Parts Managers	FROM: Gregory Gunther, Senior Manager, Vehicle Compliance and Analysis, Engineering Services
RE: <b>Recall Campaign Launch Notification</b> <b>Inspect 12V Starter/Alternator Wiring Harness</b> <b>MY22-23 SL (232 platform)</b>	DATE: November 3, 2023

Campaign No. 2023100014, November 2023

SUBJECT: **Model SL (232 platform)**  
**Model Year 2022-2023**

## **Inspect 12V Starter/Alternator Wiring Harness**

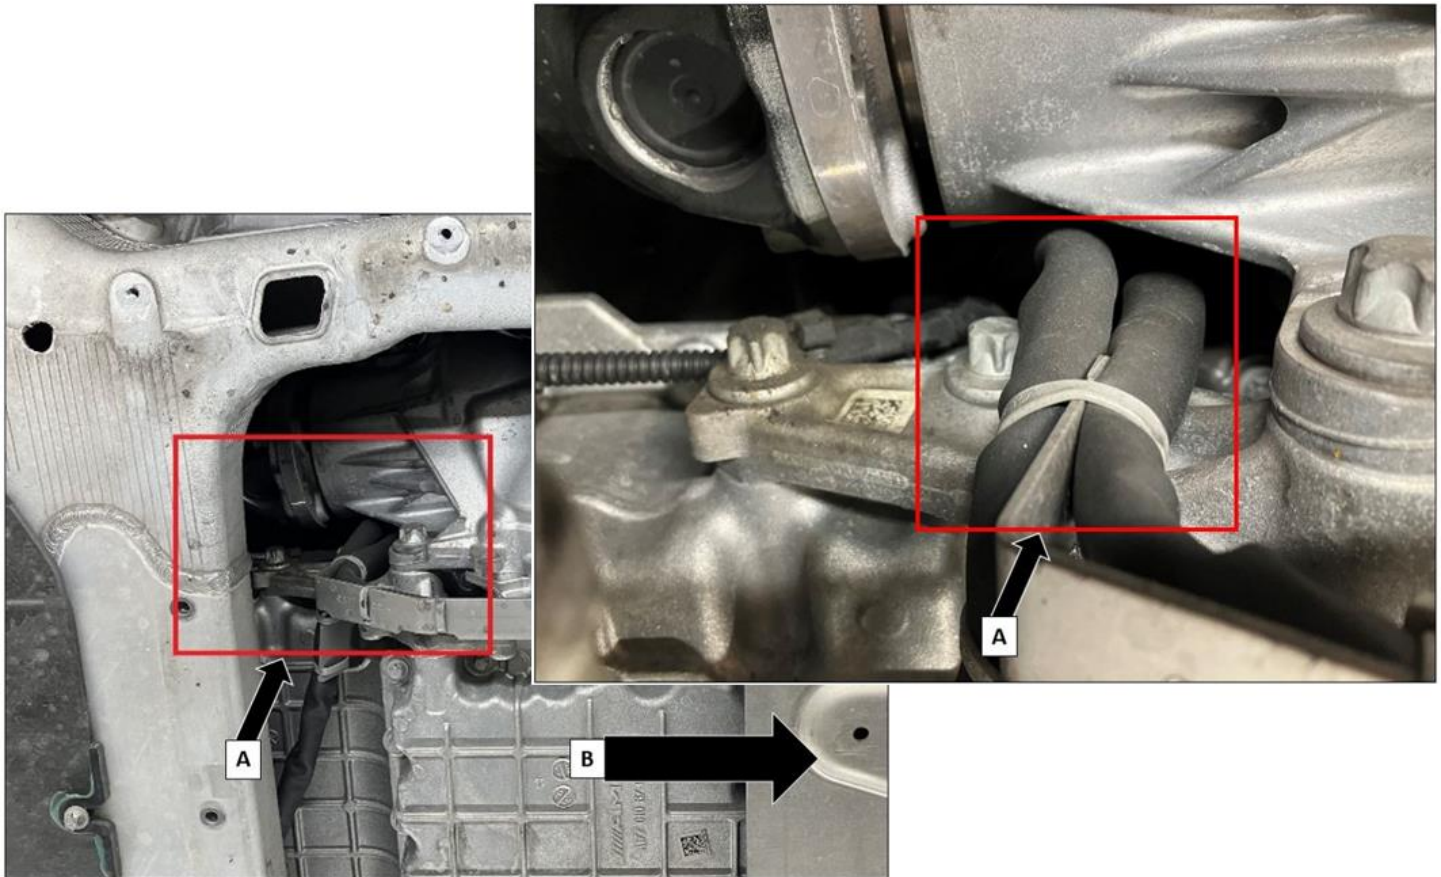
2. Check if the 12V starter/alternator wiring harness is too close to the propeller shaft and inspect it for damage near the propeller shaft (**A, Figure 1**).

**Figure 1:** Inspect starter/alternator wiring harness near propeller shaft (**arrow A**), direction of travel (**arrow B**)

- a. Starter/alternator wiring harness **not damaged**, carry out **Work Procedure 1**.
- b. Starter/alternator wiring harness **damaged**, carry out **Work Procedure 2**.

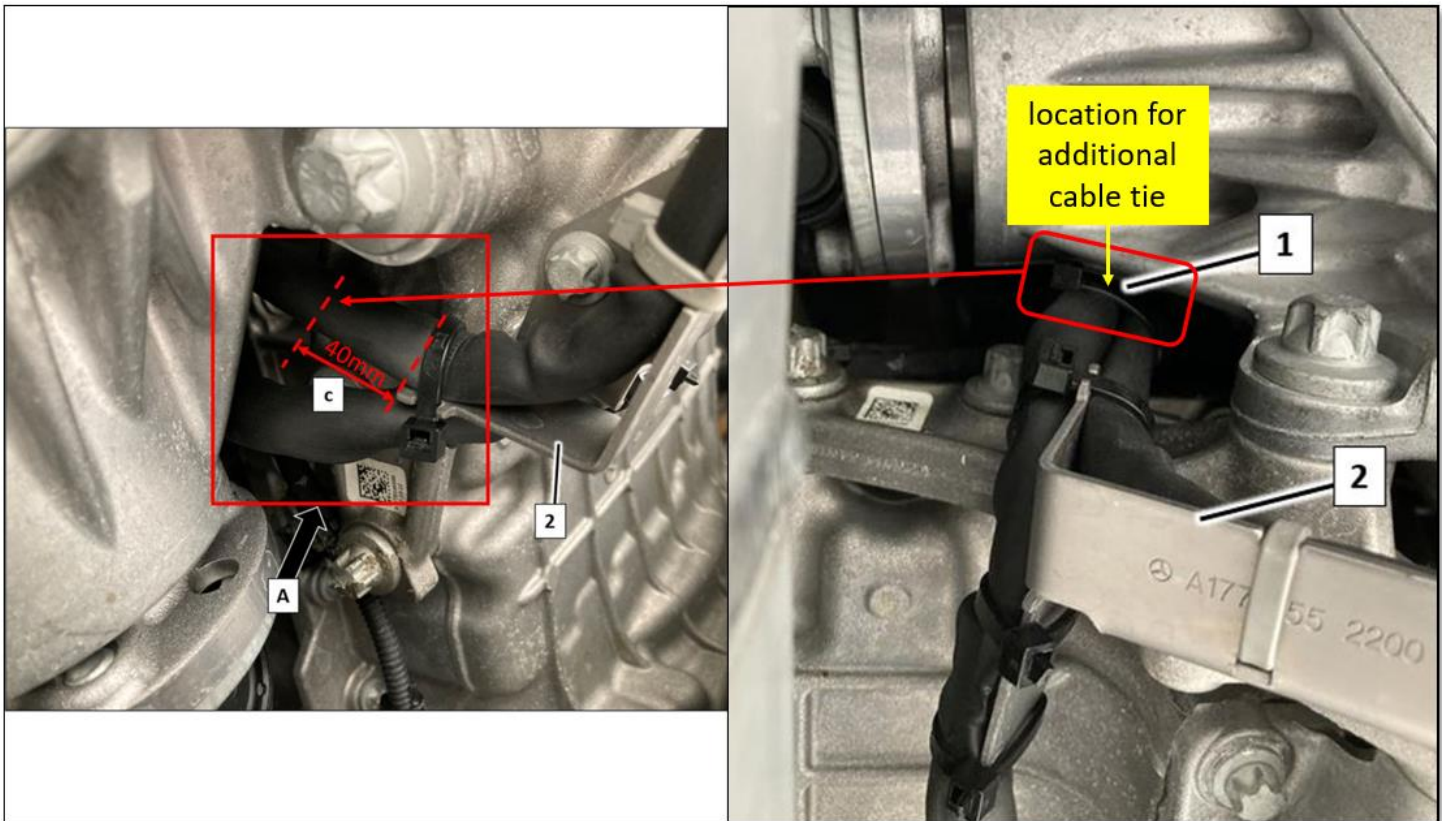
**Figure 2:** Install cable tie on starter/alternator wiring harness

1. If the starter/alternator wiring harness is **not damaged**, install an additional cable tie (1, **Figure 2**) in area near the propeller shaft at approx. 40 mm (**dimension c, Figure 2**) above the bracket (2, **Figure 2**).
