Safety Recall 23KWK: C500/T660/T800/W900 Seatbelt Intermediate Connecting Point (ICP) Bar Spacer

23KWK / 23V717 / 2023-573

11/28/2023

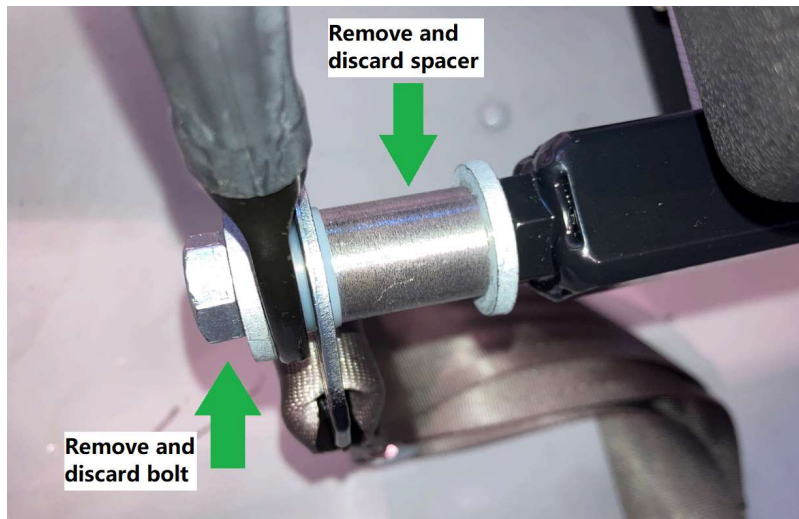
On certain Kenworth model year 2018 through 2024 C500/T660/T800/W900 trucks with Sears Atlas 70 or 80 series seats, an additional spacer was included in the joint connecting the seat structure to the seatbelt tether and buckle. This spacer results in an increased moment arm on the seat

structure, which increases the load on the joint. A failed Intermediate Connecting Point (ICP) bar may allow the seatbelt to slip when fully loaded by the weight of the seat occupant during a severe collision, which may increase the risk of injury.

1. Remove and discard the bolt securing the seatbelt buckle to the ICP bar on the right side of the seat.
2. Remove and discard the spacer.
