Subarunet Announcement

UPDATE Safety Recall/STOP SALE: WRP-23 Driveshaft Failure

Subaru of America, Inc. (Subaru) has initiated a safety recall for certain 2023 model year WRX vehicles, certain 2024 model year Crosstrek and Impreza vehicles, and certain 2023-2024 model year Forester vehicles.

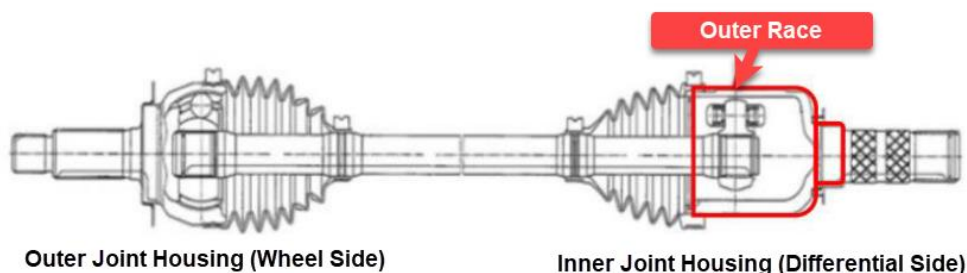
The vehicles included in this recall may be equipped with a front drive shaft assembly with an outer race (shown below) that could crack, due to improper cooling during the manufacturing process.

For stop sale and SSLP vehicles only, Subaru retailers should inspect the front drive shaft lot numbers. If the affected lot number is found, the vehicle is to remain on HOLD under this stop sale until recall remedy parts are available. A future announcement will be made when parts are available.

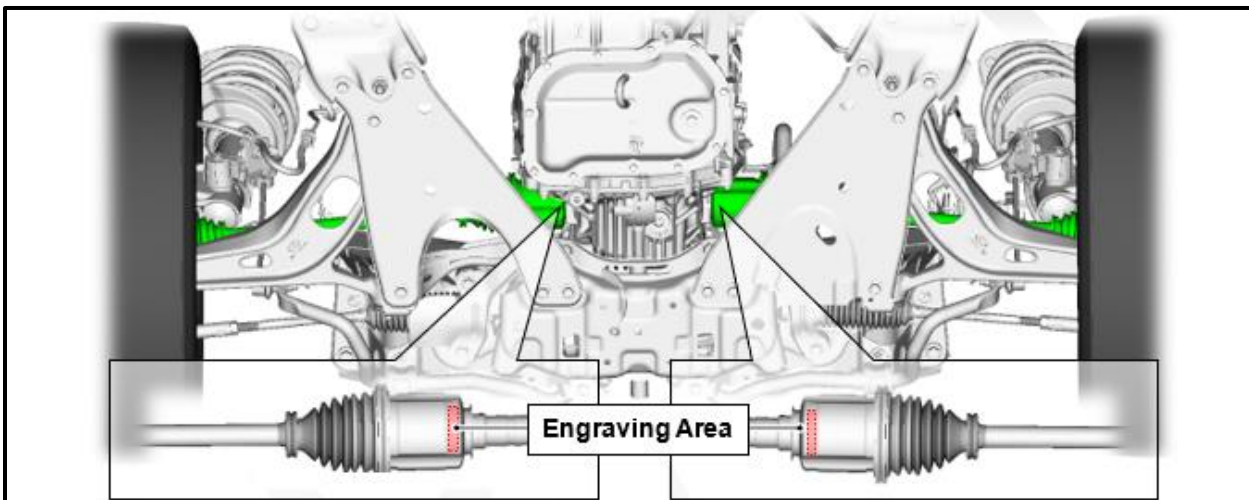
- There are three engravings on the drive shaft outer race. One is the lot number, and the others are NOT lot numbers. The lot number engraving is shown in the images below.
- SLOWLY rotate the wheel to find the lot number. Remove dust and/or dirt using a clean cloth to make the numbers more visible. A flashlight will also aid in the reading.

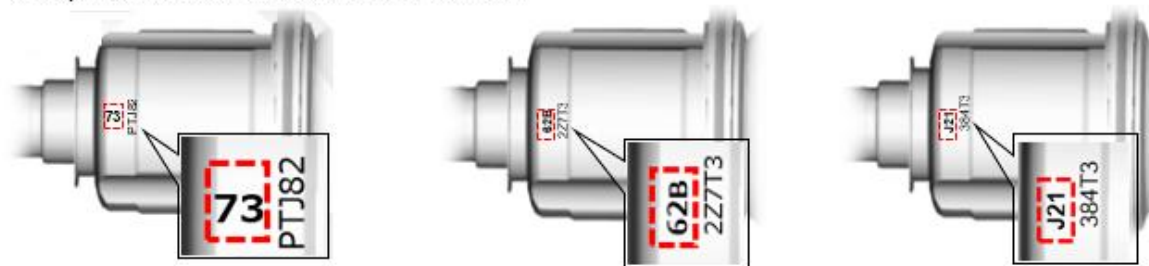
There is one engraving of either of the following types on the outer race. The 2-digit number (followed by a letter) in the red frame below is a lot number.

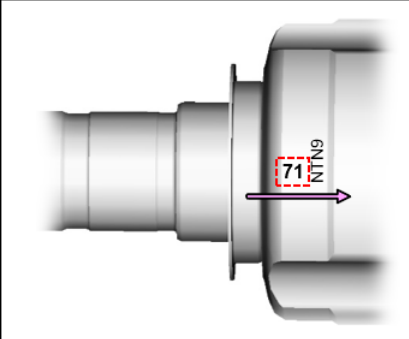
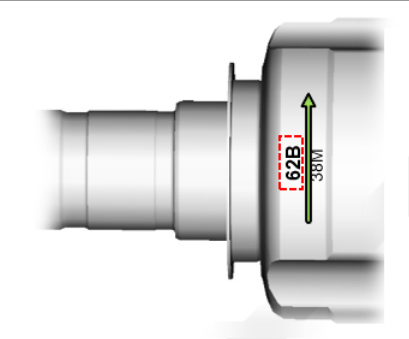
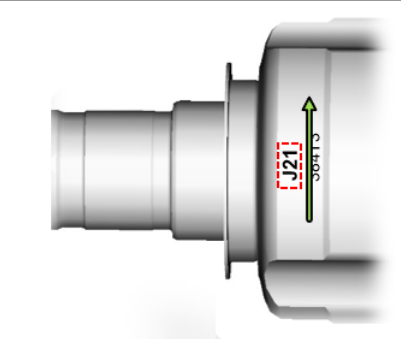
Engraving Type 1	Engraving Type 2	Engraving Type 3
2-digit number is engraved in the axis direction.	3 digit-character starting with a number is engraved in the circumferential direction.	3 digit-character starting with a number is engraved in the circumferential direction.

Results		
Engraving style 1	Refer to the table below for further details.	
Engraving style 2 or 3	The drive shaft is a good part. Record and attach the lot number to the repair order.

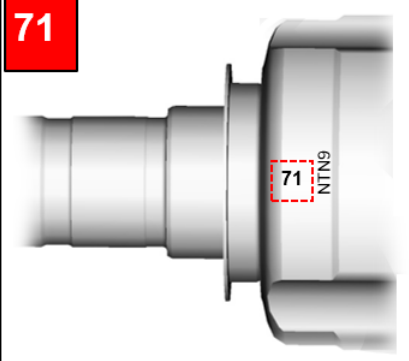
71

Results					
71, 73 or 75		The drive shaft is a defective part. The vehicle is to be placed on HOLD under Stop Sale until further notice.			
Other 2-digit numbers		The drive shaft is a good part. Record and attach the lot number to the repair order.

YES: The vehicle should remain on HOLD under Stop Sale until remedy parts are available. No claim should be submitted until the affected driveshaft(s) are replaced.
