TO: Freightliner Dealer Principals, General Managers, Sales Managers, Service Managers, Parts Managers	FROM: Anthony Washington, Senior Manager, Regulations and Certifications
<b>Re: Launch Recall Campaign Notification</b> <b>Model: Sprinter (907)</b> <b>Model Year: 2021</b> <b>Check Top Coat Paint Adhesion</b> <b>NHTSA ID: 23V806</b>	DATE: October, 2024

Campaign No. :	Campaign Desc. :	Check Top Coat Paint Adhesion
2024010004	VS3LACKHA	
This is to notify you of a Recall Campaign launch to check the Top Coat Paint Adhesion on approximately 5 MY 2021-2023 Freightliner Sprinter Vans. The recall campaign will be visible on the <a href="http://www.safercar.gov">www.safercar.gov</a> website and may generate questions from customers. All affected VINs will be flagged as "OPEN" in VMI and cannot be sold until remedied.		
Background		
Issue	Mercedes-Benz AG, the manufacturer of Sprinter vehicles, has determined that on certain Freightliner Sprinter (907 platform) vehicles, the chemical composition of the topcoat paint might not meet specifications. In such a case, adhesion of the fixed windows to the vehicle body might become impaired. As a result, a loosening or detachment of the windows

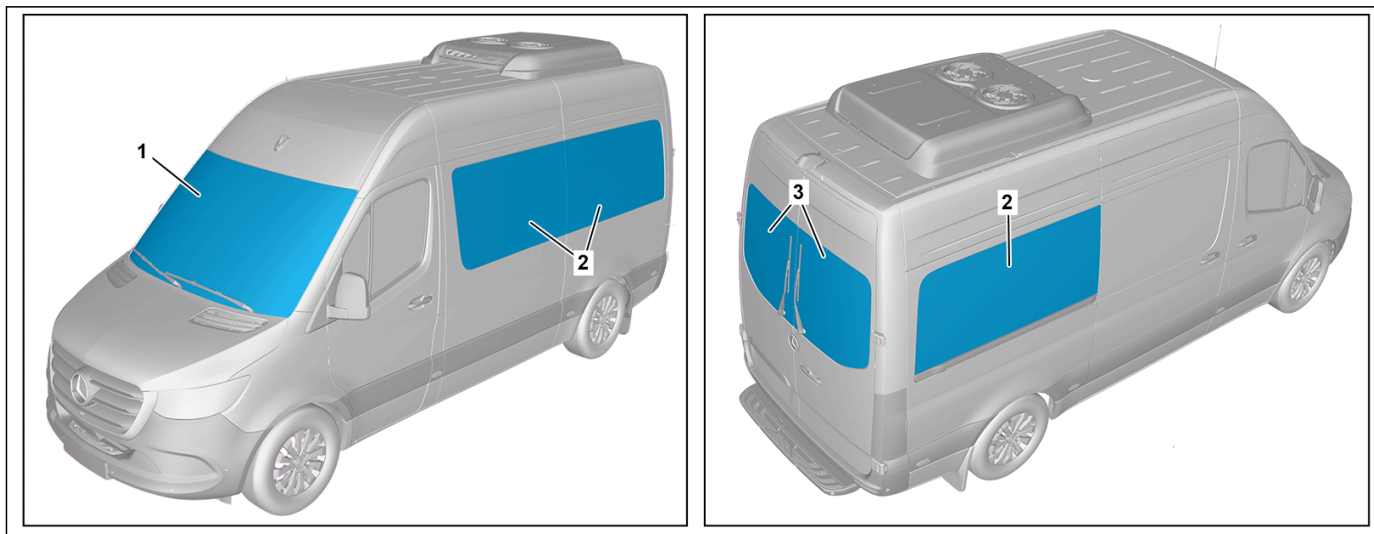
D98.00-A102-78

1 Windshield

2 Side window(s)

3 Rear windows

<b>Remove</b>		
4	Remove windshield (1).	<p>Model 907</p> <p>except code F49 (Heated windscreen)</p> <p>Model 907</p> <p>with code F49 (Heated windscreen)</p>	<p>AR67.10-D-1700TS</p> <p>AR67.10-D-1700TSB</p>
5	Remove side window (2).	Model 907.6/7	AR67.30-D-2400TS
6	Remove rear windows (3).	<p>Model 907.6/7 with code H22 (Heated rear window) and with code W61 (Windows in tailgate / rear-end doors) or code W78 (Windows in tailgate or rear-end door with wiper and washer system)</p> <p>Model 907.6/7 except code H22 (Heated rear window) and with code W61 (Windows in tailgate / rear-end doors) or code W78 (Windows in tailgate or rear-end door with wiper and washer system)</p>	<p>AR67.20-D-5145TS</p> <p>AR67.20-D-5145TSB</p>

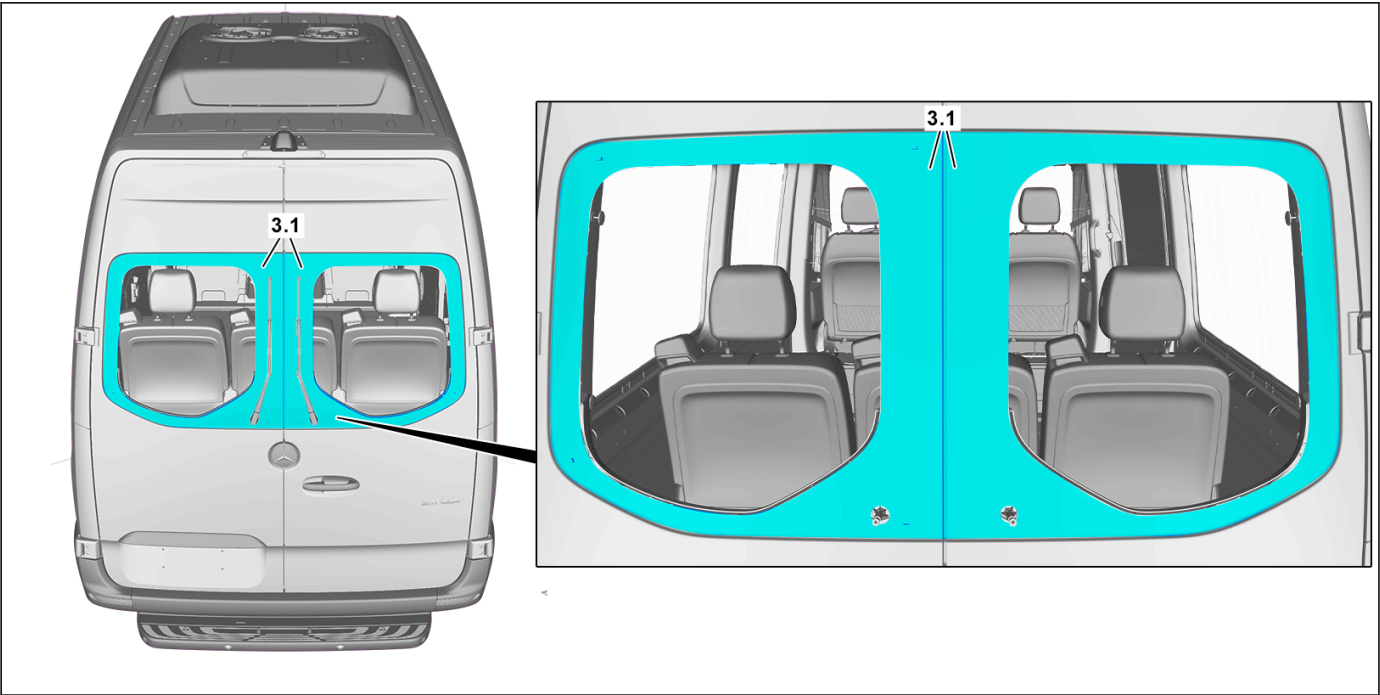
D98.00-A105-79

3.1      *Rear window contact surface*

</p> <p>See guidelines for paint technology in the workshop portal.</p>	
8	Grind respective contact surfaces (1.1, 2.1, 3.1) down to bare metal.

<b>Clean</b>		
9	Clean contact surfaces (1.1, 2.1, 3.1).	Cleaner	<a href="#">BR00.45-Z-1025-04A</a>

10	Prime contact surfaces (1.1, 2.1, 3.1) in repair areas using primer filler.

Use only primer fillers approved by manufacturer. See guidelines for paint technology in the workshop portal.	
11	Paint contact surfaces (1.1, 2.1, 3.1) in repair area.

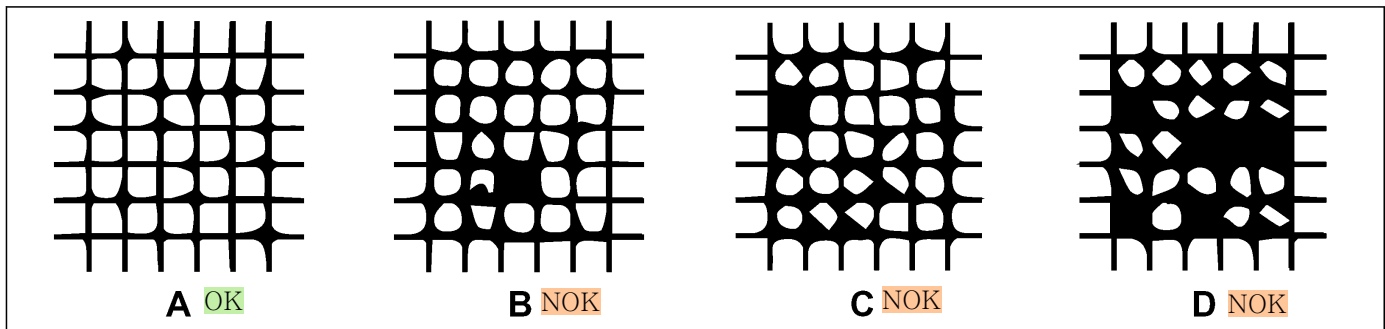
D98.00-0002-07

Cross cut parameter	Description	Illustration
0	The cut edges are completely smooth and none of the squares of the cut show signs of chipping.	-
1	Minor chipping of the coating at the points of intersection of the grid lines. Chipped-off area not more than 5% of the cross cut surface.	Fig. A
2	Coating is chipped off along the cut edges or at the points of intersection of the grid lines. Chipped-off area more than 5% but not more than 15% of the cross cut surface.	Fig. B
3	Coating is chipped off in wide strips along the cut edges partially or completely or some squares are partially or completely chipped off. Chipped-off area more than 15% but not more than 35% of the cross cut surface.	Figure C
4	Coating is chipped off in wide strips along the cut edges or some squares are partially or completely chipped off. Chipped-off area more than 35% but not more than 65% of the cross cut surface.	Figure D

5	Every case of chipping which cannot be categorized as cross cut parameter 4 any more.	-

- 6 Evaluate paint residue on adhesive tape. If the evaluation is in the "cross-cut test characteristic value" 2, 3, 4 or 5, **Contact your VAOM to have a CAC case created.**
