TO: Mercedes-Benz Dealer Principals, General Managers, Sales Managers, Service Managers, Parts Managers	FROM: Anthony Washington, Senior Manager, Regulations and Certifications
Re: Launch Recall Campaign Notification Model: Sprinter (907) Model Years: 2021-2023 Check Top Coat Paint Adhesion NHTSA ID: 23V806	DATE: October, 2024

IMPORTANT RECALL CAMPAIGN INFORMATION

Campaign No. :	Campaign Desc. :	Check Top Coat Paint Adhesion
2024010004	VS3LACKHA	
This is to notify you of a Recall Campaign launch to check the Top Coat Paint Adhesion on approximately 126 MY 2021-2023 Mercedes-Benz Sprinter Vans. The recall campaign will be visible on the www.safercar.gov website and may generate questions from customers. All affected VINs will be flagged as " OPEN " in VMI and cannot be sold.		
Background		
Issue	Mercedes-Benz AG, the manufacturer of Sprinter vehicles, has determined that on certain Mercedes-Benz Sprinter (907 platform) vehicles, the chemical composition of the topcoat paint might not meet specifications. In such a case, adhesion of the fixed windows to the vehicle body might become impaired. As a result, a loosening or detachment of the windows cannot be ruled out over the vehicle

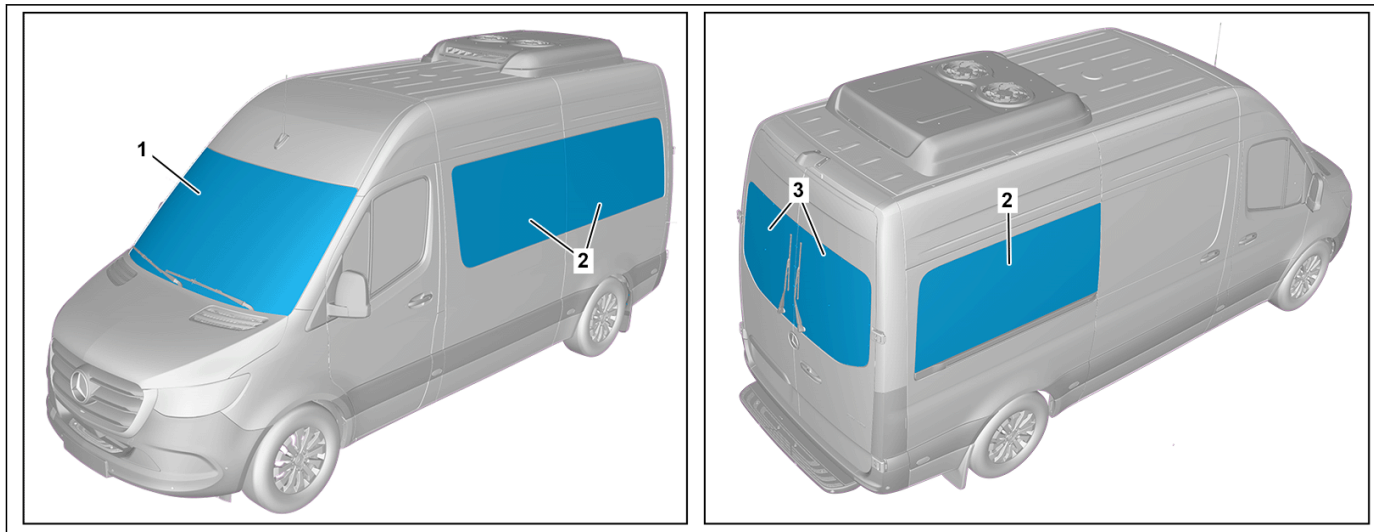
D98.00-A102-78

1 Windshield

2 Side window(s)

3 Rear windows

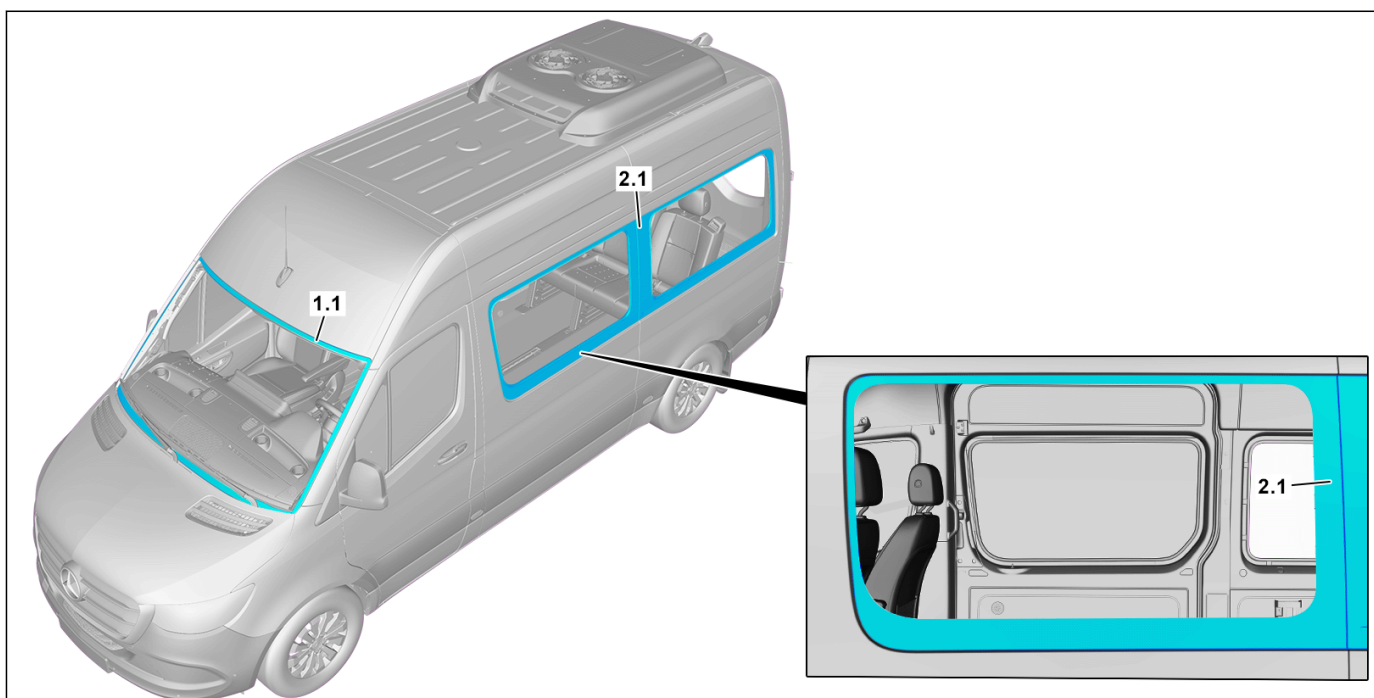
D98.00-A104-79

1.1 Windshield contact surface

2.1 Side window contact surface

</p> <p>See guidelines for paint technology in the workshop portal.</p>	
8	Grind respective contact surfaces (1.1, 2.1, 3.1) down to bare metal.

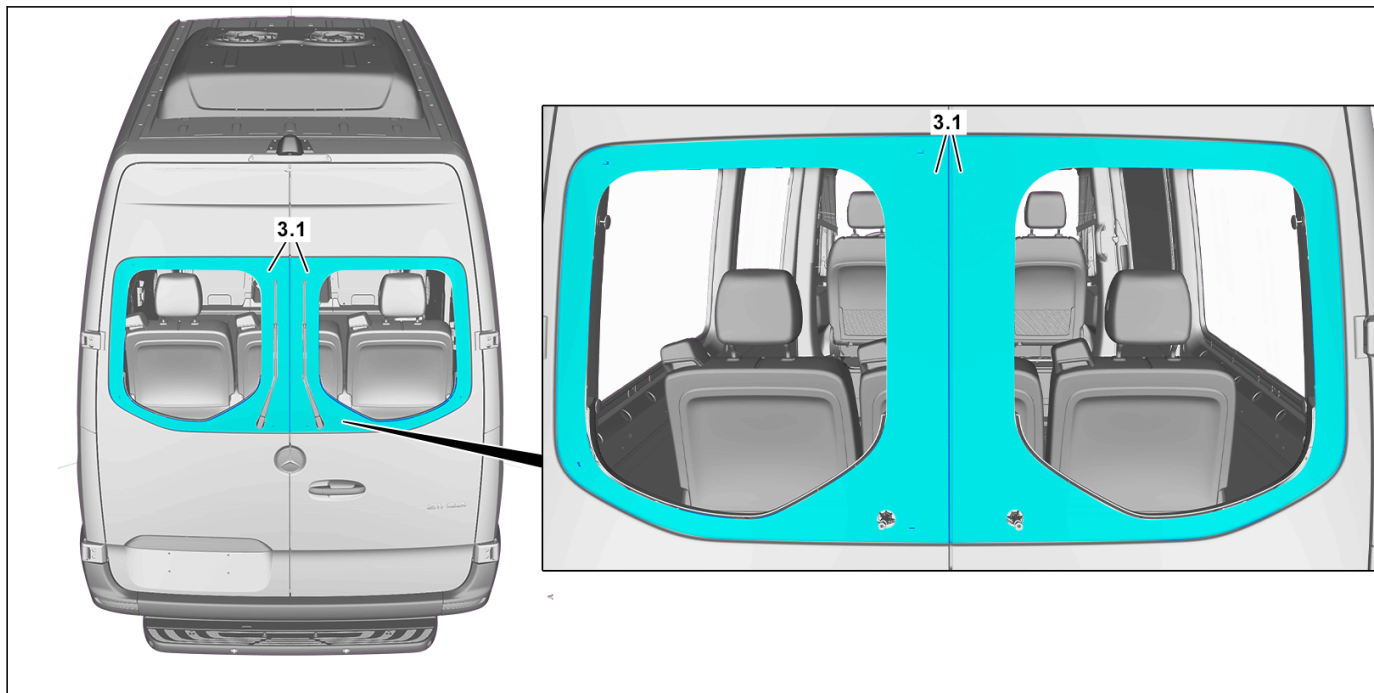
D98.00-A105-79

3.1 Rear window contact surface

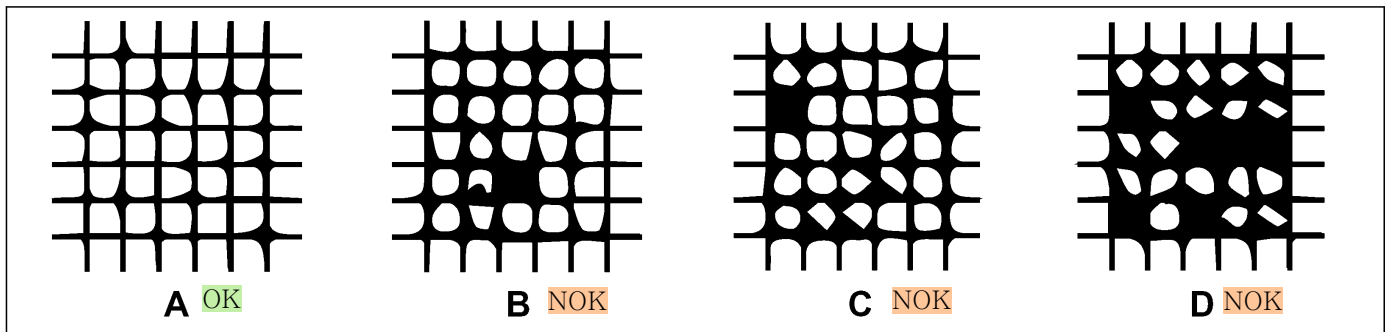
D98.00-0002-07

Cross cut parameter	Description	Illustration
0	The cut edges are completely smooth and none of the squares of the cut show signs of chipping.	-
1	Minor chipping of the coating at the points of intersection of the grid lines. Chipped-off area not more than 5% of the cross cut surface.	Fig. A
2	Coating is chipped off along the cut edges or at the points of intersection of the grid lines. Chipped-off area more than 5% but not more than 15% of the cross cut surface.	Fig. B
3	Coating is chipped off in wide strips along the cut edges partially or completely or some squares are partially or completely chipped off. Chipped-off area more than 15% but not more than 35% of the cross cut surface.	Figure C
4	Coating is chipped off in wide strips along the cut edges or some squares are partially or completely chipped off. Chipped-off area more than 35% but not more than 65% of the cross cut surface.	Figure D

5	Every case of chipping which cannot be categorized as cross cut parameter 4 any more.	-

6 Evaluate paint residue on adhesive tape. If the evaluation is in the "cross-cut test characteristic value" 2, 3, 4 or 5, **Contact your VAOM to have a CAC case created.**
