Modification Bulletin

[60-0009][MB][EUR][YT193] Steering arm mounting check

**steering arm mounting check YT193
YT193 on road**

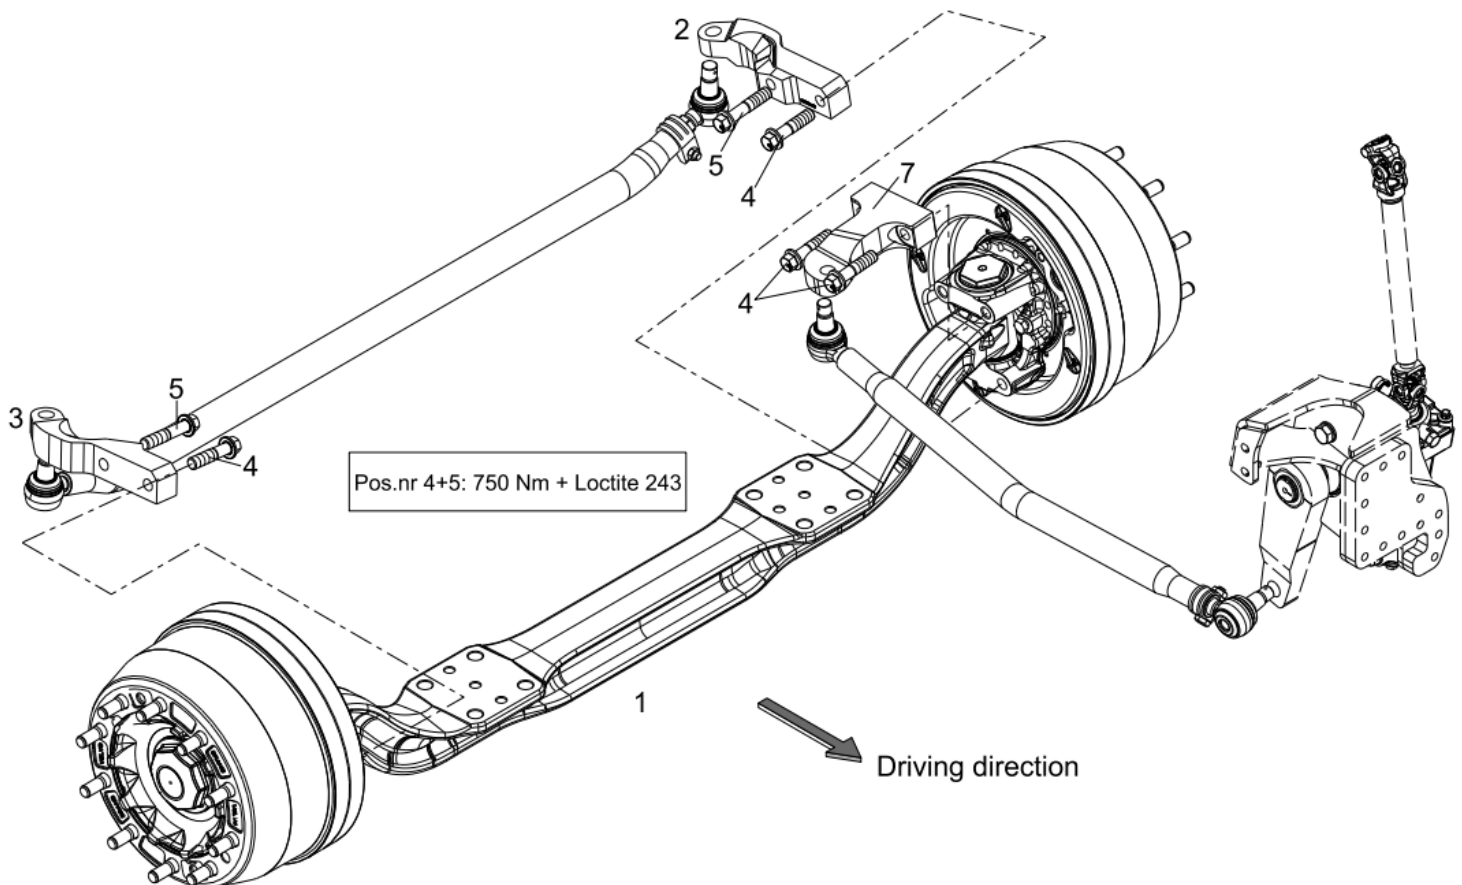
figure 1, front axle steering arms, parts group 60-01-01-146

From the start of production of the YTxx3 until november 2022 the lower steering arms have been mounted to the front axle steering knuckle without cleaning the steering knuckle contact surface from paint. This can result in an insecure connection of the steering arm to the steering knuckle. Also the steering arm that is mounted to the top of the left steering knuckle has been mounted without proper cleaning of the mounting surface.

This paint layer can cause the connection to be insecure and therefore this connection has to be remedied.

The steering arms must be removed and the contact surfaces must be cleaned from paint or other residuals. Finally the steering arms should be re-installed using new bolts. To do so please read the instructions below carefully.

1. Park the vehicle on a safe location and apply the parking brake.
2. Place wheel chocks on the rear wheels.
3. Disconnect the main switch and make sure no one can start the vehicle unintended
4. Jack up the front axle and place the front axle on axle stands.
5. Remove the 2 bolts that connect the upper steering arm (position 7 in figure 1) to the left hand side steering knuckle.
6. Clean the contact surfaces of the steering arm and the steering knuckle. Make sure that all paint or any other contamination is removed.
7. Clean the m22x1,5 threaded holes and degrease.
8. Apply two beads of Loctite 243 in the threaded holes, do not apply Loctite to the bolt.
9. Re-install the steering arm to the steering knuckle, using two new bolts V1079491.

10. Torque the bolts to 750 Nm and mark the bolt heads once torqued.
11. Remove the bolts that connect the lower steering arms (position 2 and 3 in figure 1) to the steering knuckles.
12. Clean the contact surfaces of the steering arms and the steering knuckles. Make sure that all paint or any other contamination is removed.
13. Clean the 4 m22x1,5 threaded holes and degrease.
14. Apply two beads of Loctite 243 in the threaded holes, do not apply Loctite to the bolt.

15. Re-install the steering arms to the steering knuckle, using new bolts. Use one time V1079491 and one time V20392139 per side.
16. Jack up the front axle, remove axle stands and lower the front axle.
