January 2024
FL987 A-B
NHTSA #23V-879
NHTSA #23V-846 (School Bus)
Transport Canada #2023-696

Subject: High Voltage Junction Box Inverter Cable

Models Affected: Specific model years 2023-2025 Freightliner Custom Chassis (FCCC) MT50E chassis and Thomas Built Buses (TBB) Saf-T-Liner C2 Jouley electric school buses, manufactured February 28, 2022, through October 18, 2023.

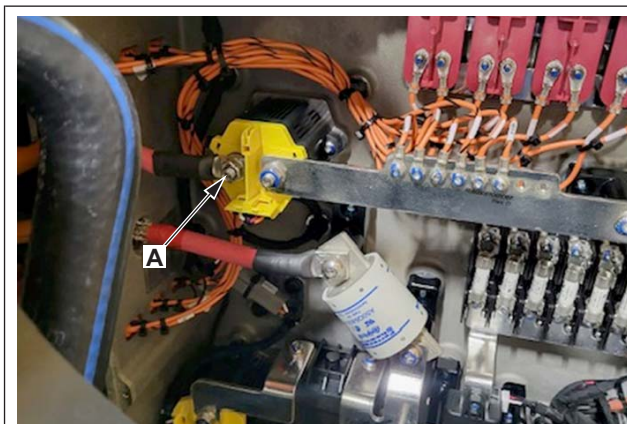
Fig. 1, High-Voltage Junction Box (inside view)

On the affected vehicles, fasteners at the joint connecting the high voltage inverter cable to the associated junction box hardware may not have been secured properly, which could lead to loss of drive power without prior warning, increasing the risk of a crash.

A. Remove the fastener from the upper high-voltage cable connection.

4. Repair the upper high-voltage (HV) cable connection.
 - 4.1 Remove the fastener from the upper HV cable connection (yellow device), located inside the high-voltage junction box (HVJB). See **Fig. 1**.
 - 4.2 Apply Loctite® 243 (blue) to the fastener threads.
 - 4.3 Reinstall the fastener on the upper HV cable connection, and tighten 89 lbf·in (1005 N·cm).
