January 2024
FL987 A-B
NHTSA #23V-879
NHTSA #23V-846 (School Bus)
Transport Canada #2023-696
(Revised March 2024)

Subject: High Voltage Junction Box Inverter Cable

Models Affected: Specific model years 2021-2025 Freightliner Custom Chassis (FCCC) MT50E chassis and Thomas Built Buses (TBB) Saf-T-Liner C2 Jouley electric school buses, manufactured December 11, 2019, through October 18, 2023.

Repairing High-Voltage (HV) Cable Connections

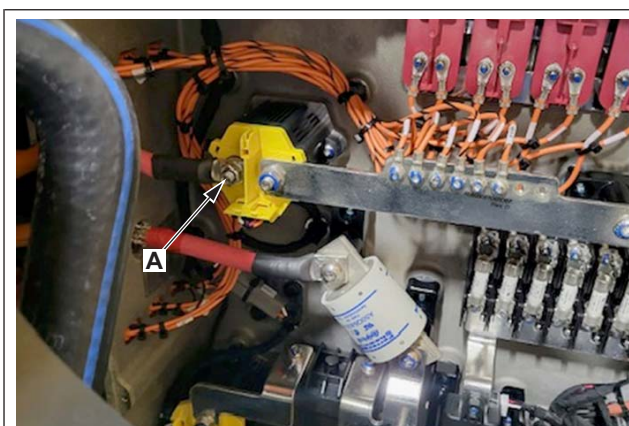
Fig. 1, High-Voltage Junction Box (inside view)

On the affected vehicles, fasteners at the joint connecting the high voltage inverter cable to the associated junction box hardware may not have been secured properly, which could lead to loss of drive power without prior warning, increasing the risk of a crash.

4. Repair the upper high-voltage (HV) cable connection.
 - 4.1 Remove the fastener from the upper HV cable connection (yellow device), located inside the high-voltage junction box (HVJB). See **Fig. 1**.
 - 4.2 Apply Loctite® 243 (blue) to the fastener threads.
 - 4.3 Install the fastener on the upper HV cable connection, and tighten 89 lbf-in (1005 N-cm).

- A. Remove the fastener from the upper high-voltage cable connection.
