TO: Mercedes-Benz Dealer Principals, General Managers, Sales Managers, Service Managers, Parts Managers	FROM: Anthony Washington, Senior Manager, Regulations and Certifications
Re: Launch Recall Campaign Notification Model Sprinter Model Year 2023 Check Front Strut Bolt Connection	DATE: January, 2024

IMPORTANT RECALL CAMPAIGN INFORMATION

Campaign No. :	Campaign Desc. :	Check Front Strut Bolt Connection
2024010005	VS3FEDDOR	
<p>This is to notify you of a Recall Campaign Launch to check the Front Strut Bolt Connection on approximately 33 MY 2023 Mercedes-Benz Sprinter Vans. The recall campaign will be visible on the www.safercar.gov website and may generate questions from customers. All affected VINs will be flagged as "OPEN" in VMI and cannot be sold.</p>		
Background		
Issue	<p>Mercedes-Benz AG, the manufacturer of Mercedes-Benz Sprinter Vans, has determined that on certain Model Year ("MY") 2023 Sprinter (907 platform) vehicles, the body contact surface at the front left suspension strut bolt connection might not meet current specifications. In this case, the front suspension strut bolt connection might loosen due to vibrations while driving, which might hinder the suspension st

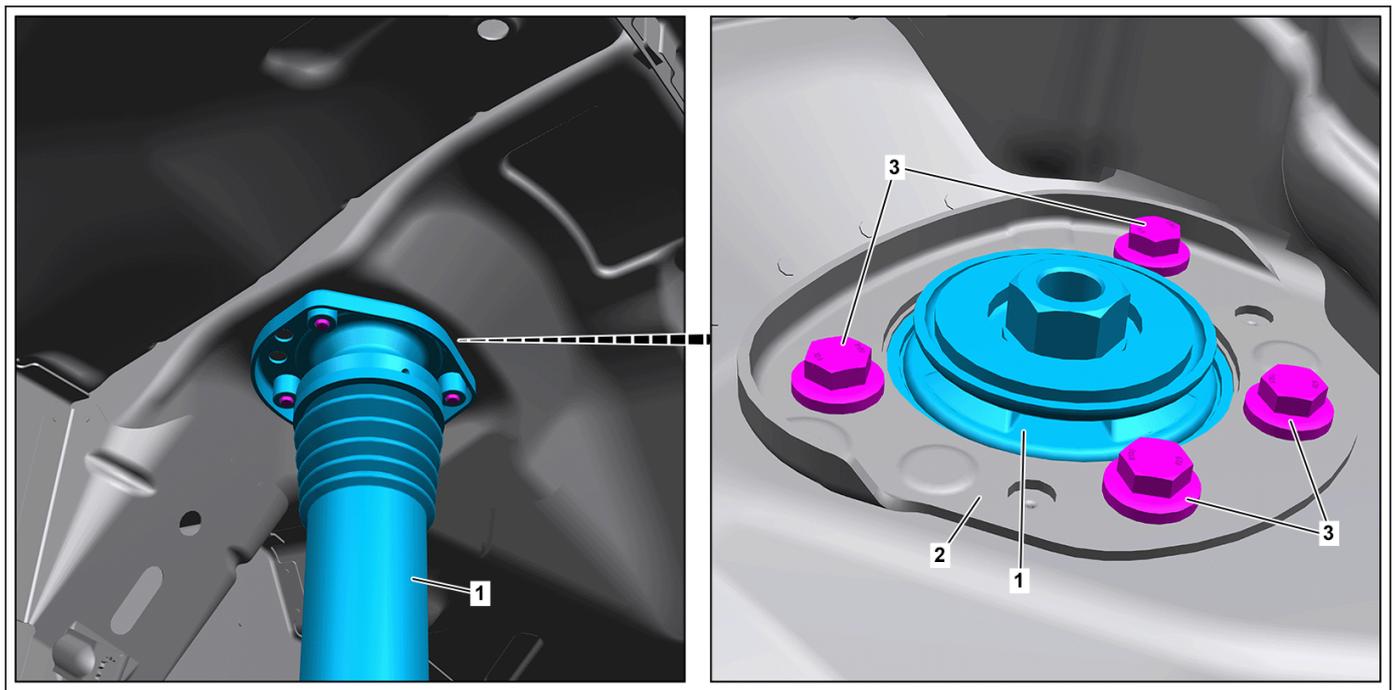
D32.25-A004-79

Check		
8	Check contact surface of support bushing of left front shock-absorber strut (1) for soiling caused by underbody protection.

<p>To do so, check if underbody protection was applied to or in the screw holes. Check area (B) on both sides, i.e. also in vehicle interior under support ring (2) for soiling through underbody protection.</p> <p>If there is no underbody protection (arrow B) in the area (B) on the contact surface or the screw holes,</p> <p style="text-align: center;">↓</p> <p>continue with operation step 12.</p> <p>If underbody protection (arrow B) is present in area (B) on contact surface or screw holes,</p> <p style="text-align: center;">↓</p> <p>continue with operation step 9.</p>	AR32.25-D-0121A

Remove underbody protection			
9	Using rotary wire brush to remove underbody protection in area (B) and around screw holes.	i Commercially available devices/ tools Rotary wire brush	
10	Clean contact surface.	Cleaner	BR00.45-Z-1025-04A

13	Attach shock-absorber strut (1).	i Position support ring (2). i Screw in screws(3) and tighten. Nm Bolt, support bearing to body	BA32.25-Z-1002-02TSR
14	Remove jack under transverse control arm.	i Commercially available devices/ tools Vehicle jack	
15	Attach left front wheel.		AR40.10-D-1100TS
