TO: Mercedes-Benz Dealer Principals, General Managers, Sales Managers, Service Managers, Parts Managers	FROM: Anthony Washington, Senior Manager, Regulations and Certifications
<b>Re: Launch Recall Campaign Notification</b> <b>Model: Sprinter (907)</b> <b>Model Year: 2020</b> <b>Inspect Driveshaft Crossmember</b>	DATE: April, 2024

**IMPORTANT RECALL CAMPAIGN INFORMATION**

<b>Campaign No. :</b>	<b>Campaign Desc. :</b>	<b>Inspect Driveshaft Crossmember</b>
<b>2024010017</b>	<b>VS3QUERTR</b>	
<p>This is to notify you of a Recall Campaign launch to inspect the driveshaft crossmember on approximately <b>8</b> MY 2020 Mercedes-Benz Sprinter Vans. The recall campaign will be visible on the <a href="http://www.safercar.gov">www.safercar.gov</a> website and may generate questions from customers. All affected VINs will be flagged as "<b>OPEN</b>" in VMI and cannot be sold until remedied.</p>		
<b>Background</b>		
<b>Issue</b>	<p>Mercedes-Benz AG ("MBAG"), the manufacturer of Mercedes-Benz Sprinter vehicles, has determined that on certain Sprinter (907 platform) vehicles, the strength of a crossmember at the body-in-white might not meet specifications. In this case, the bolt connection of t

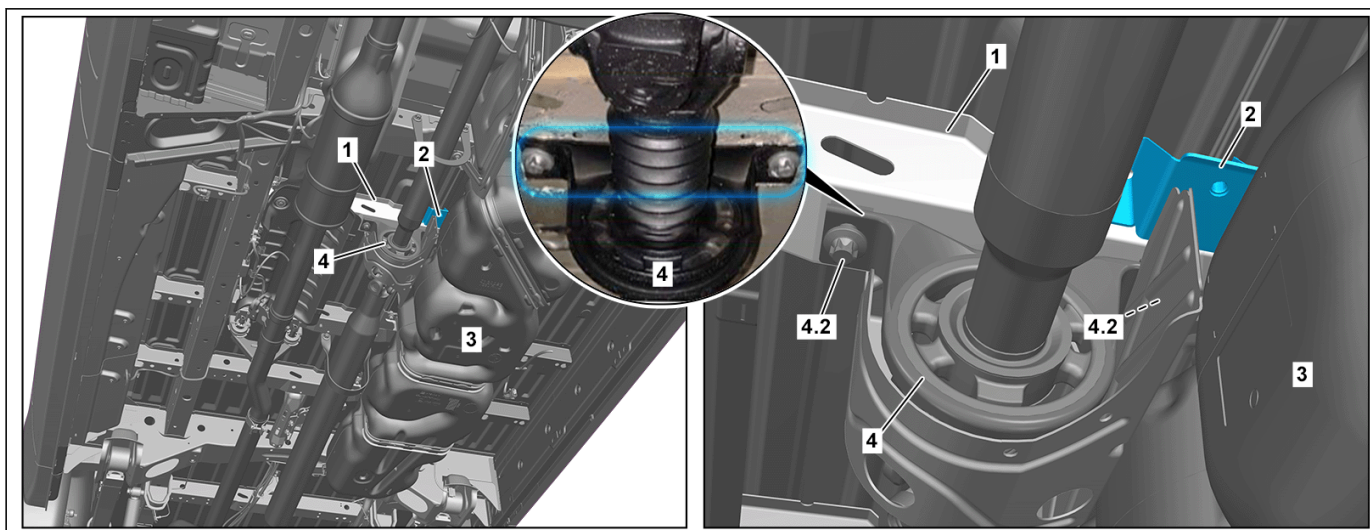
D41.10-A045-78

1 Crossmember

2 Bracket

4 Propeller shaft intermediate bearing

3	Check crossmember (1).

Check whether holder (2) is installed at crossmember (1).	
4	Check whether spot welds (5.1) are present.		
5	Check retaining plates (5).

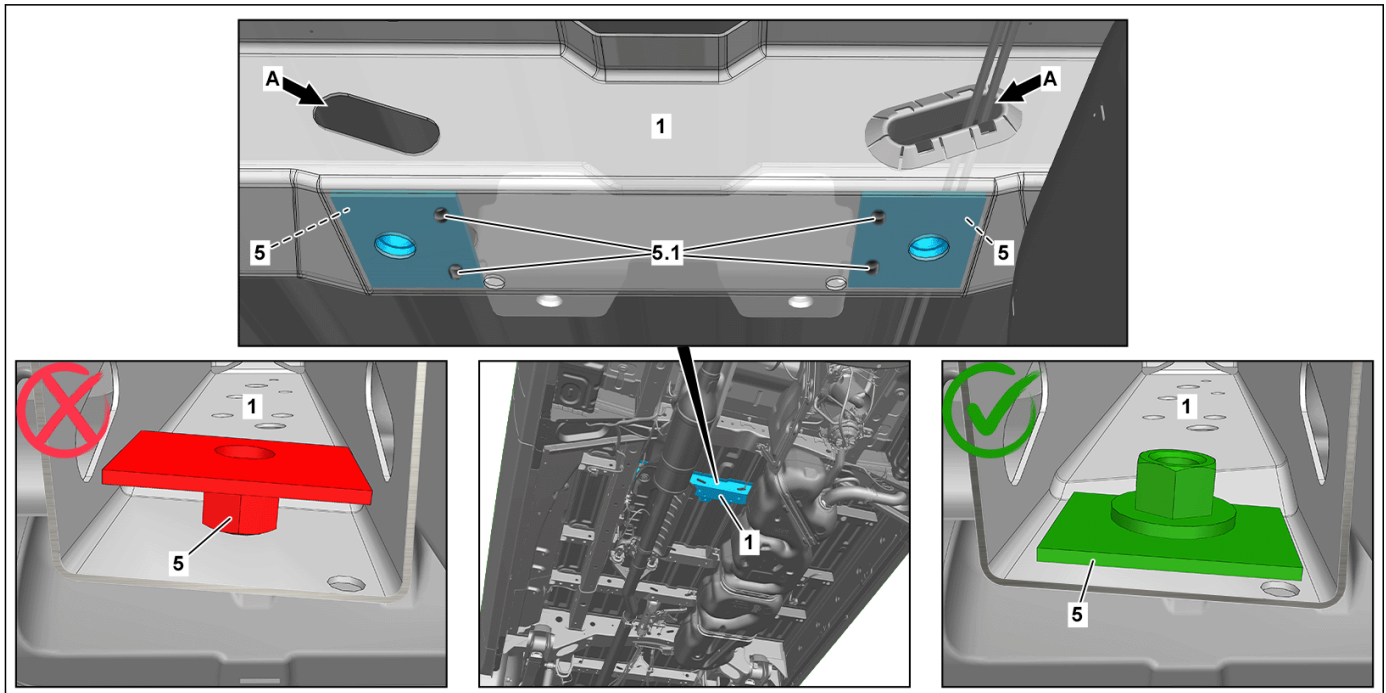
D41.10-A047-79

1 Crossmember                      5 Retaining plate                      5.1 Welding points

Using the openings of the crossmember (1) (arrows A), check whether retaining plates (5) are correctly installed. To do so, use an endoscope.	
<b>Create PTSS case</b>			
6	Create PTSS case.	If at least one of the following conditions is present:

- <b>Holder (2) installed</b> - <b>Spot welds (5.1) missing</b> - <b>Retaining plates (5) not correctly installed</b>

For the PTSS case, create representative pictures regarding the applicable construction conditions of operation steps 3 to 5. When doing so, the connection of the propeller shaft (4) on the crossmember (1) must also be clearly recognizable. File pictures with repair order in a tamperproof manner.	
<b>Perform repair</b>			
7	Perform repair in accordance with PTSS case.

The response to the PTSS case provides the work to be performed.
