TO: Mercedes-Benz Dealer Principals, General Managers, Sales Managers, Service Managers, Parts Managers	FROM: Anthony Washington, Senior Manager, Regulations and Certifications
Re: Launch Recall Campaign Notification Model 907 Sprinter Model Years 2019-2022 Inspect Frame Reinforcement	DATE: February, 2024

IMPORTANT RECALL CAMPAIGN INFORMATION

Campaign No. :	Campaign Desc. :	Inspect Frame Reinforcement
2024010007	VS3ROHRAH	
<p>This is to notify you of a Recall Campaign to inspect the Frame Reinforcement on approximately 3,602 MY 2019-2022 Mercedes-Benz Sprinter Vans. The recall campaign will be visible on the www.safercar.gov website and may generate questions from customers. All affected VINs will be flagged as "OPEN" in VMI and cannot be sold.</p>		
Background		
Issue	<p>Mercedes-Benz AG ("MBAG"), the manufacturer of Mercedes-Benz Sprinter Vans, has determined that on certain Sprinter (907 platform) vehicles, the longitudinal frame members of the body-in-white might not meet specifications. Missing reinforcements might lead to damage in the rear area of the longitudinal frame members. Over time, impairment of driving stability cannot be ruled out. In addition, vehicles equipped

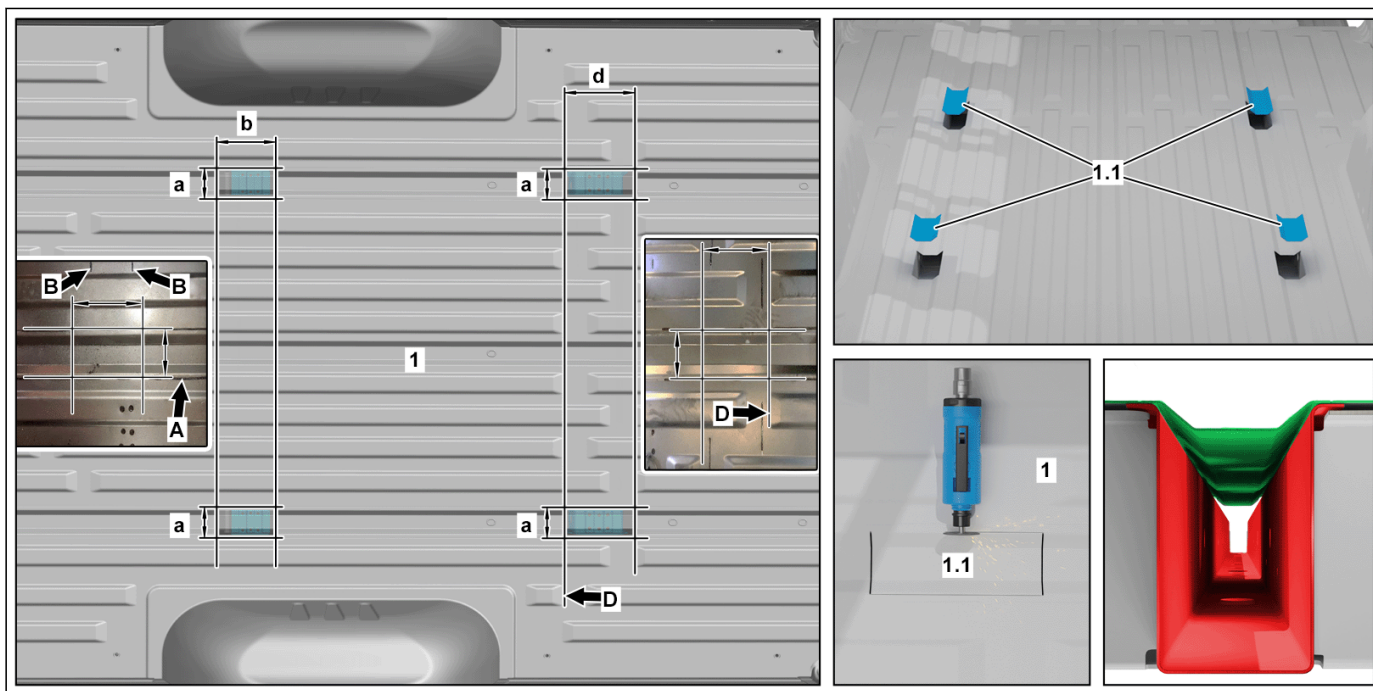
D61.25-A014-79

1 Vehicle floor

1.1 Sections

01 Welding protection blanket

a Dimension (width of crease)

b Dimension (approx. 120 mm)

d Dimension (approx. 190 mm)

c Dimension (approx. 565 mm)

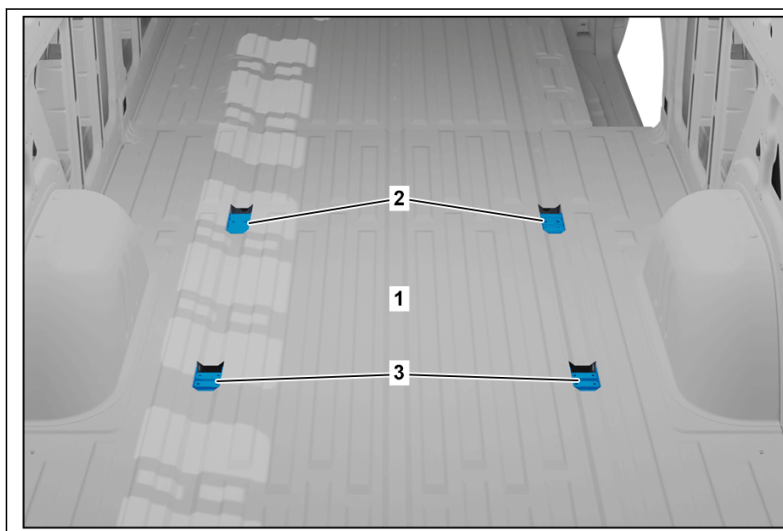
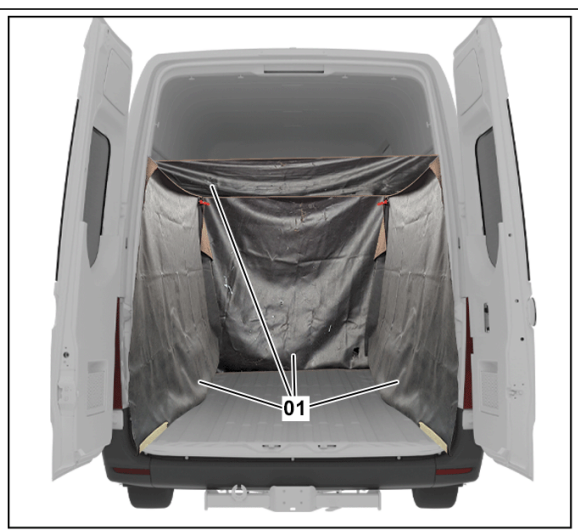
D61.25-A013-78

1 Vehicle floor
2 Reinforcements

3 Reinforcements
01 Welding protection blanket
