TO: Freightliner Dealer Principals, General Managers, Sales Managers, Service Managers, Parts Managers	FROM: Anthony Washington, Senior Manager, Regulations and Certifications
Re: Launch Recall Campaign Notification Model Sprinter Model Years 2019-2021 Check Partition Wall Bolts	DATE: January, 2024

Campaign No. :	Campaign Desc. :	Check Partition Wall Bolts
2024010006	VS3TREWAN	
<p>This is to notify you of a Recall Campaign Launch to check the partition wall bolts on approximately 51 MY 2019-2021 Freightliner Sprinter Vans. The recall campaign will be visible on the www.safercar.gov website and may generate questions from customers. All affected VINs will be flagged as "OPEN" in VMI and cannot be sold.</p>		
Background		
Issue	Mercedes-Benz AG ("MBAG"), the manufacturer of Freightliner Sprinter Vans, has determined that on certain Sprinter (907 platform) vehicles, the bolted connection of the partition wall might not meet specifications. In this case, a deformation of the partition wall under load could be possible. In addition, an influence on the load securing function cannot be ruled out which could increase the risk of injury in the event of a crash.	
What We're Doing	DVUSA wil

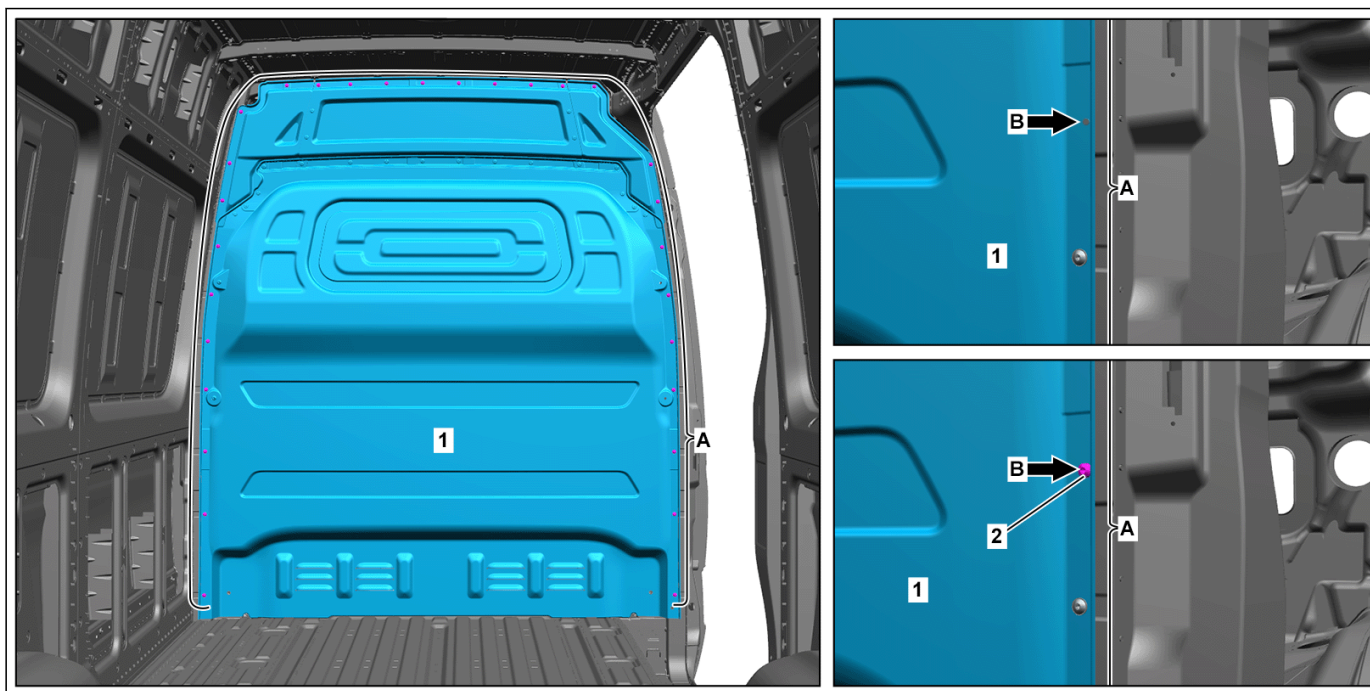
D68.74-A016-79

1 Partition wall

2 Screw

Additional screw connection		
2

Do not unhook belts from seat belt retractors.	AR68.30-D-4705TS
3	Locate holes (arrow B) for additional screw connections at partition (1) and center punch.

Holes must be drilled into the B-pillar for the additional screw connection. The holes (arrow B) in the partition (1) serve as a template.	
4	Drill holes for additional screw connection in B-pillar with \varnothing 4 mm bit.

Tightening torque maximum 5 Nm.	
8
