TO: Mercedes-Benz Dealer Principals, General Managers, Sales Managers, Service Managers, Parts Managers	FROM: Gregory Gunther, Senior Manager, Vehicle Compliance and Analysis, Engineering Services
RE: <b>Recall Campaign Launch Notification</b> <b>Replace Fuel Pump Delivery Module – Wave 2</b> <b>MY21-24 C-Class, E-Class, S-Class, SL, GT, GLC, GLE, GLS and G-Class (205/206, 213/238, 223, 232, 290, 253/254, 167 and 463 platforms)</b>	DATE: April 5, 2024

Campaign No. 2024010011, April 2024

## **Replace Fuel Pump Delivery Module Wave 2**

Mercedes-Benz AG, the manufacturer of Mercedes-Benz vehicles, has determined that on certain MY 2021-2024 C-Class, E-Class, S-Class, SL, GT, GLC, GLE, GLS and G-Class vehicles (205/206, 213/238, 223, 232, 290, 253/254, 167 and 463 platforms), the fuel pump impeller might not meet current specifications in regards to material characteristics. As a consequence, the impeller might deform and contact the fuel pump housing and result in mechanical resistance on the impeller. In some instances, this could cause the fuel pump to stop operating. As a result, the vehicle could lose propulsion, which could increase the risk of crash or injury. Before the fuel

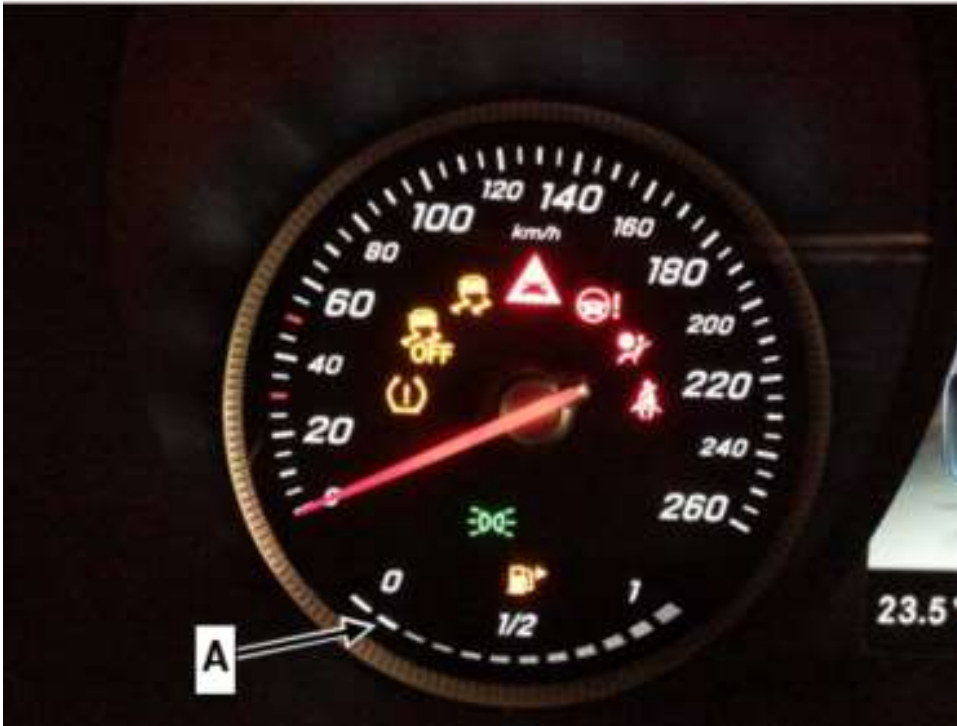
Figure 1 (shown on model 205)

- i** The fuel tank may only be filled up to a **maximum of 20%**.
- i** This corresponds to two lines (A) on the fuel display (**Figure 1**).

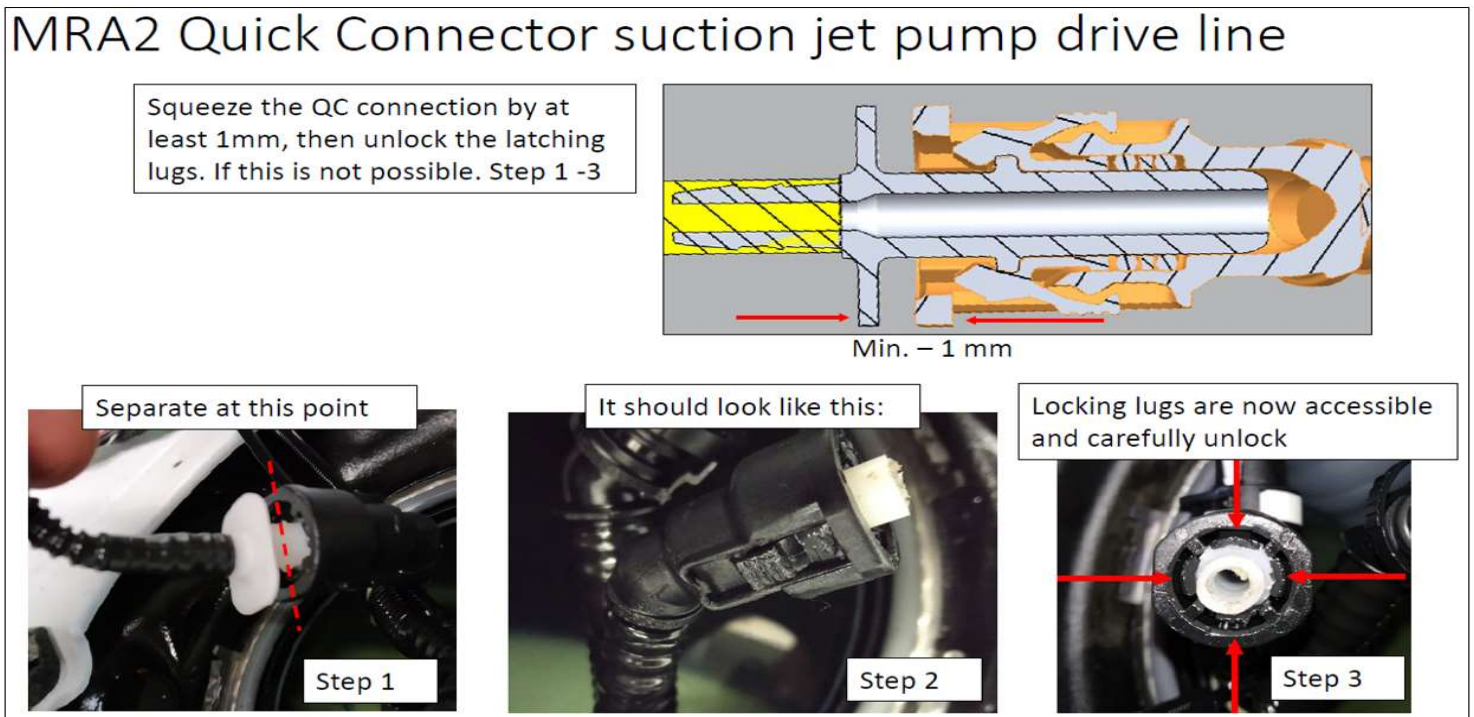
Figure 2

**i** **Only model 206, 232:** Note on disassembly of suction jet pump drive line quick connector.

The procedure steps 1-3 should only be performed when the quick disconnect is not working (**Figure 2**).

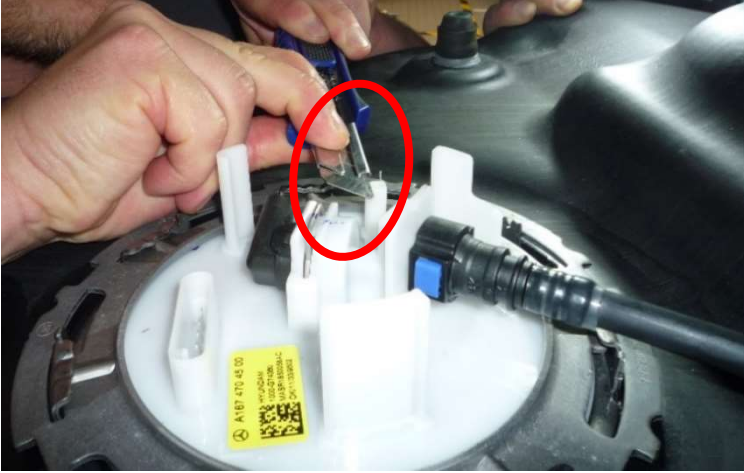
**Figure 3**

**i** For **all** vehicles with code 228 stationary heater, the connection for the fuel supply system must be cut off before installing the fuel pump (**Figure 3**).

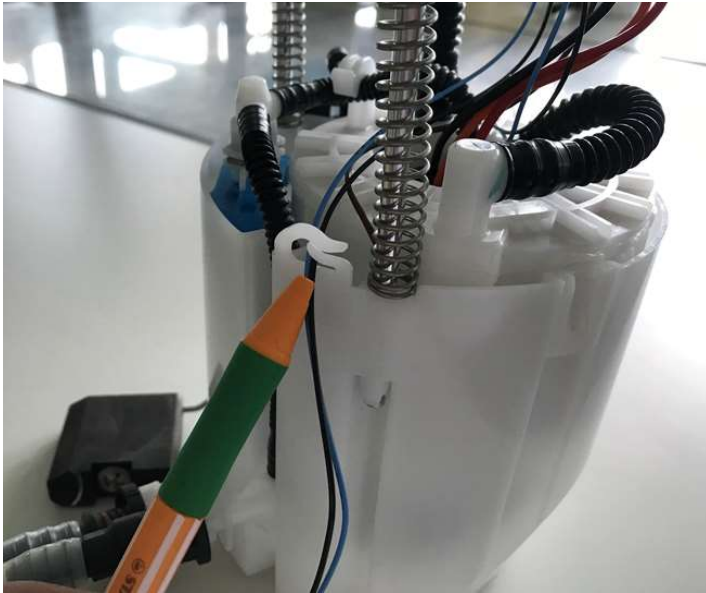
**i** Delivery modules that are delivered **without float-and-lever sensor** must be modified. (**Figure 4-7**)

**Figure 4** (remove electric lines from routing clip)
