TO: Mercedes-Benz Dealer Principals, General Managers, Sales Managers, Service Managers, Parts Managers	FROM: Gregory Gunther, Senior Manager, Vehicle Compliance and Analysis, Engineering Services
RE: Recall Campaign Launch Notification Replace Fuel Pump Delivery Module – Wave 4 MY21-24 C-Class, E-Class, S-Class, SL, GT, GLC, GLE, GLS and G-Class (205/206, 213/238, 223, 232, 290, 253/254, 167 and 463 platforms)	DATE: August 6, 2024

Campaign No. 2024010011, July 2024

Replace Fuel Pump Delivery Module – Wave 4

Order No. P-RC-2024010011

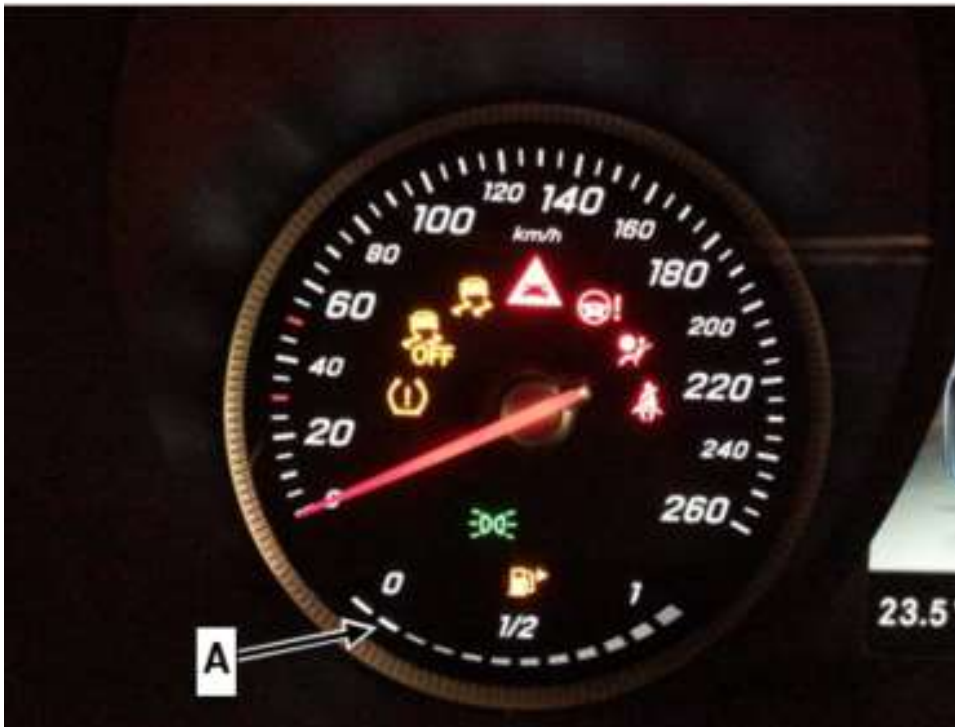
Figure 1 (shown on model 205)

- i** The fuel tank may only be filled up to a **maximum of 20%**.
- i** This corresponds to two lines (A) on the fuel display (**Figure 1**).

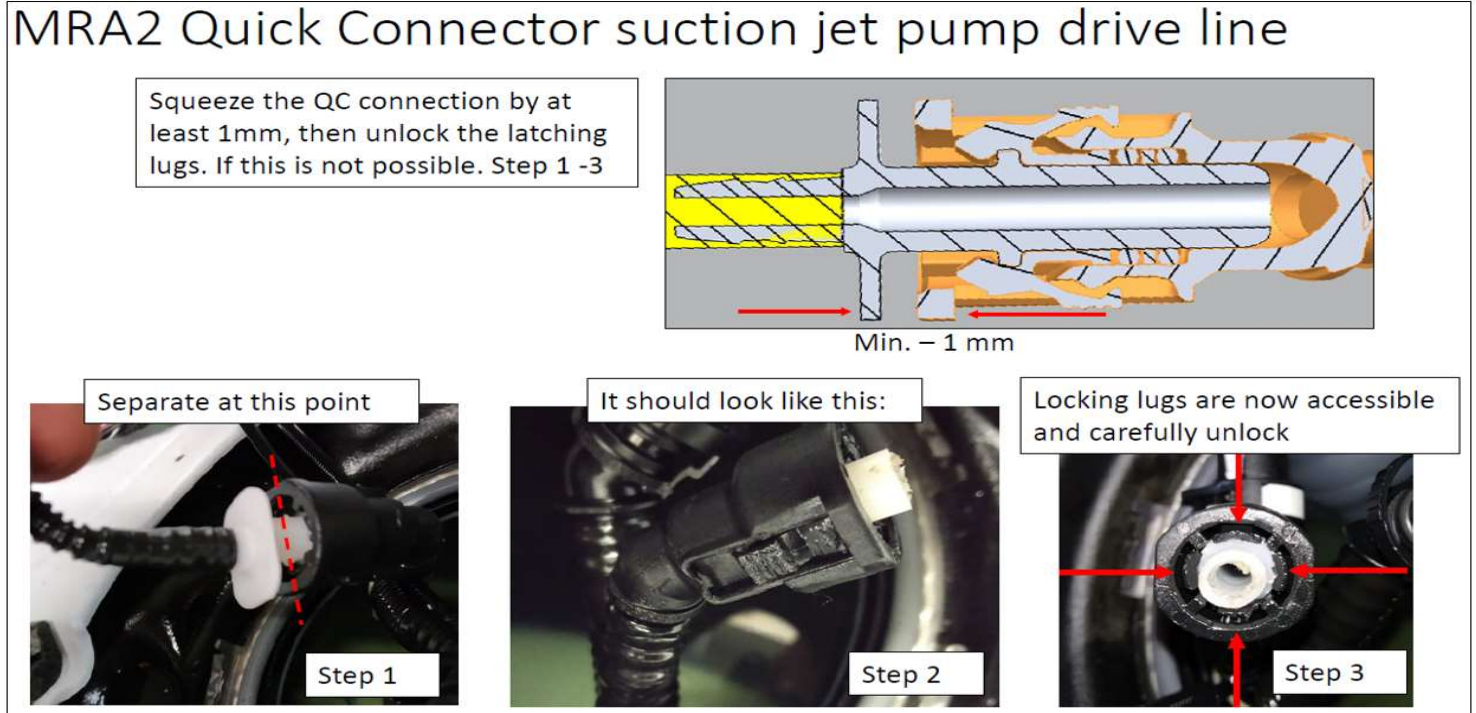
Figure 2

i Only model 206, 232: Note on disassembly of suction jet pump drive line quick connector.

The procedure steps 1-3 should only be performed when the quick disconnect is not working (**Figure 2**).

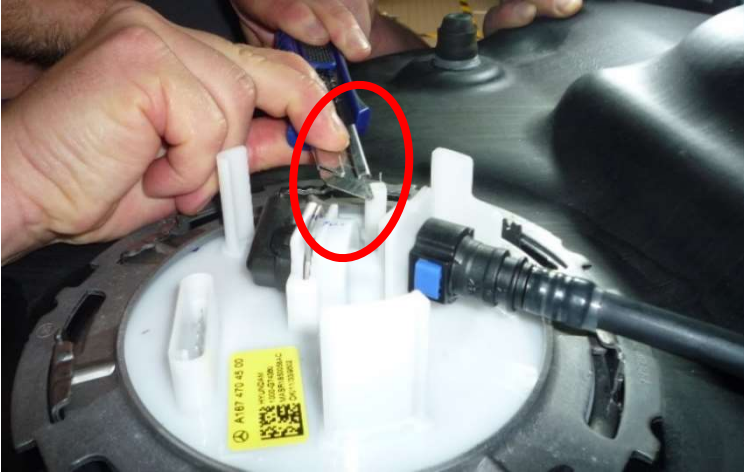
Figure 3

i For **all** vehicles with code 228 stationary heater, the connection for the fuel supply system must be cut off before installing the fuel pump (**Figure 3**).

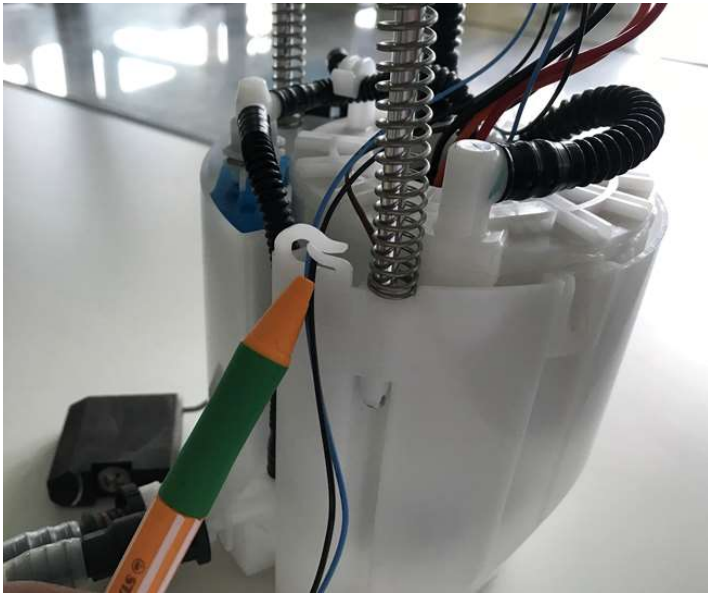
i Delivery modules that are delivered **without float-and-lever sensor** must be modified. (**Figure 4-7**)

Figure 4 (remove electric lines from routing clip)

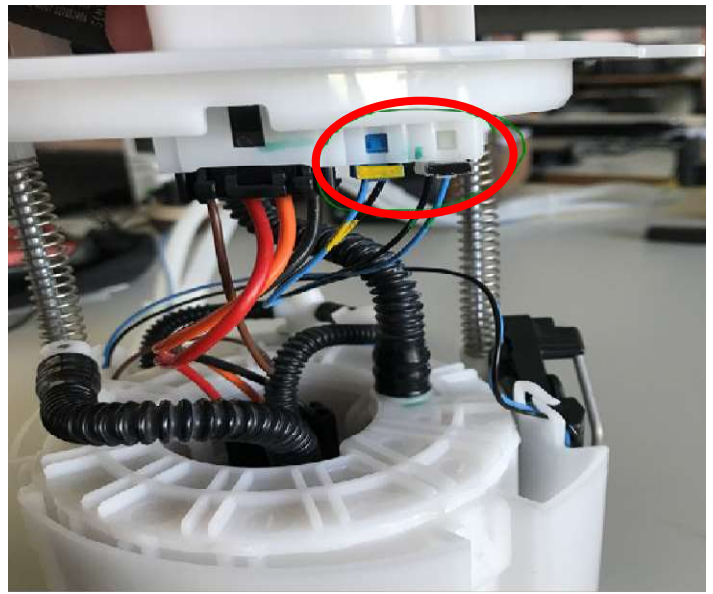
Figure 5 (release corresponding connector and disconnect the contacts)

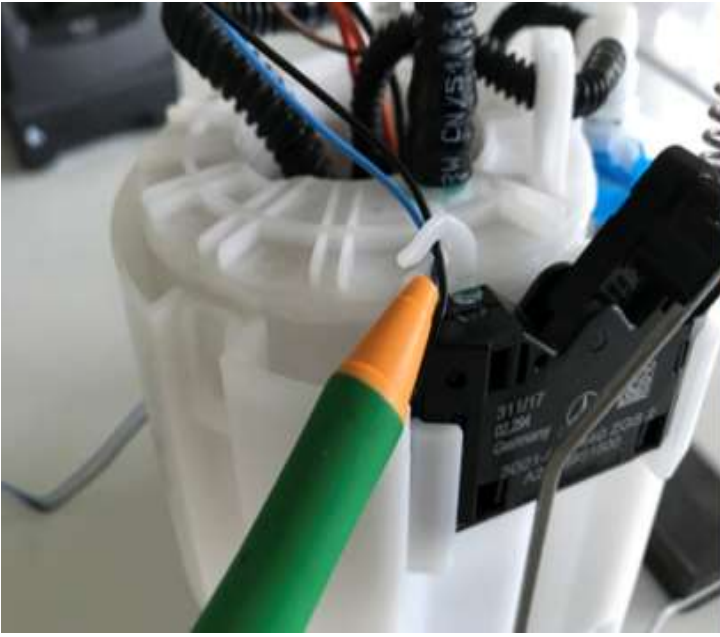
Figure 6 (remove lines from routing clip)

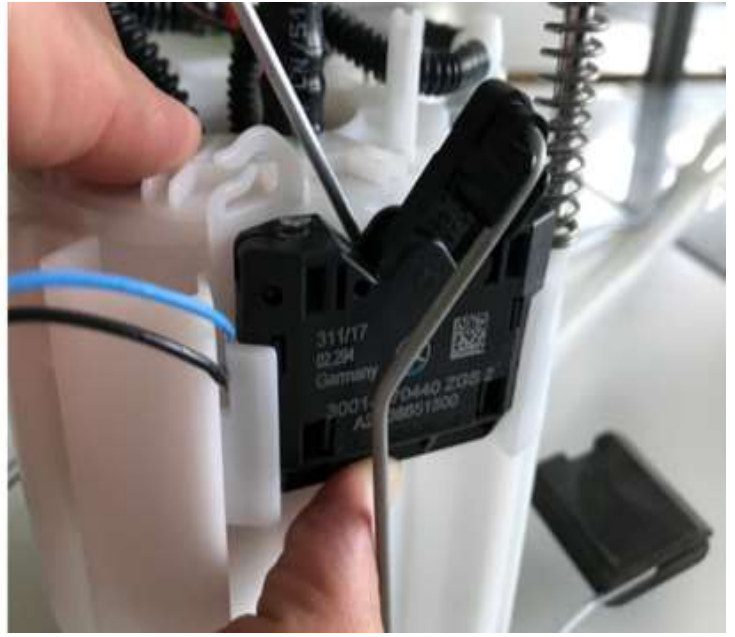
Figure 7 (using a screwdriver, carefully push float-and-lever sensor housing away from module housing and at the same time push float-and-lever sensor housing upwards.)

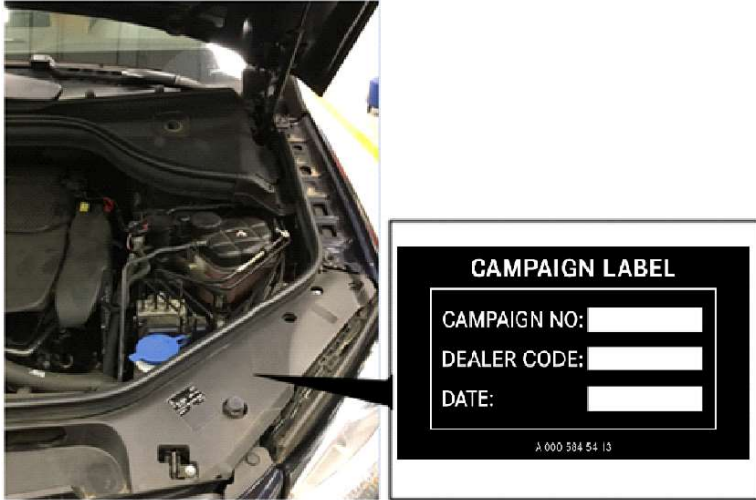
Figure 1

Apply Proof of Correction Label (A 000 584 54 13) to area identified in **Figure 1**. Fill in the blank areas of the label. The “**Campaign No.**” for the California Proof of Correction is unique and must be entered as such (23V880), your “**Dealer Code**”, and the “**Date**” of the repair, using a black permanent marker.
