TO: Mercedes-Benz Dealer Principals, General Managers, Sales Managers, Service Managers, Parts Managers	FROM: Gregory Gunther, Senior Manager, Vehicle Compliance and Analysis, Engineering Services
RE: Recall Campaign Launch Notification Replace Fuel Pump Delivery Module – Wave 5 MY21-24 C-Class, E-Class, S-Class, SL, GT, GLC, GLE, GLS and G-Class (205/206, 213/238, 223, 232, 290, 253/254, 167 and 463 platforms)	DATE: September 20, 2024

Campaign No. 2024010011, July 2024

Replace Fuel Pump Delivery Module – Wave 5

Order No. P-RC-2024010011

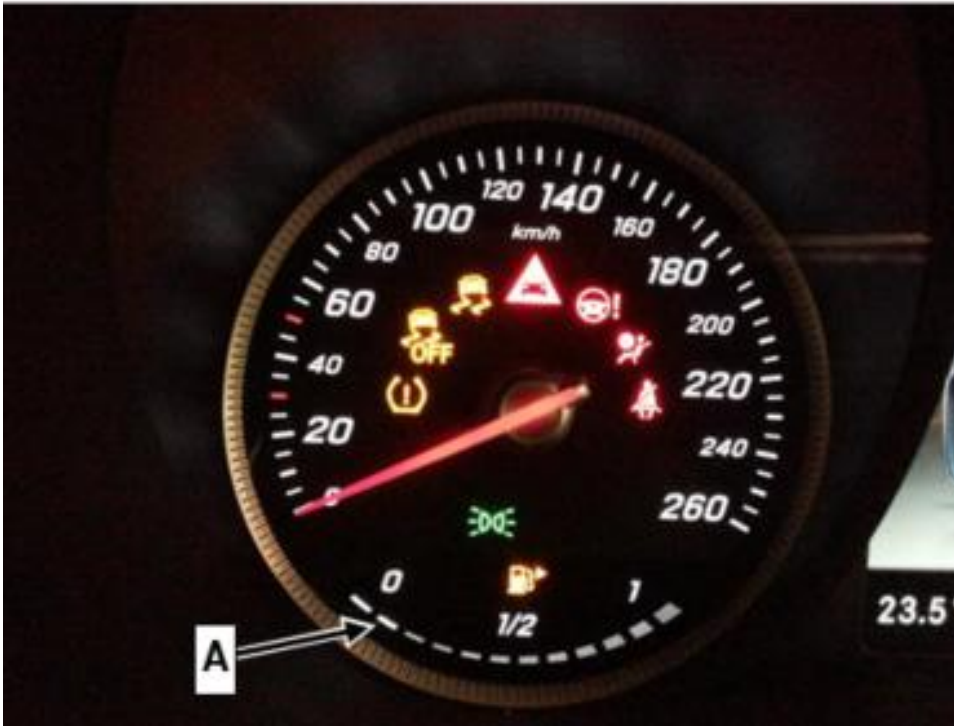
Figure 1 (shown on model 205)

- i** The fuel tank may only be filled up to a **maximum of 20%**.
- i** This corresponds to two lines (A) on the fuel display (**Figure 1**).

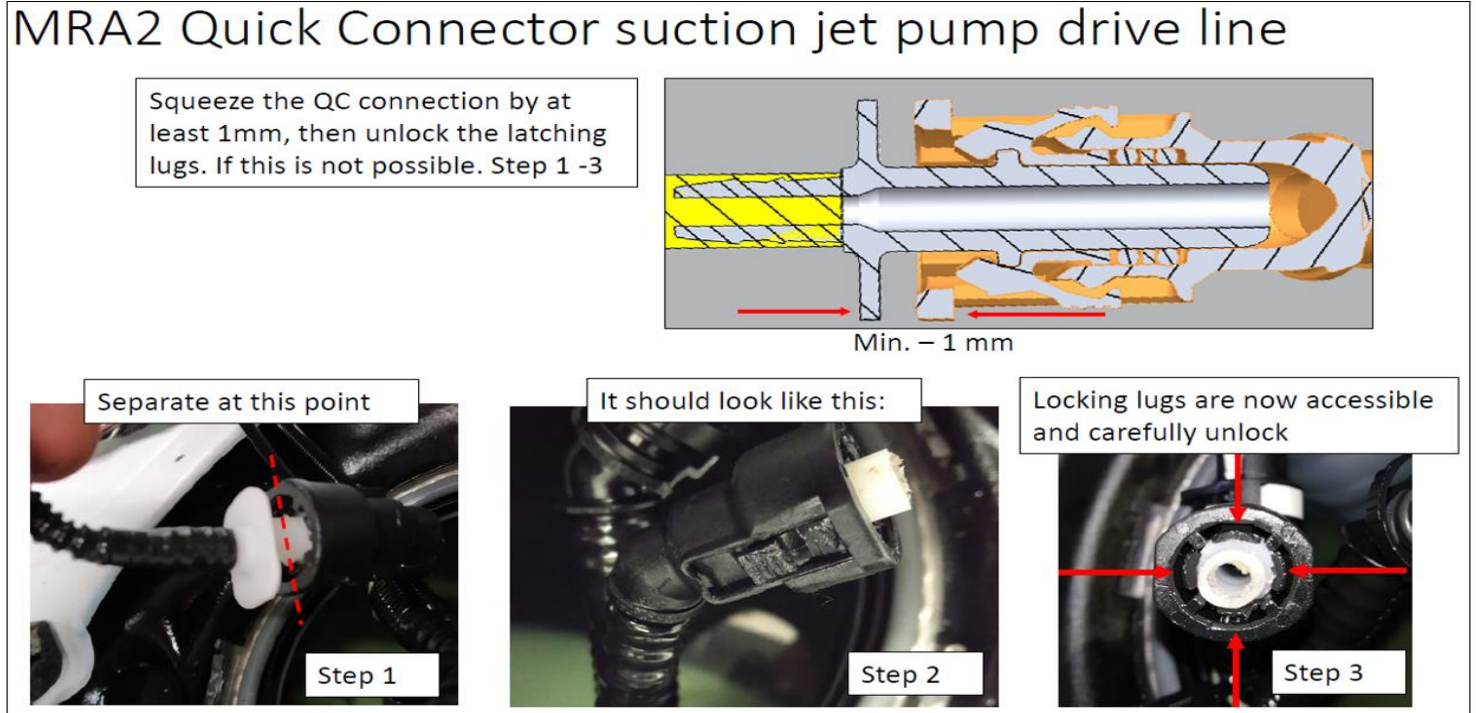
Figure 2

i Only model 206, 232: Note on disassembly of suction jet pump drive line quick connector.

The procedure steps 1-3 should only be performed when the quick disconnect is not working (**Figure 2**).

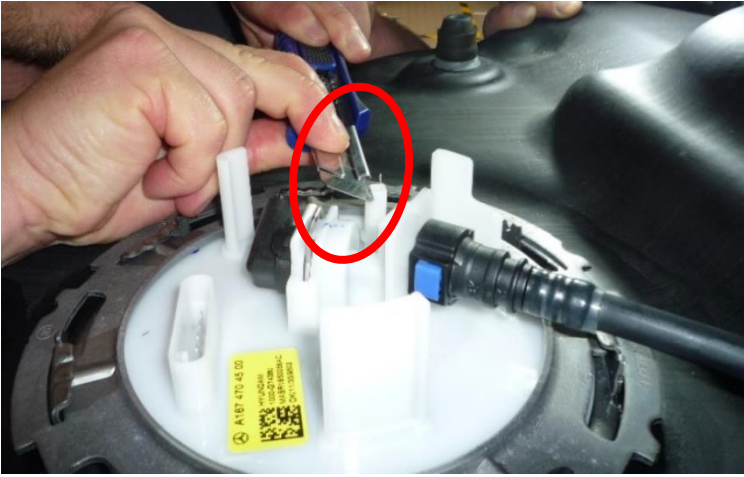
Figure 3

i For **all** vehicles with code 228 stationary heater, the connection for the fuel supply system must be cut off before installing the fuel pump (**Figure 3**).

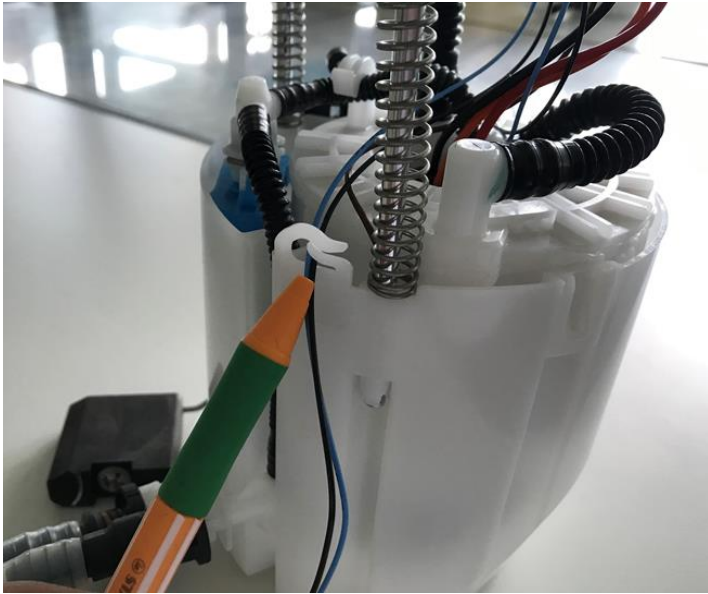
Figure 4 (remove electric lines from routing clip)

i Delivery modules that are delivered **without float-and-lever sensor** must be modified. (**Figure 4-7**)

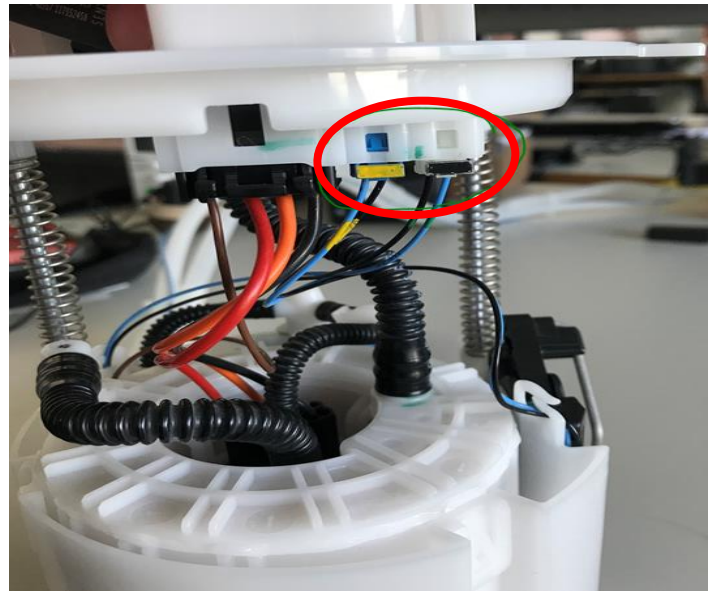
Figure 5 (release corresponding connector and disconnect the contacts)

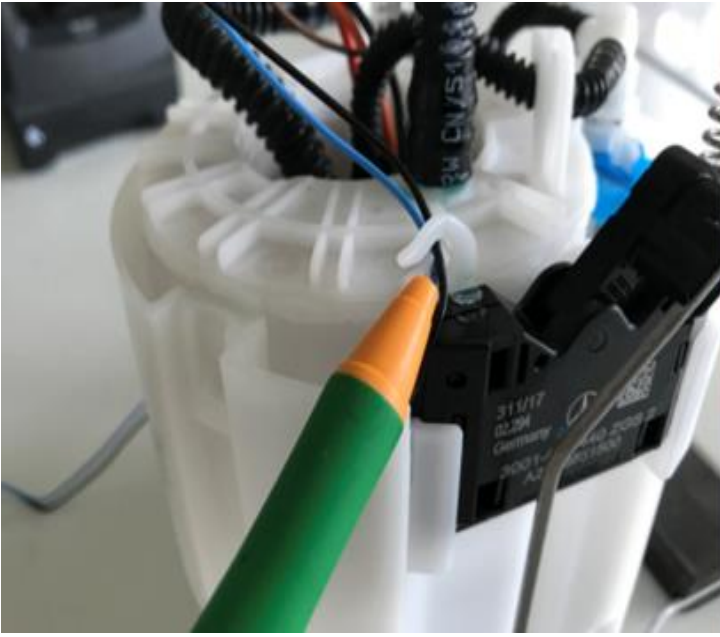
Figure 6 (remove lines from routing clip)

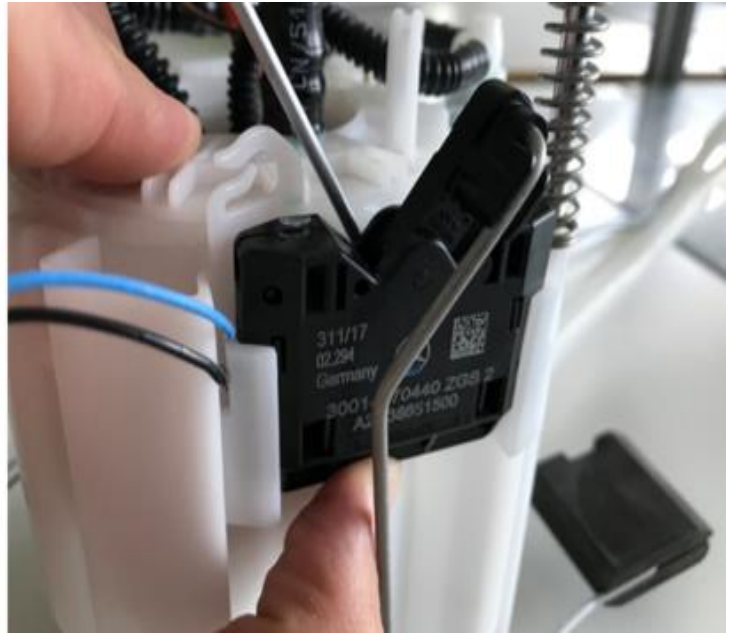
Figure 7 (using a screwdriver, carefully push float-and-lever sensor housing away from module housing and at the same time push float-and-lever sensor housing upwards.)
