IMPORTANT SAFETY RECALL

NHTSA Recall Number: 23V-003
Altec Identifier: CSN-3045

Rotation Bearing Cap Screw Inspection

Units Affected: Certain DC45/47 and DM45/47B derricks built from September 2022 to November 2022. Verify your unit is affected by reviewing the attached list or accessing Altec Connect.

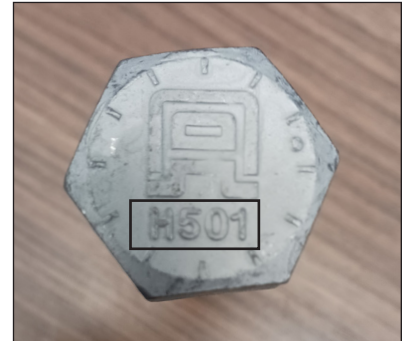
Figure 1 — H501 Head Marking

Background: Altec has learned that one or more of the cap screws installed in the rotation bearing inner and/or outer race on certain units may be longer than specified. This can cause the cap screw(s) to bottom out in the mounting hole(s), preventing the required preload from being achieved. While there have been no reports of cap screw failures to date, insufficient preload could cause rotation bearing cap screws to fail prematurely.

2. Visually inspect all the cap screw heads in both rotation bearing races to check for an H501 head marking below the Altec logo (refer to Figure 1).

5. Repair is required. Perform steps a through f shown below.

- a. Take the unit out of service until the repair has been completed.
- b. Determine the kit part number(s) required as shown below, based on which race contained cap screw(s) with the H501 head marking. If cap screw(s) with this head marking are found in both rotation bearing races, both kits are required.

- Inner Race Rotation Bearing Fasteners Kit, part number 990644104
 - Outer Race Rotation Bearing Fasteners Kit, part number 990644105
- c. Arrange for the installation of the required kit(s) using either of the methods shown below.
