IMPORTANT SAFETY RECALL

NHTSA Safety Recall: 22E-055

AWNING INSPECTION AND WELD/SEAM REPAIR

Recall Number:	22E-055		
Product:	Awnings		
Date:	Original: July 15, 2022	Labor Rate:	.30 hours inspection only .30 hours repair only
	Current: Sept. 1, 2022		1.5 hours fabric replacement only

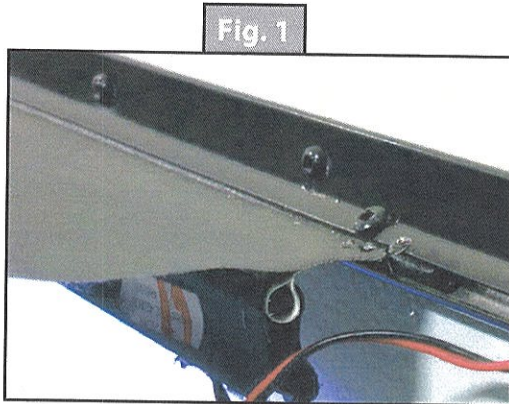
The purpose of this document is to provide guidance, as well as visual aides, to dealers performing inspection on units that may have insufficient awning weld(s). The inspection point is at the awning fabric seam at the awning rail at the wall of the unit (Fig. 1). This only affects awnings manufactured January 17, 2022 – June 14, 2022. The date of manufacture can be located on the variant code label (Fig. 2) located on the awning.

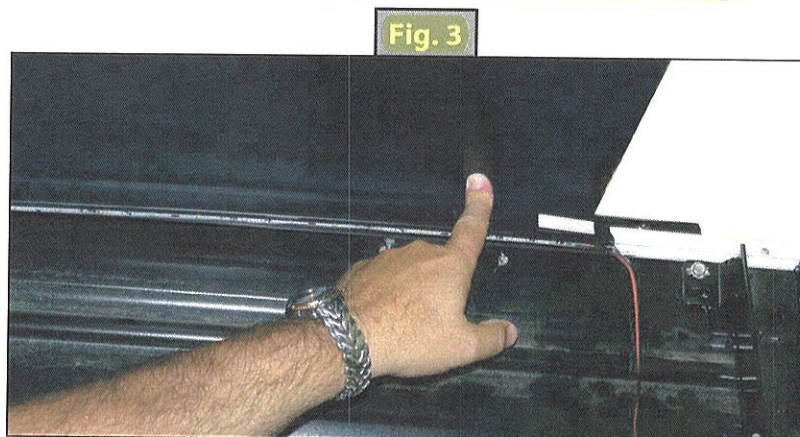
1. Extend the awning.
2. From underneath the awning, about 1" to 1.5" from the fabric edge, push up on the fabric with one finger (Fig. 3) until the awning fabric is flush with the top of the awning rail. Look for any separation or visible daylight at the seam. Perform push test at both ends of the awning.

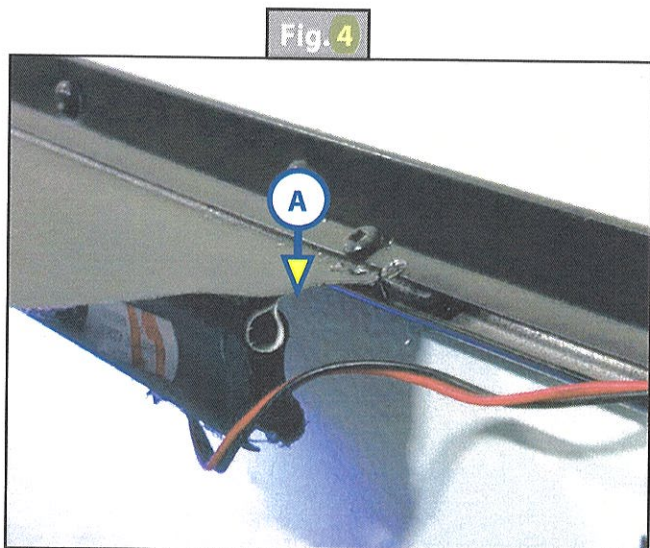
1. Position stepladder next to the unit to view the topside of the awning at the unit wall from either end (drive/idler side).
2. Inspect the weld near the awning rail (Fig. 4A).
 - A. Fig. 4 shows no separation at the seam. It does not require repair or replacement.
 - B. Fig. 5 shows separation at the seam (Fig. 5A).
 - I. If the separation is less than 6 inches, repair can be accomplished using the procedure described in [TI-434](#).
 - II. If the separation is over 6 inches it will require awning fabric replacement using the procedure described in [TI-166](#).
