Terex Advance

**IMPORTANT SAFETY
RECALL**

SN 23V-150

Subject: Improperly installed/torqued steering shaft

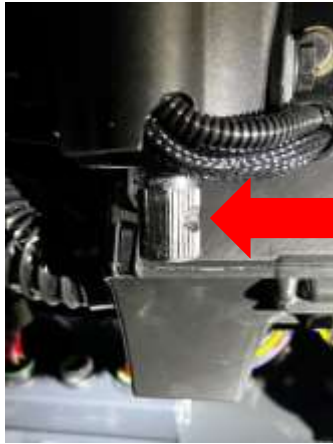
Align bolt with groove

7. Visually check and ensure that the bolt is in the proper groove attaching the steering shaft to the steering column. If aligned properly with groove apply clockwise tightening rotation while securing the nut until properly torqued.
8. If improperly installed remove bolt and properly align new bolt and steering shaft with the groove in the steering column. Apply a clockwise tightening rotation while securing the nut until properly torqued.
9. Set torque wrench to 60 lb-ft (81 Nm).

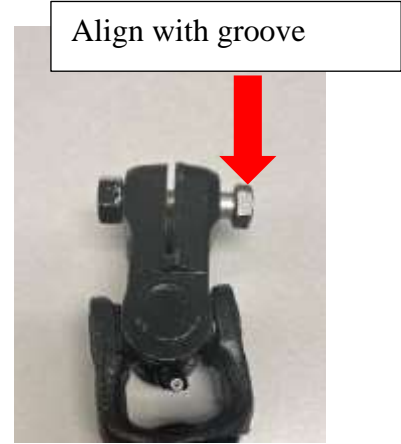
Align with groove

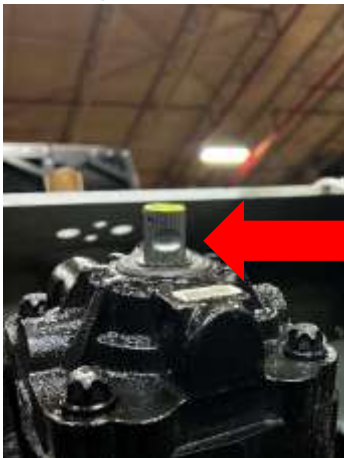
Align bolt with groove

10. Visually check and ensure that the bolt is in the proper groove attaching the steering shaft to the steering gear. If aligned properly with groove apply clockwise tightening rotation while securing the nut until properly torqued.
11. If improperly installed remove bolt and properly align new bolt and steering shaft with the groove on the steering gear. Apply a clockwise tightening rotation while securing the nut until properly torqued.
12. Remove the wheel chocks.

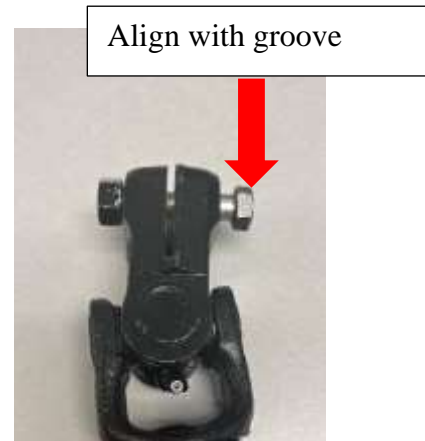
Align with groove
