## IMPORTANT SAFETY RECALL

**NHTSA Recall Number:** 23V216

**Altec Identifier:** CSN-3064

# CUSTOMER SERVICE NOTICE CSN-3064-A

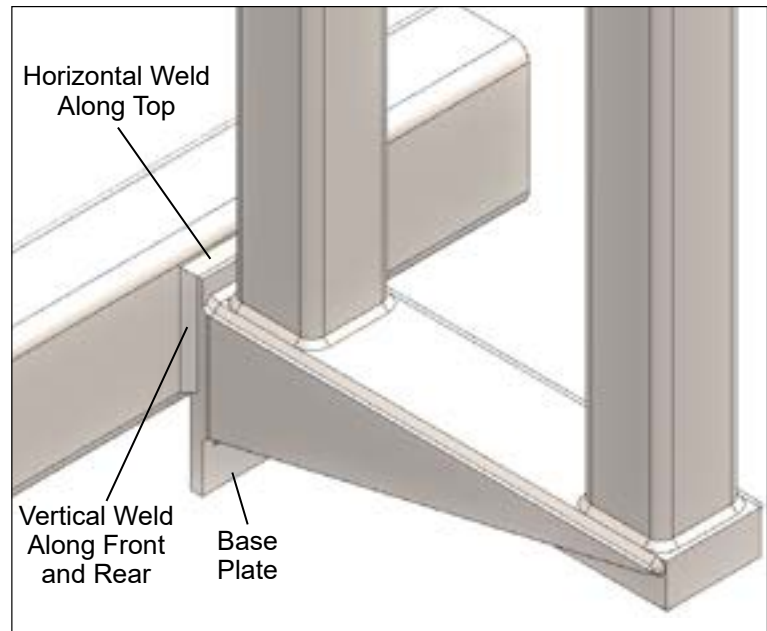
**Figure 3 — Inspecting Rear Pole Rack Welds**

4. Using a flashlight, and a mirror or digital camera, if required, confirm if there is a horizontal weld across the top and a vertical weld on both sides of the rear pole rack base plate (refer to Figure 3). If the unit has two rear pole racks, inspect both of them.

- If the unit has one rear pole rack, proceed as shown below.
  - If there is no horizontal weld, inspect the vertical welds for any cracks or distortion. Then proceed to step 5.
  - If there is a horizontal weld and both vertical welds, proceed to step 6.
  - If there is a horizontal weld and one vertical weld but the other vertical is missing, proceed to step 12.

- If the unit has two rear pole racks, proceed as shown below.
  - If there is no horizontal weld on one or both rear pole racks, inspect the vertical welds for any cracks or distortion. Then proceed to step 5.
  - If there is a horizontal weld and both vertical welds on both rear pole racks, proceed to step 6.
  - If there is a horizontal weld and one vertical weld but the other vertical weld is missing on one or both rear pole racks, proceed to step 12.

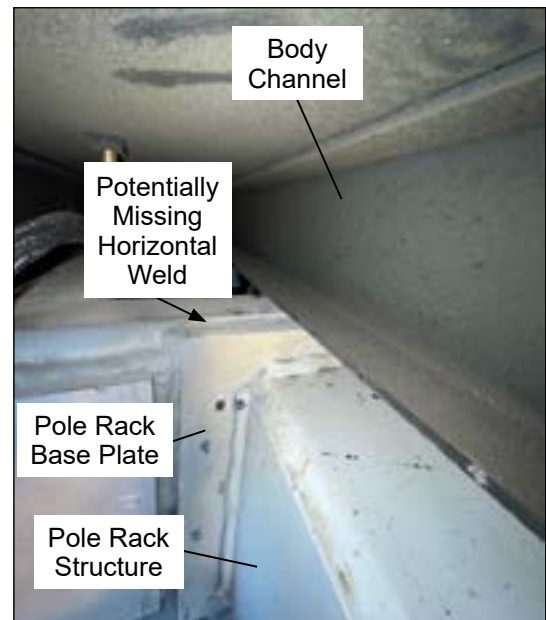
**Figure 4 — Inspecting for Body Channel Interference with Welding**

5. Determine the body material (steel or aluminum) and whether there is a body channel over the base plate on the rear pole rack(s) that will be in the way of adding the missing horizontal weld(s) (refer to Figure 4).

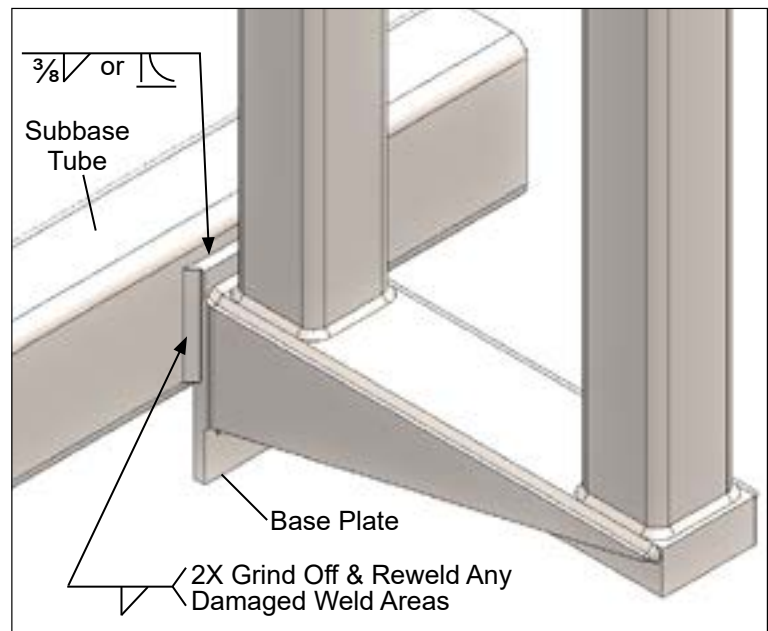
**Figure 12 — Welding Rear Pole Rack Base Plate**

22. Clean the surfaces along the top of the pole rack base plate and along the two vertical welds on the sides of the base plate to remove any grease, dirt, paint, rust, etc. (refer to Figure 12).

23. Use a flashlight to inspect both vertical welds along the sides of the base plate for any cracking or deformation, particularly at the top and bottom ends of the welds, and for any missing weld.

24. Grind off any damaged vertical weld bead, and continue to grind off the weld bead about 1/2" beyond the damaged area(s). Do not grind into the side of the subbase tube.

25. Weld along the top of the base plate (refer to Figure 12) using a 3/8" fillet weld if the joint is as on the flat side of the subbase tube as shown in the picture or using a flare-bevel weld if the top of the base plate is above the corner radius of the subbase tube. Weld along any areas of removed or missing vertical welds on both sides using the same size fillet weld as the original weld.
