IMPORTANT SAFETY RECALL

NHTSA Recall Number: 23V326

Altec Identifier: CSN-3076

Hollow Auger Extension Shaft Hardware

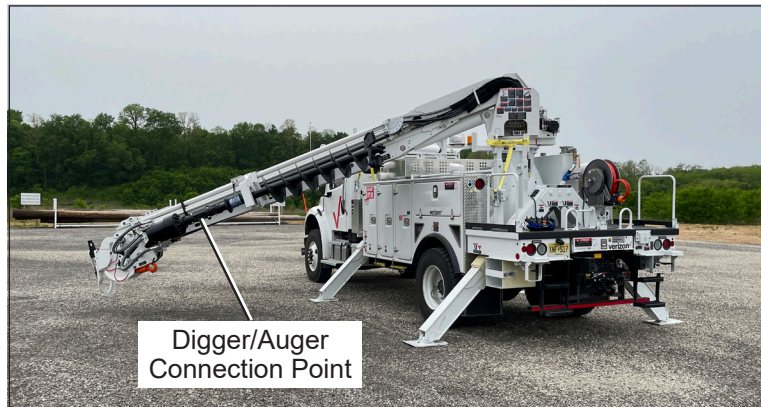
Figure 1 — Digger/Auger Connection Point

1. Position the unit on a level surface where the booms can be elevated and rotated. Apply the parking brake, and engage the power take-off (PTO). Chock the wheels, and properly set the outriggers.
2. Put the unit in machine mode, unstow the unit, and rotate and lower the boom tip so the digger/auger connection point is accessible while working from the ground (refer to Figure 1). Do not unstow the auger. This inspection can be completed while keeping the auger stowed.

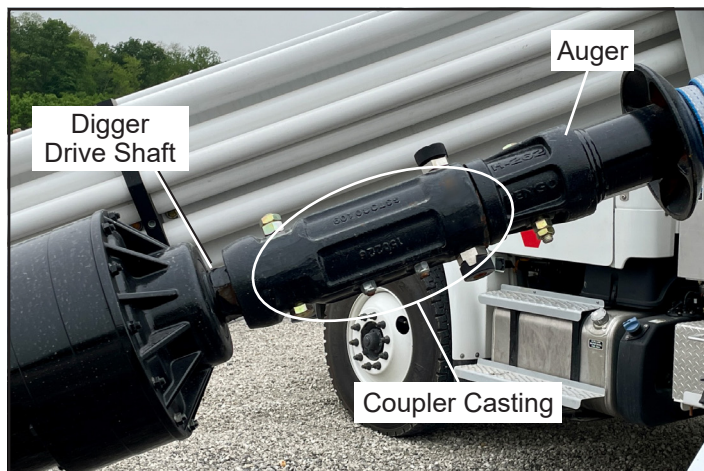
Figure 2 — Coupler Casting

3. Disengage the PTO, and turn off the engine. Remove the key from the ignition, and secure it following your employer's vehicle lockout/tagout procedure.
4. Locate the coupler casting. Coupler castings are typically painted black and located between the digger drive shaft and the auger, as shown in Figure 2. Visually inspect the coupler casting for identifying designations.
 - If the coupler casting contains the designation "PENGO," proceed to step 5.
 - If the coupler casting does not contain the designation "PENGO," this notice does not apply. Perform steps a and b.
 - a. Put the unit back into service.
 - b. Complete the Inspection Sheet at the end of this notice, and return it to Altec.

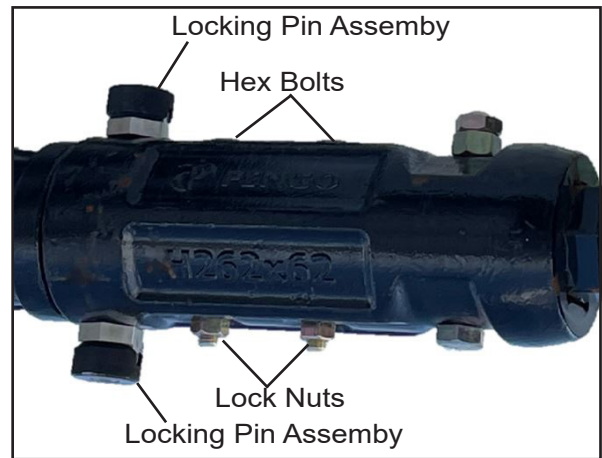
Figure 4 — Coupler Casting Hardware

5. Visually inspect both sides of the coupler casting for two locking pin assemblies and two sets of hex bolts and lock nuts as shown in Figure 4.
 - If the locking pin assemblies, hex bolts, and lock nuts are present, perform steps a through d.
 - a. Verify the two locking pin assemblies are wrench-tight.
 - b. Verify the two hex bolts and lock nuts are wrench-tight.
 - c. Put the unit back into service.
 - d. Complete the Inspection Sheet at the end of this notice, and return it to Altec.

- If the locking pin assemblies, hex bolts, and lock nuts are missing, do not unstow or use this auger extension until it has been repaired. Proceed to step 6.
- If the locking pin assemblies are present, but one or more hex bolt or lock nut is missing, do not unstow or use this auger extension until it has been repaired. Verify the locking pin assemblies are wrench-tight. Proceed to step 6.
- If both sets of hex bolts and lock nuts are present, but one or both locking pin assemblies are missing, this auger extension can not be used for screw anchor installation until it has been repaired. It may be used for auger drilling after verifying the hex bolts and lock nuts are wrench-tight. Proceed to step 6.

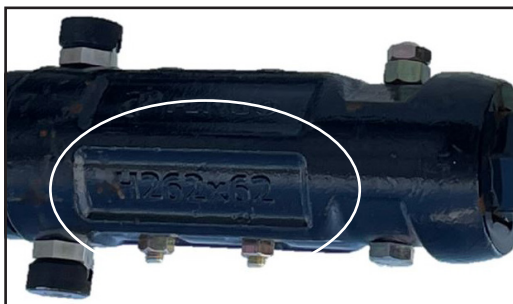
Figure 4 — Coupler Casting Designation

6. Visually inspect the coupler casting for one of two designations cast into one of its faces as shown in Figure 4. Determine the required parts kit based on the coupler casting designation. Each kit contains two locking pin assemblies, two hex bolts, two lock nuts, and installation instructions.

Casting Designation	Kit Part Number	Quantity Required
H262x62	991623797	
H250x62	991623798

7. Order and schedule the installation of the required parts as marked above using either of the methods shown below.
 - Contact Altec Service to schedule the installation of the required parts.
 - Contact Altec Parts to order the required parts, and schedule for your own technician or your third party provider to install them.
8. Do not complete the Inspection Sheet at the end of this notice. Completion of the CSN will be documented after the vehicle is repaired.
