IMPORTANT SAFETY RECALL

NHTSA Recall Number: 23V417

Altec Identifier: CSN-3086

Axle U-Bolt Torque Inspection

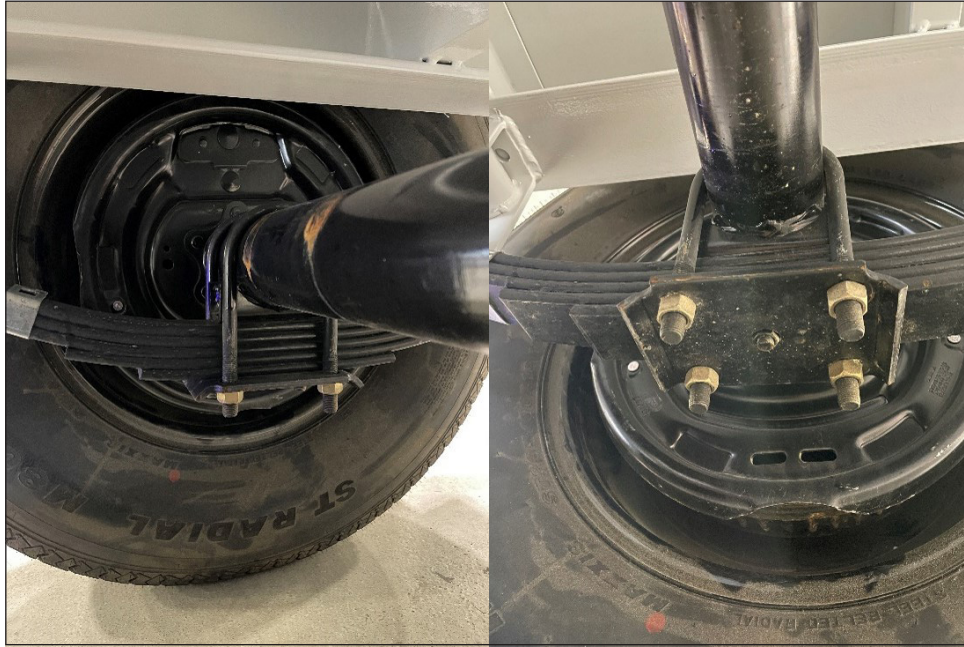
Figure 1 — Trailer Axle U-Bolts and Nuts

1. Position the trailer on a level surface. Chock the wheels.
2. Locate the U-bolts and hex nuts on the underside of the trailer (refer to Figure 1).

3. Verify a total quantity of four U-bolts and eight hex nuts are present.
 - If no U-bolts or hex nuts are missing, proceed to step 4.
 - If any U-bolts or hex nuts are visibly loose, damaged, or missing, remove trailer from service.

- a. Contact Altec to order replacement kit 991641868 or schedule the installation of this kit by Altec.
 - b. Do not complete the Inspection Sheet at the end of this notice. Completion of the CSN will be documented after the unit is repaired.

- c. Do not complete the remaining steps in the Inspection and Repair Procedure.
4. Torque all hex nuts to 55 foot-pounds.
5. Put the trailer back into service.
