Recall Number:	23E-008		
Product:	Global Latch		
Date:	02.23.2023	Labor Rate:	Inspection Only - 0.3 Hour/Inspect & Replace - 0.7 Hour

Preliminary procedures for inside latch assembly part replacement

This section of document refers to the replacement of the inside latch assembly of the complete door lock assembly with latch on certain motorized entry doors. A portion of the latch is breaking off when attempting to exit the coach. The instructions are applicable to using a replacement inside latch assembly PN 2023005033 for the 920 Series door and inside latch assembly PN 2022010407 for the 3500 Series door.

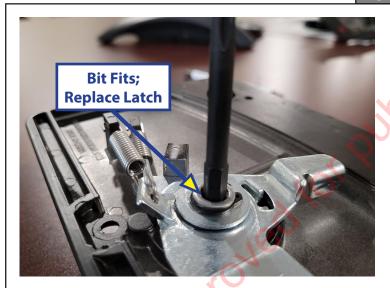
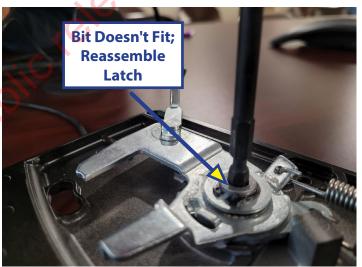
Fig. 5

- 1. Using a 1/4" screwgun bit, try to insert the bit into the spun rivet of the inside latch assembly (Fig. 5).
- **2.** If bit fits into rivet opening there are two options:
 - **A.** Replace the complete latch assembly, including both inside and outside latch assemblies.
 - **B.** Replace just the inside latch assembly to be combined with current outside latch assembly.
- **3.** If the bit does not fit, no action is required. Proceed to latch reassembly instructions.

New Inside Latch Asssembly Needed

Replacement Not Needed
