EQUIPMENT SAFETY RECALL

Gear Position Sensor

Reference: 93A / NHTSA 23E-069

FCA US LLC

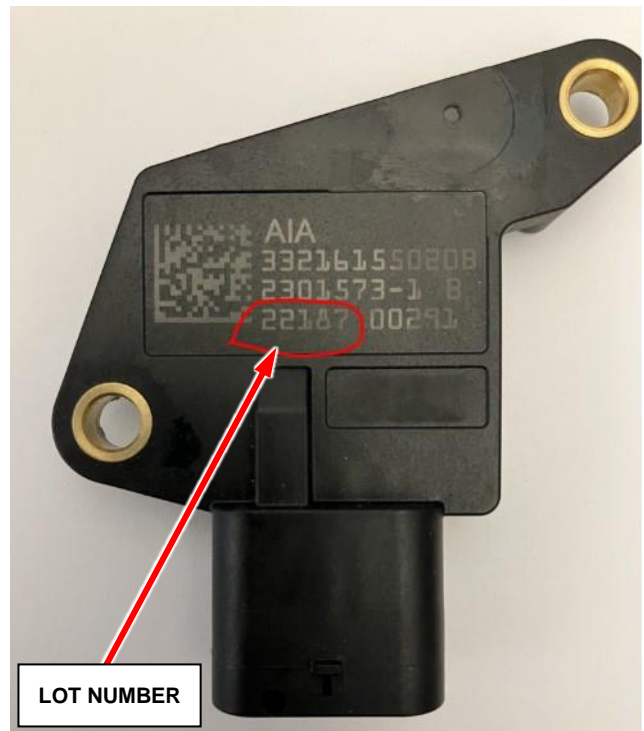
**Figure 1 – Gear Position Sensor
Inspect Lot Number**

1. If the gear position sensor is installed on a vehicle it must first be removed from the vehicle to view the Lot number, follow the Service Procedure removal steps in Section A. Gear Position Sensor Remove and Install.
2. Read the 5-digit Lot number on lower left (Figure 1).
3. If the Lot number is one of the following the sensor is suspect and must be repurchased or if installed on a vehicle sensor must be replaced:
 - 22042
 - 22043
 - 22076
 - 22077
 - 22187
 - 22207

4. If the Lot number is different than those listed, the sensor is not suspect and may be returned to the customer or reinstalled on the vehicle.

Render unusable and DISCARD any suspect sensors.

NOTE: If sensor is NOT suspect and is to be reinstalled on a vehicle, NEW screws MUST be used. Old screws are NOT to be reinstalled.
