WIRE CHANGE FOR 50AMP POWER CONTROL SYSTEM ON BRINKLEY MODEL G 5TH WHEELS

Recall Number:	Brinkley RV ID: PCI-2023-01; NHTSA Recall No. 23V-664; Transport Canada recall No. 2023-550		
Product:	Power Control System		
Date:	October 16, 2023	Labor Rate:	1.0 hours

This document refers to Brinkley Model G Series 5th Wheels and the requirement to replace the 10-gauge white wire with a larger 6-gauge white wire in the energy management Power Control System. This will be done by replacing the complete box assembly that houses the wiring.

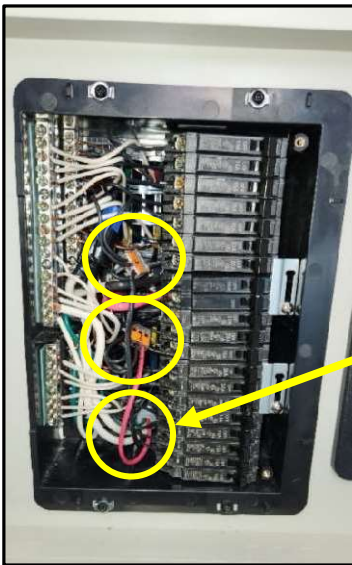
This is where the Power Control System wires enter into the panel from back of the power distribution center.

- Remove the 12-gauge black wire and red wire from Wago Connectors for wires connecting to the Power Control System.

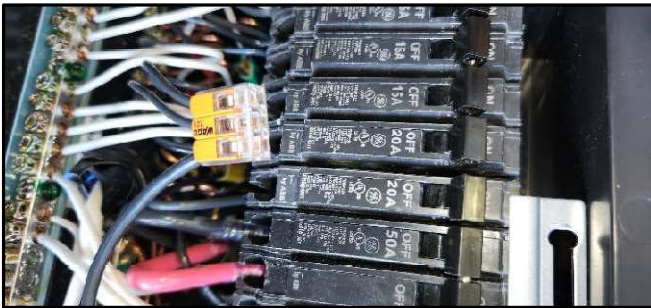
A close up of the top circle in the above photo.

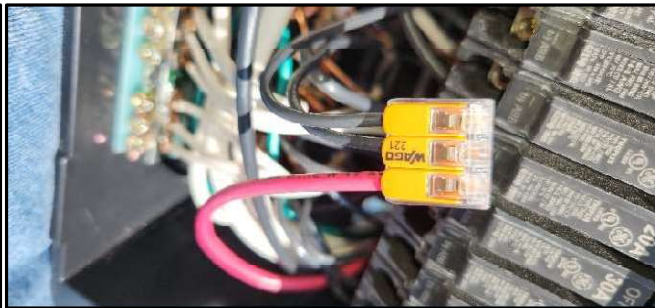
A close up of the middle circle in the above photo.
