APA1 - Replacing Additional Pump (Stop Delivery / Recall Campaign)

Model Line: **Panamera (971)**

Model Year: **As of 2017 up to 2021**

Concerns: **Additional pump for air conditioning control**

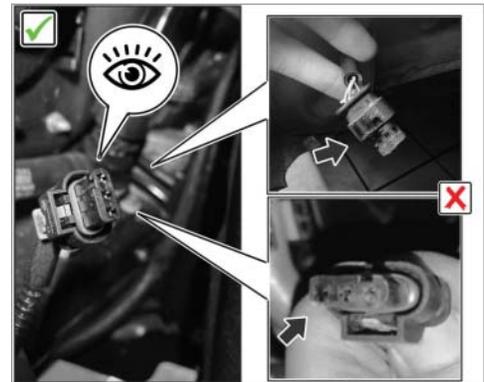
Checking connector

2 Check connector connection for additional pump for visible thermal deformations.

- If no damage to the connector is visible, **continue with Step 3.**
- If damages to the connector are visible, document this with a digital camera and repair the connector. Please claim the part number APA10000005 for the remaining cost of the APA1 connector kit that your dealer was charged, max amount \$10.49. Please use designation "Shipping Costs" or "Price Difference" when claiming. To do this, **continue with** ⇒ *Technical Information '803719 repairing the plug connection for the additional pump'*.
