SIB 52 01 23

RECALL 23V-039: SIDE AIR BAG COVER (REAR SEATS)

This Service Information Bulletin (Revision 3) replaces SI B52 01 23 **dated February 2023**.

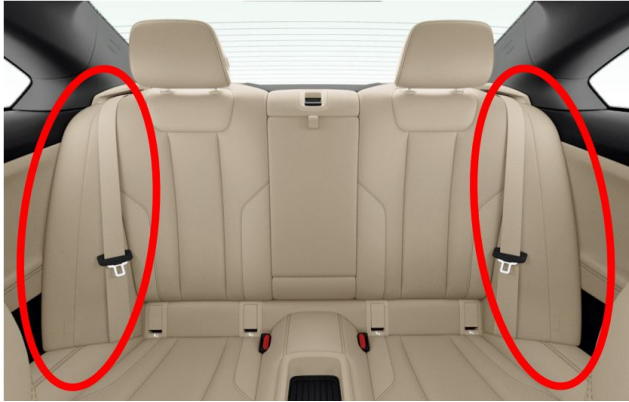
Replace the rear seat backrest side panels (left and right; circled) in accordance with repair instructions 52 26 008 (backrest side panel at the rear seat back).

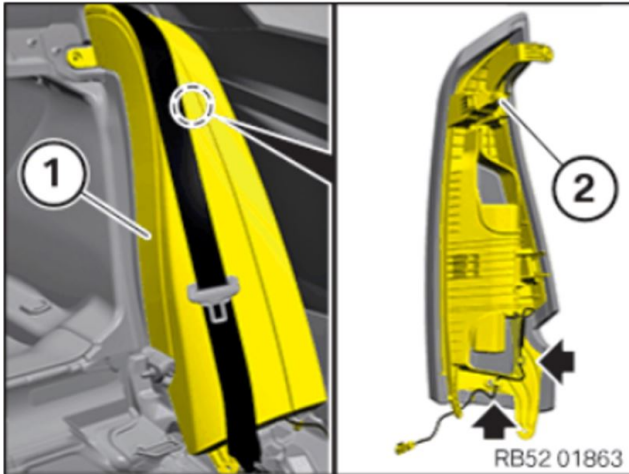
Unclip and remove the backrest side panel section (1) on the rear seat backrest from the clamp (2).

Check the clamp (2) for damage. A replacement clamp should be present on the new part.

Repeat for opposite side of vehicle.
