SIB 52 01 23

## RECALL 23V-039: SIDE AIR BAG COVER (REAR SEATS)

RE: Recall 23V-039: Side Air Bag Cover (Rear Seats) – B52 01 23

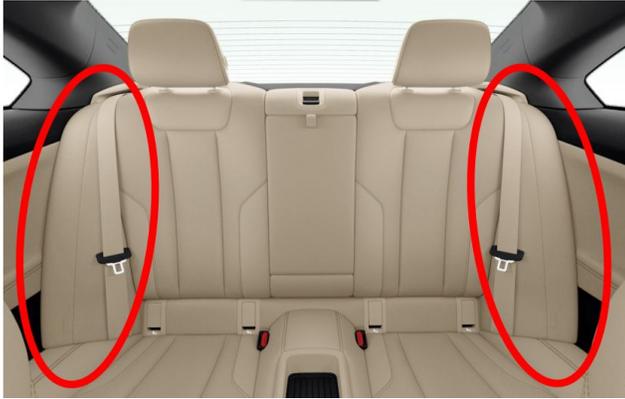
Replace the rear seat backrest side panels (left and right; circled) in accordance with repair instructions 52 26 008 (backrest side panel at the rear seat back).

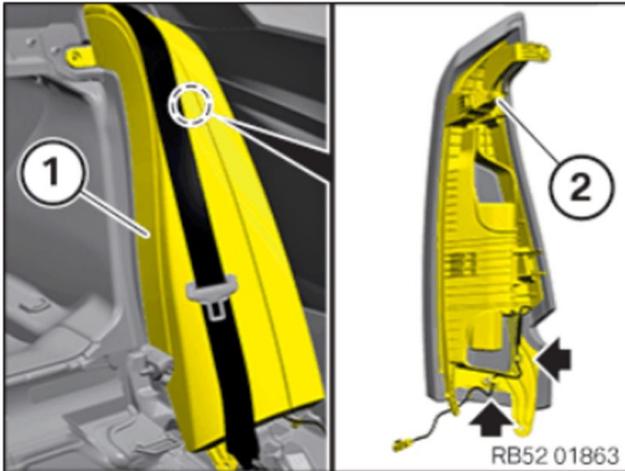
Unclip and remove the backrest side panel section (1) on the rear seat backrest from the clamp (2).

Check the clamp (2) for damage. A replacement clamp should be present on the new part.
