TECHNICAL INSTRUCTIONS

23TA01

VEHICLE MAY LOSE MOTIVE POWER WHILE DRIVING

2021 RAV4 PRIME

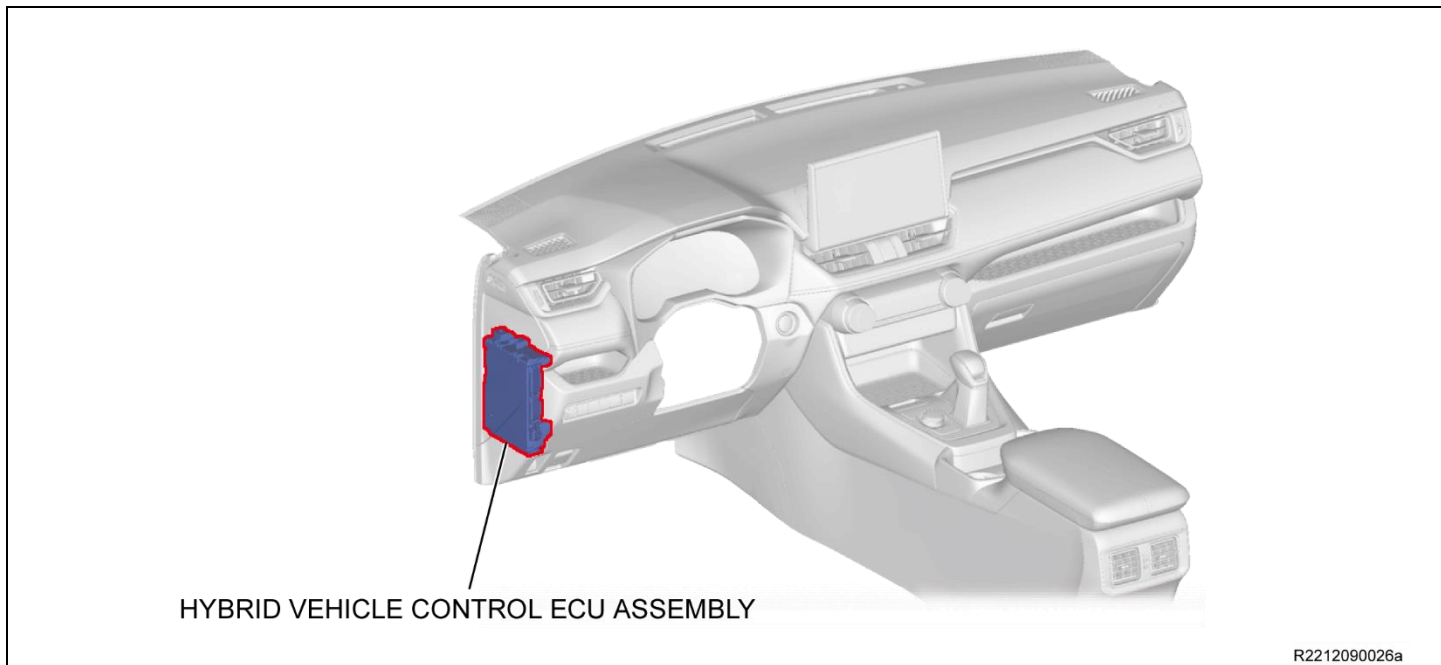
The Hybrid Vehicle Control ECU (HEV-ECU) in the subject plug-in hybrid electric vehicles contains software that could cause the hybrid system to shut down after driving continuously in “EV Mode” in cold temperatures and then the accelerator pedal is rapidly pressed to further accelerate the vehicle. **System shutdown with the loss of motive power at higher speeds can increase the risk of a crash.**

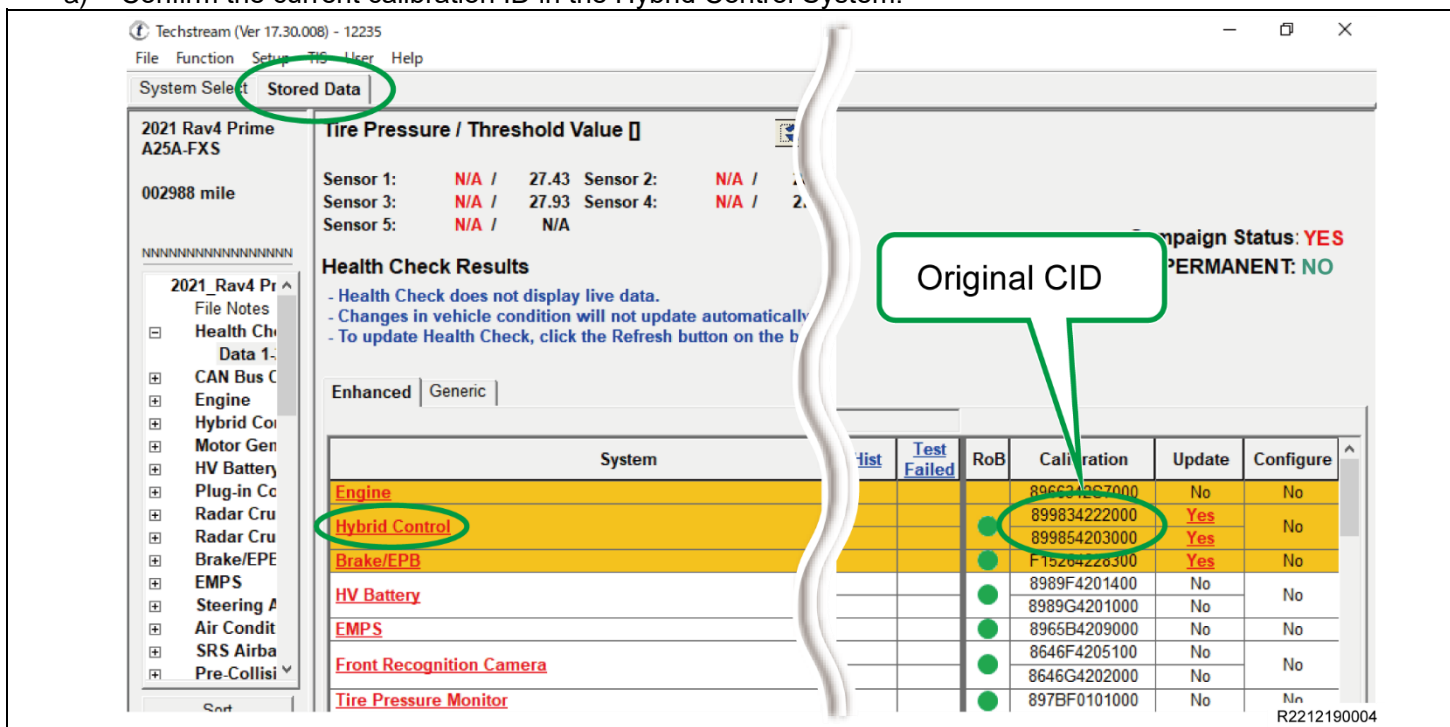
a) Confirm the current calibration ID in the Hybrid Control System.

The calibration IDs to re-flash in this campaign are as shown in the table below.

Vehicle Model Spec	Hybrid Vehicle Control ECU Calibrations		
	CPU	Current Calibration ID	NEW Calibration ID
RAV4 PHEV	Main	899834222000	899834222200
	Sub	899854203000	899854203100
