SAFETY RELATED RECALL

Global Recall Action Number: N763v3

Camshaft Carrier Drill Hole

Publication No.: N763v3 Model: Range Rover (LK) Model Year: 2023 Model: Range Rover Sport (L1) Model Year: 2023 Model: Discovery (LR) Model Year: 2022 - 2023 Model: Defender (LE) Model Year: 2020 - 2023 Model: Range Rover Velar (LY) Model Year: 2023 - 2024 Model: Range Rover (LG) Model Year: 2020 - 2022 Model: Range Rover Sport (LW) Model Year: 2019 - 2022 Date of Issue: 18 May 2023

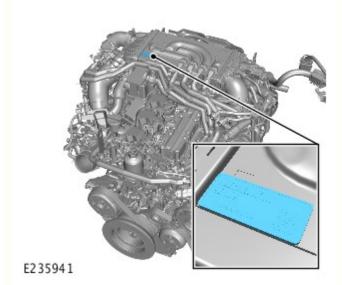
1. Inspect the engine serial number, located on the charge air cooler.

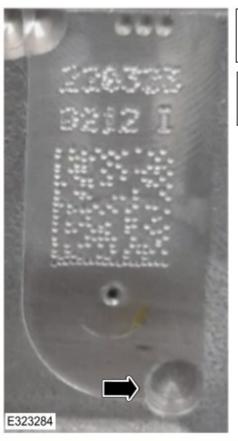
ONLY INSPECT FOR THE SPECIFIC DRILLED TOOLING MARK IN THE LOCATION HIGHLIGHTED BY THE ARROW WITHIN THE ILLUSTRATION. DISREGARD ANY TOOLING MARKS WHICH ARE NOT HIGHLIGHTED BY AN ARROW WITHIN THE ILLUSTRATION.

The failure condition shown highlights 1 drilled tooling mark in the lower right side of the tooling stamp.

> • If the 1 drilled tooling mark in the lower right side of the tooling stamp is present, then the vehicle has failed the inspection.

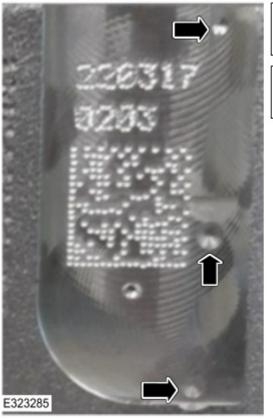
ONLY INSPECT FOR THE SPECIFIC DRILLED TOOLING MARKS IN THE LOCATIONS HIGHLIGHTED BY THE ARROWS WITHIN THE ILLUSTRATION. DISREGARD ANY TOOLING MARKS WHICH ARE NOT HIGHLIGHTED BY AN ARROW WITHIN THE ILLUSTRATION.

• If the 3 drilled tooling marks in the upper, middle and lower right side of the tooling stamp are **ALL** present, then the vehicle has failed the inspection.

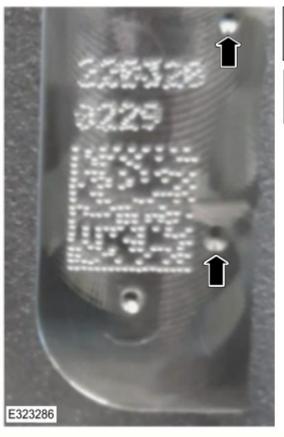
ONLY INSPECT FOR THE SPECIFIC DRILLED TOOLING MARKS IN THE LOCATIONS HIGHLIGHTED BY THE ARROWS WITHIN THE ILLUSTRATION. DISREGARD ANY TOOLING MARKS WHICH ARE NOT HIGHLIGHTED BY AN ARROW WITHIN THE ILLUSTRATION.

The failure condition shown highlights 2 drilled tooling marks in the upper and middle right side of the tooling stamp.

> • If the 2 drilled tooling marks in the upper and middle right side of the tooling stamp are BOTH present, then the vehicle has failed the inspection.

- Vehicles with LESS than 500 miles, which FAILED the below inspection procedure:
 - Renew the camshaft carrier, (see TOPIx Workshop Manual section 303-01: Engine - INGENIUM I6 3.0L PETROL - Removal and Installation - Camshaft Carrier).
 - Claim option codes C / D / É / F from the Warranty option code table.
