SAFETY RELATED RECALL

Global Recall Action
Number: H426v2

Camshaft Carrier Drill Hole	Publication No.: H426v2
	Model: F-PACE (X761)
	Model Year: 2023 - 2024
	Date of Issue: 20 February 2023

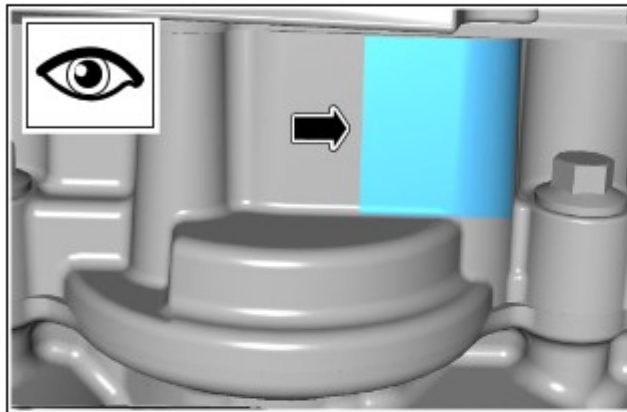
E323282

2. Locate the highlighted area of the camshaft carrier shown in the illustration.
