SAFETY RELATED RECALL

Global Recall Action
Number: H426v3

Subject: Camshaft Carrier Drill Hole	Publication No.: H426v3
	Model: F-PACE (X761)
	Model Year: 2023 - 2024
	Date of Issue: 18 May 2023

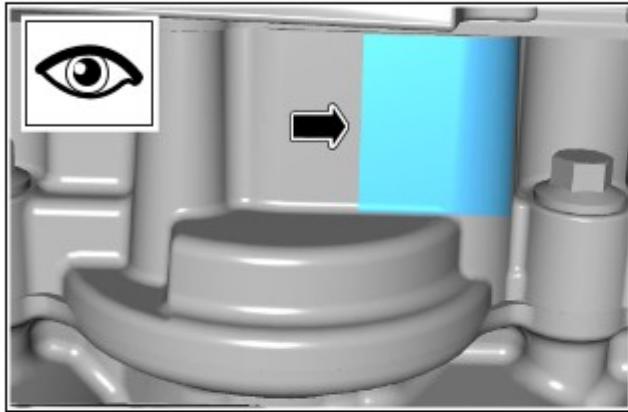
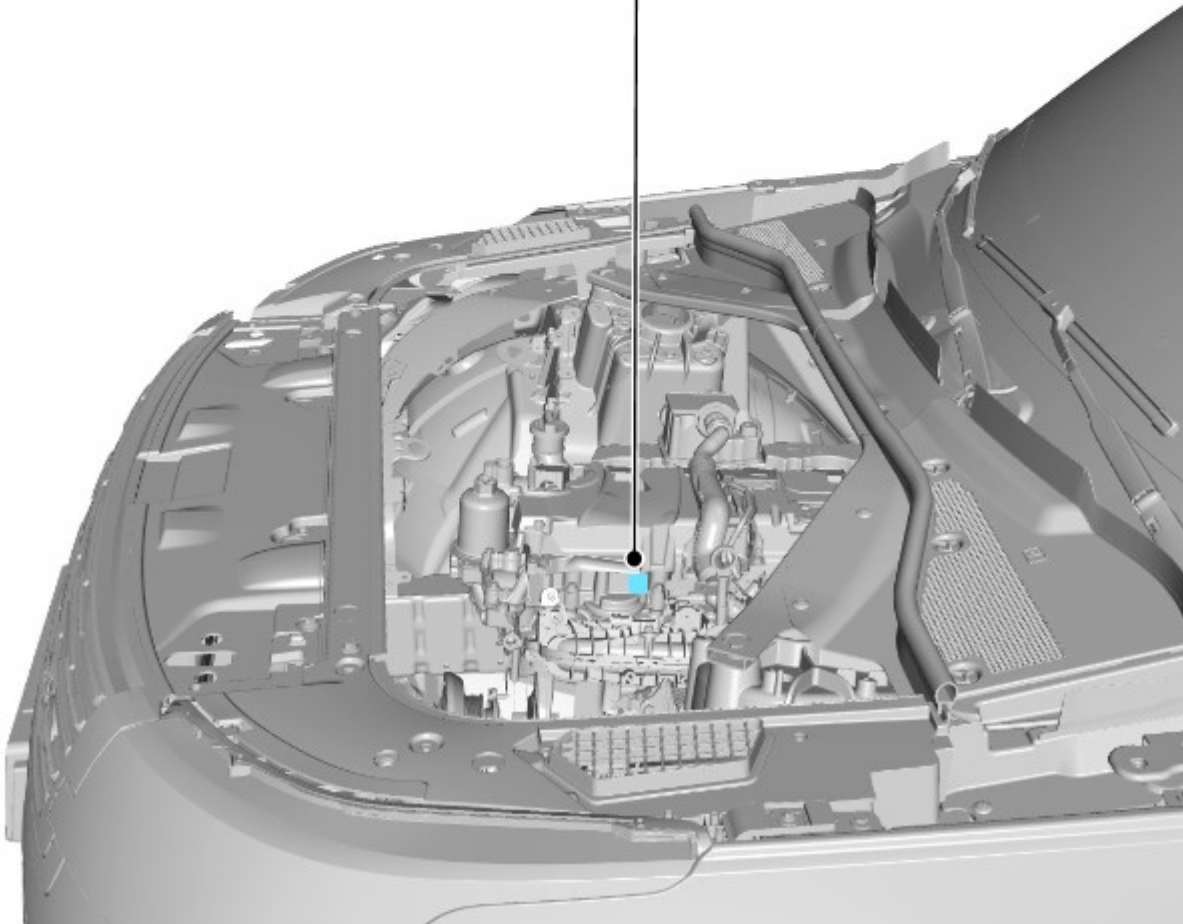
E323282

2. Locate the highlighted area of the camshaft carrier shown in the illustration.

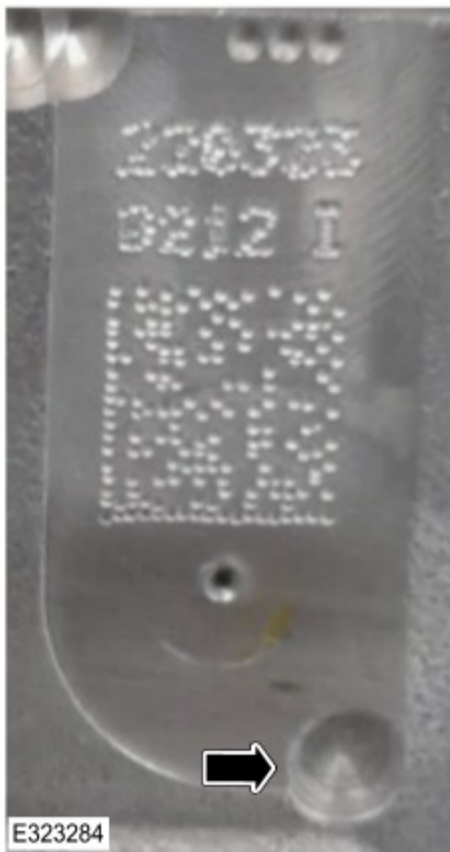
5.

The failure condition shown highlights 1 drilled tooling mark in the lower right side of the tooling stamp.

- If the 1 drilled tooling mark in the lower right side of the tooling stamp is present, then the vehicle has failed the inspection.

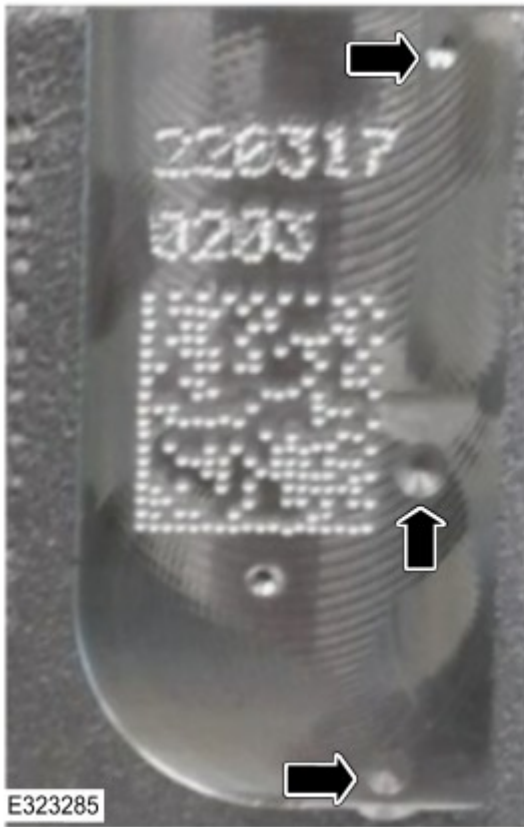
6.

The failure condition shown highlights 3 drilled tooling marks in the upper, middle and lower right side of the tooling stamp.

- If the 3 drilled tooling marks in the upper, middle and lower right side of the tooling stamp are **ALL** present, then the vehicle has failed the inspection.

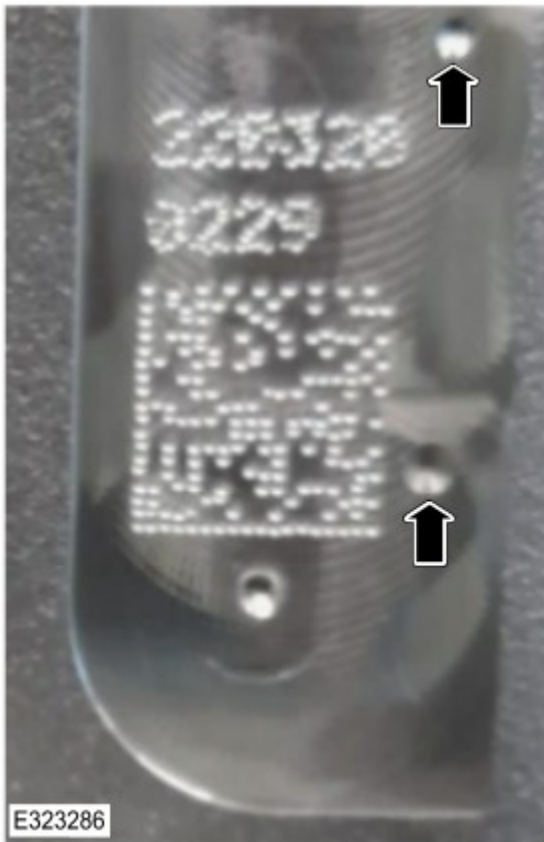
7.

The failure condition shown highlights 2 drilled tooling marks in the upper and middle right side of the tooling stamp.

- If the 2 drilled tooling marks in the upper and middle right side of the tooling stamp are **BOTH** present, then the vehicle has failed the inspection.
