Recall Campaign Bulletin

Campaign No. 2023030005, April 2023

SUBJECT: **Model G-Class (463 platform)**
Model Year 2019-2022

Inspect Front Axle Wiring Harness

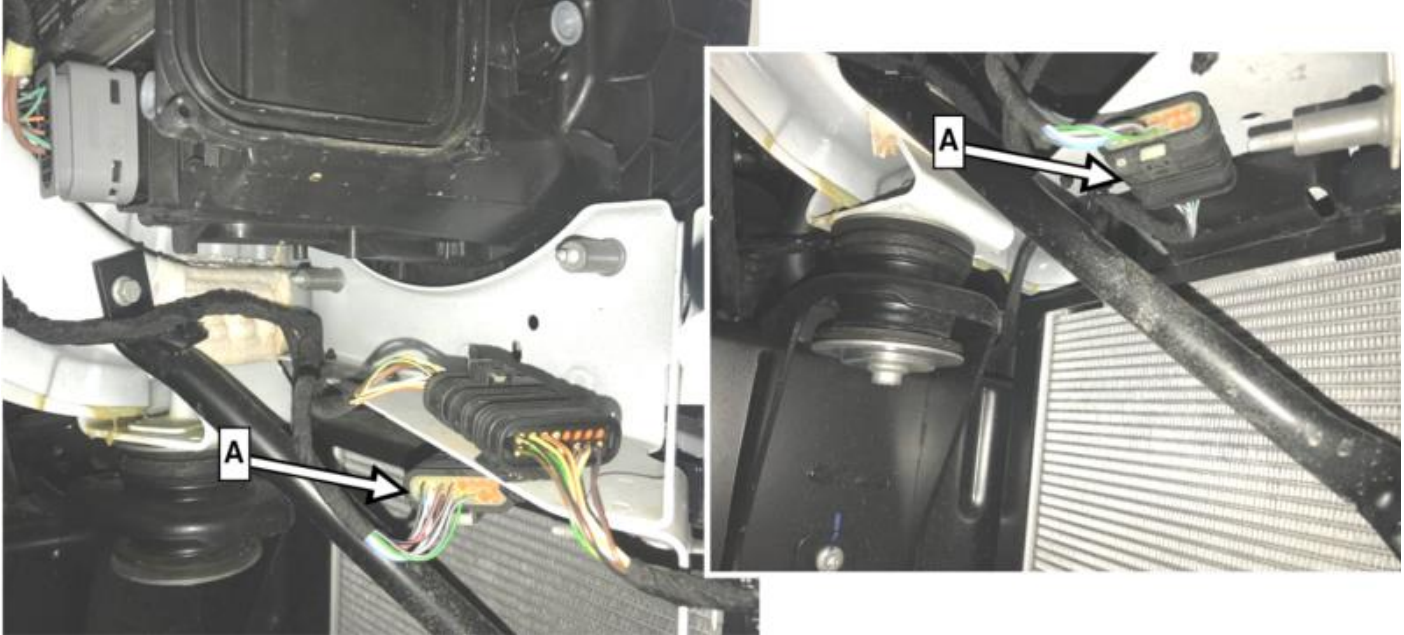
**Figure 1**

1. Remove fender liner in front right fender (AR88.10-P-1300XG).
i Contrary to the work instructions in WIS, it is not necessary to remove the wheel and tire assembly!
2. Unclip plug housing (A, Figure 1) and disconnect.

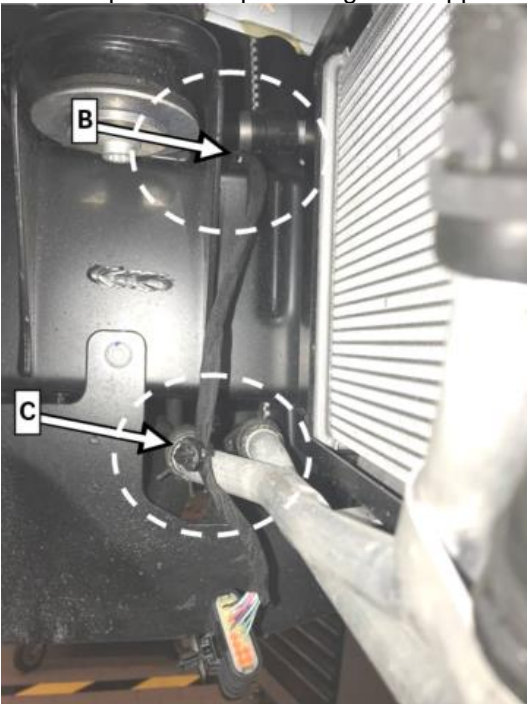
**Figure 2**

3. Unclip line from panel edge and upper trailing arm (B and C, Figure 2).

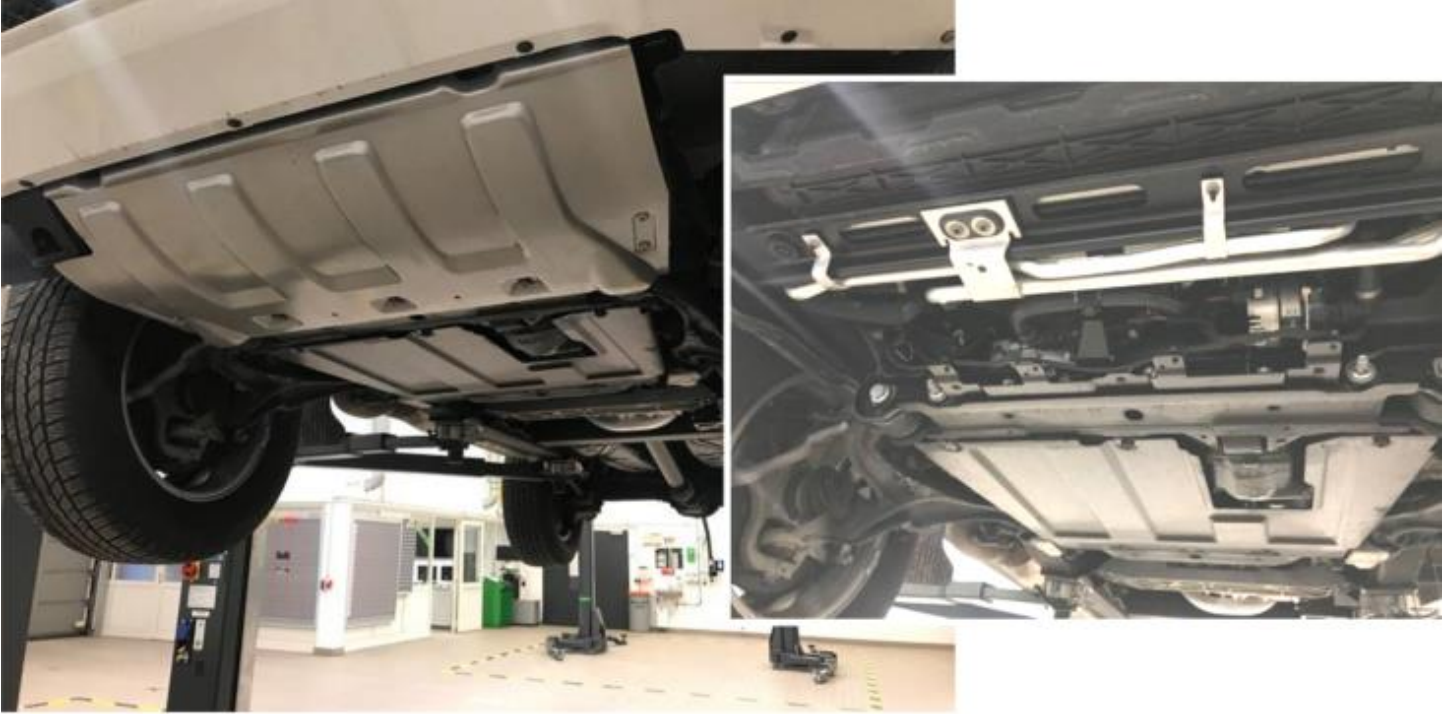
Figure 3

4. Remove front engine compartment lining (Figure 3).

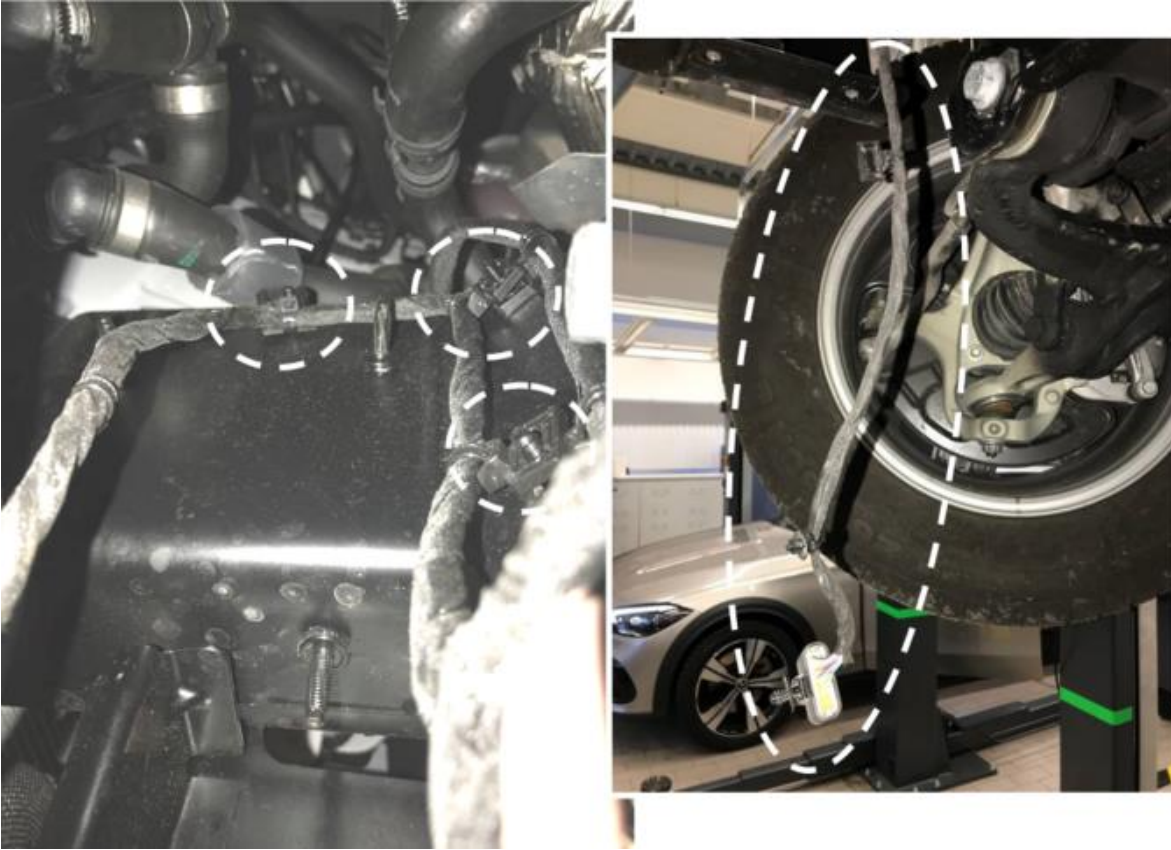
Figure 4

5. Unclip wiring harness from wheel arch at right trailing arm and place inwards in engine compartment (Figure 4).

i Hang wiring harness downwards vertically.

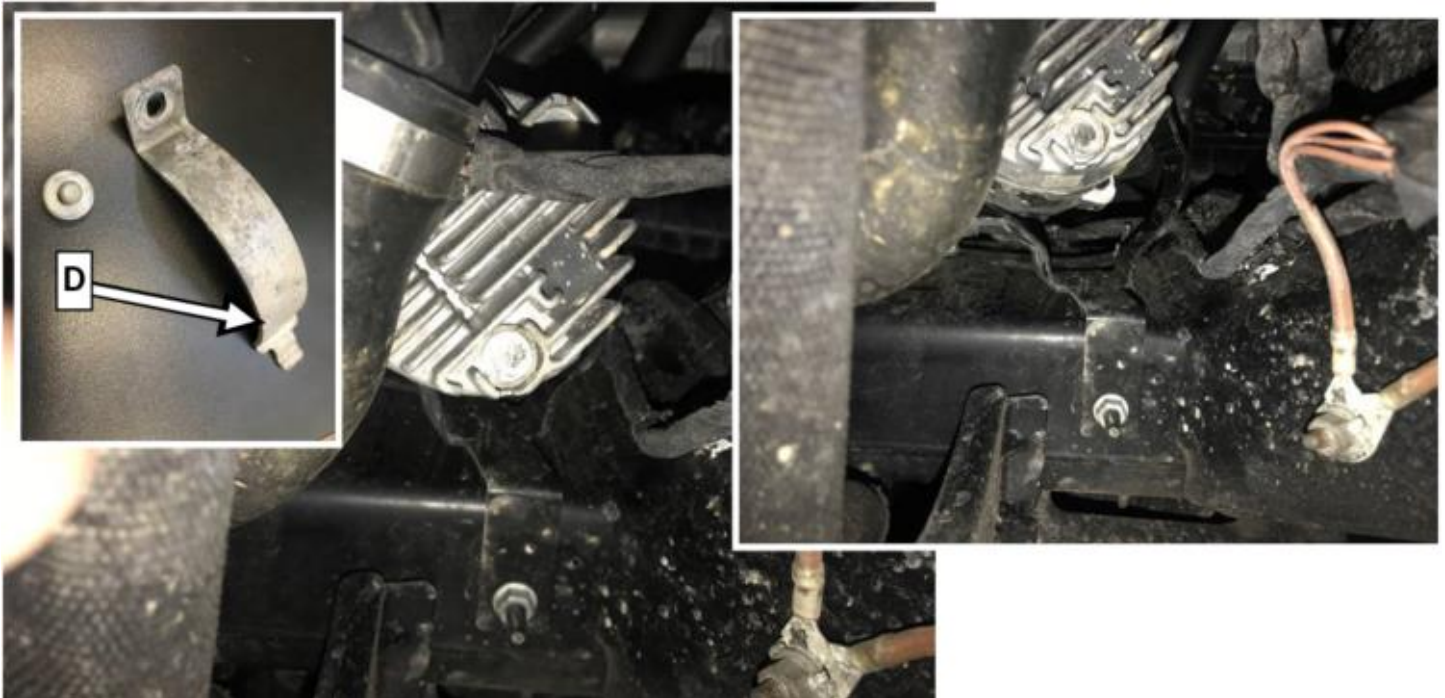
Figure 5

i For V8 engines, the retaining clamp (D, Figure 5) of the circulation pump must **also** be removed, press circulation pump slightly to one side to access the wiring harness.

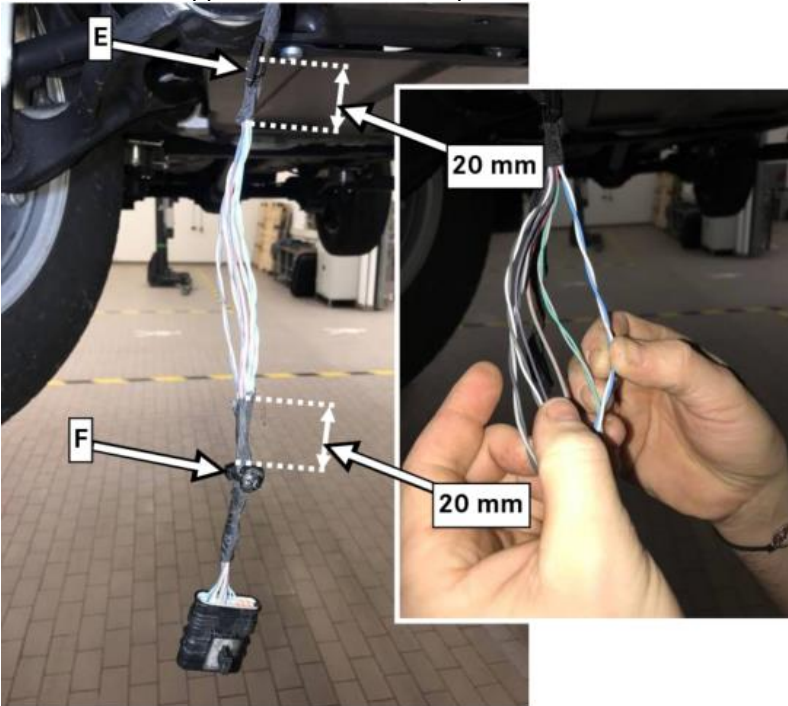
Figure 6

6. Remove the fabric insulating tape between the cable ties (E and F, Figure 6) and check all exposed individual cables for damage.

i Leave approx. 20 mm fabric tape in front of the cable ties in each case!

- a. If none of the individual cables in the exposed area are damaged: Carry out Work Procedure A.
- b. If one or more individual cables in the exposed area are damaged: Carry out Work Procedure B.
