**SAFETY (NONCOMPLIANCE) RECALL 23TA02**

**INSTRUMENT PANEL LCD MONITOR MAY GO BLANK WHILE DRIVING**

**CERTAIN 2022-2023 Model Year Tundra HV  
Certain 2023 Model Year Tundra**

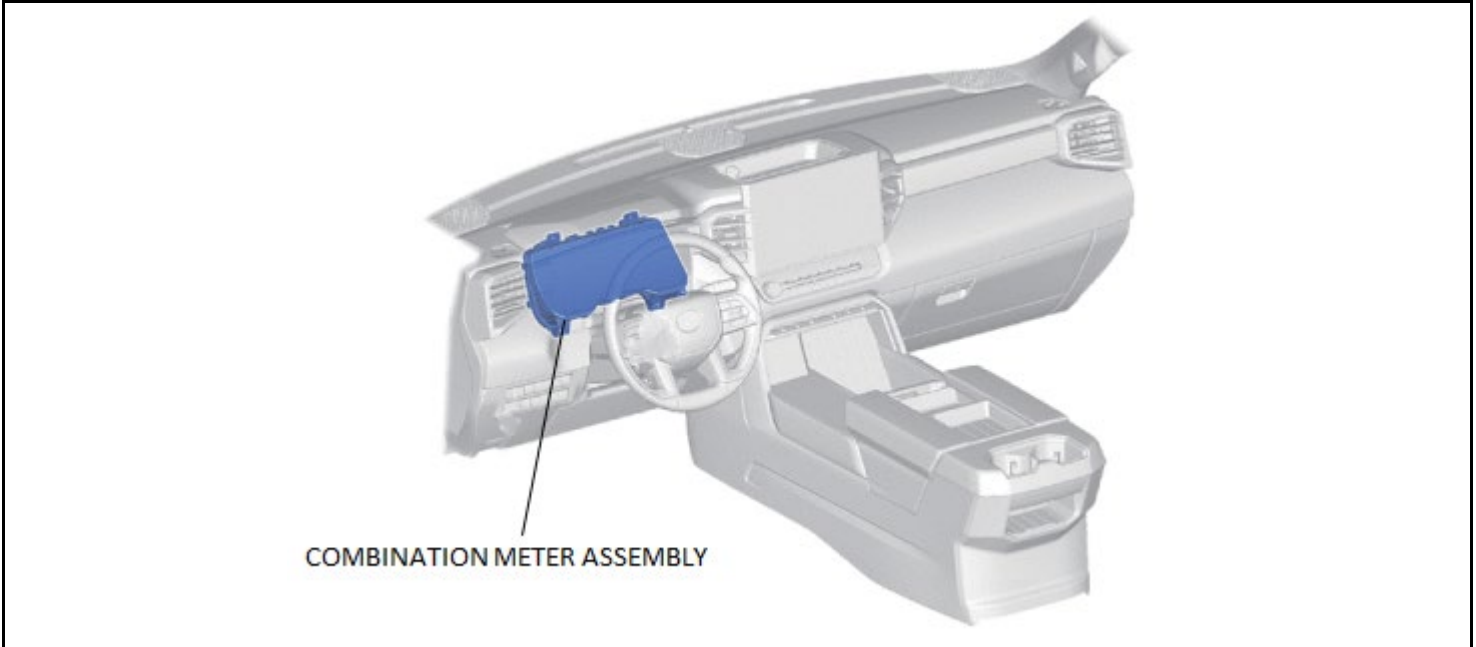
The subject vehicles are equipped with a 12.3-inch Thin Film Transistor (TFT) Liquid Crystal Display (LCD) monitor, which is used to display various information such as warning and indicator lights, vehicle gauges, messages and more. The LCD monitor can go blank due to a software issue. A blank monitor creates a noncompliance with certain federal requirements. This can reduce the driver's recognition of certain operating conditions, which can lead to an increased risk of a crash.
