Thor Motor Coach Recall Repair Instructions

| Recall # | 23v-113 & 2023-087 | | |
| Description/Title: | Palazzo lower front cap brackets | | |
| Affected Product Line(s): | Certain model year 2015 – 2023 Palazzo motorhomes | | |

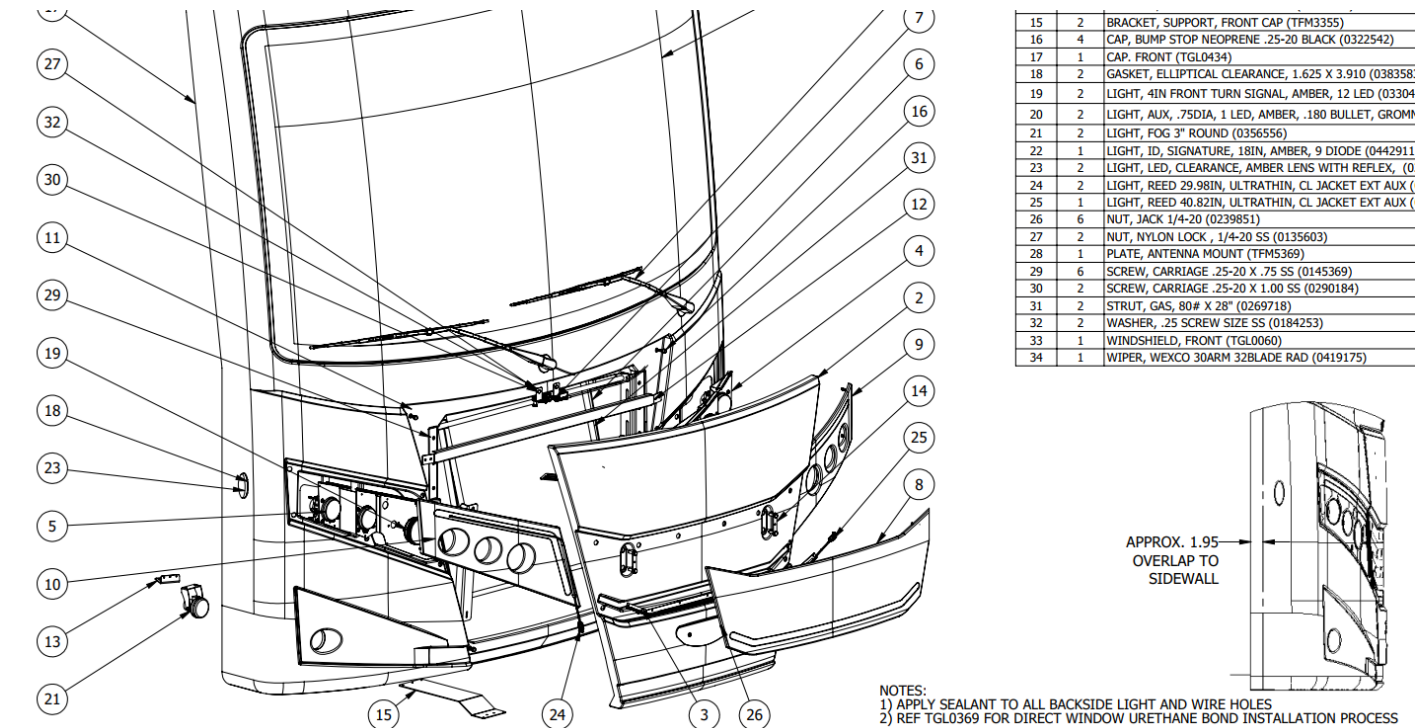
It has been discovered that on certain model year 2015 – 2023 Palazzo motorhomes that the lower front cap brackets may become loose and have the potential to fall off.

1. Inspect under the front of the motorhome to determine if one or both of the lower cap brackets are loose and/or missing. Reference print below for the location of the bracket. Bracket is identified by the ¹⁵ found on the print.

2. If the brackets are both still connected to the motorhome, ensure that the hardware used for installation matches the fasteners listed above under parts. Change out fasteners with proper hardware listed above if needed. Once that has been completed the recall has been finished, **only** continue on to step 3 if there was one or both brackets missing from the motorhome.

5. Install the new style bracket by screwing the 3/8" lag into the firewall and extending the bracket to where it needs to be installed on the underside of the cap using the #10 x 1" panhead wood screw.

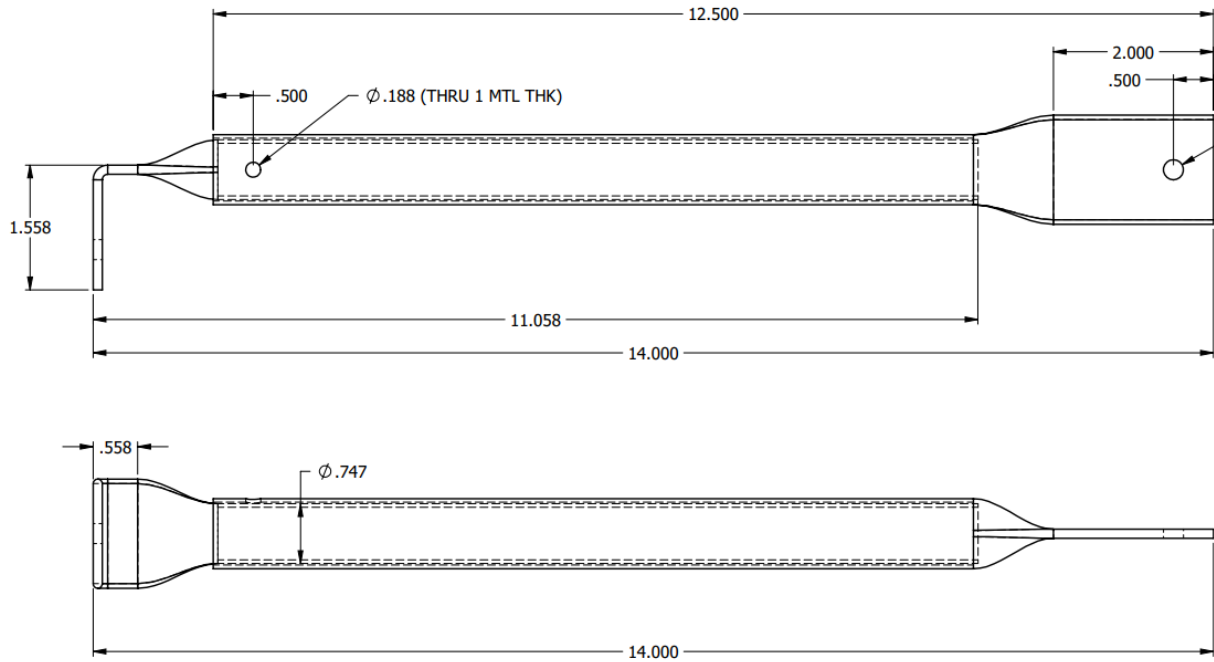
New style bracket:

4. The new bracket does not match the old style bracket that may be on the motorhome. This new bracket is a slide in tube style bracket and serves the same function as the original bracket.
