RSB 597
April 28, 2023

NHTSA #23V 138
TC #2023-110

RECALL SERVICE BULLETIN

GLOBAL ENTRY DOOR LATCH INSPECTION/ REPLACEMENT INSTRUCTIONS *MOTORIZED UNITS ONLY

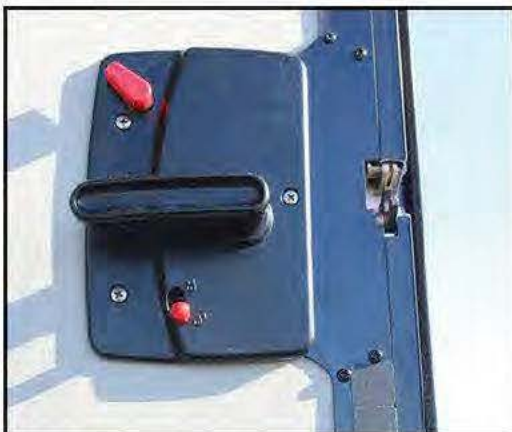
Inside Latch Assembly

This section of document refers to the replacement of the inside latch assembly of the complete door lock assembly with latch on certain motorized entry doors. A portion of the latch is breaking off when attempting to exit the coach. The instructions are applicable to using a replacement inside latch assembly PN 2023005033 for the 920 Series door and inside latch assembly PN 2022010407 for the 3500 Series door.

NOTE: When possible, all repairs should utilize the replacement of the inside latch assembly rather than the complete latch assembly. This preferred procedure is outlined first.

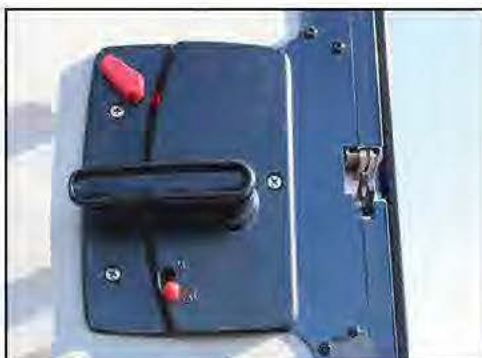
Inside Latch Assembly

The section of this document refers to the replacement of the complete door lock assembly with latch on certain motorized entry doors. A portion of the latch is breaking off when attempting to exit the coach. The complete door lock assembly with latch, PN 2021097898, is to be replaced with a redesigned part.

NOTE: This option is to be used only if replacement of the inside latch assembly is not feasible.

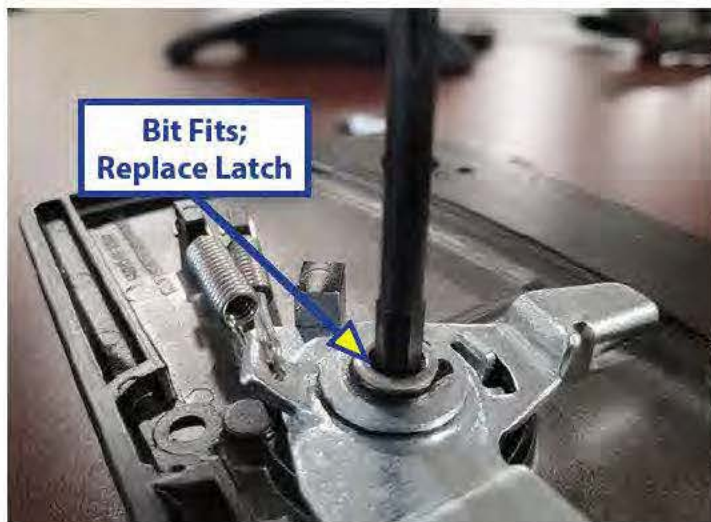
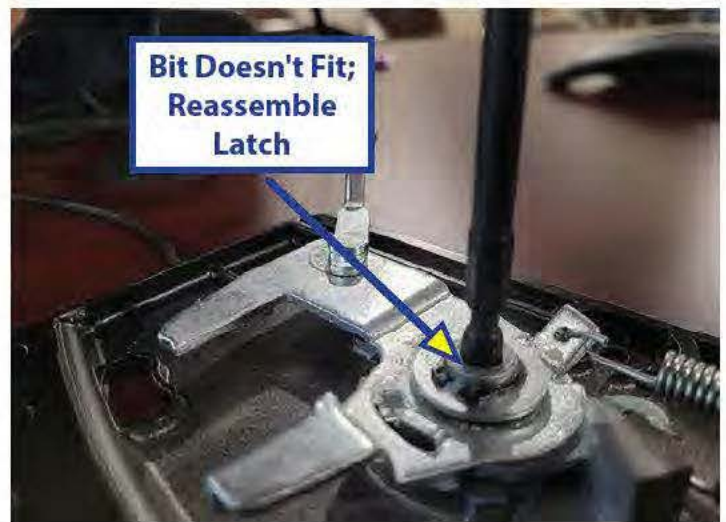
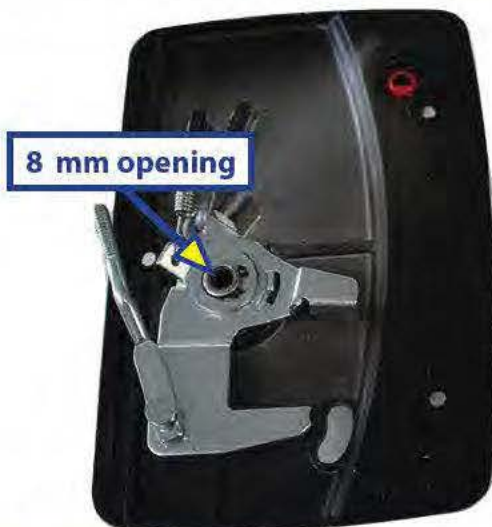
Fig. 5

New Inside Latch Assembly Needed

1. Using a 1/4" screwgun bit, try to insert the bit into the spun rivet of the inside latch assembly (Fig. 5).
2. If bit fits into rivet opening there are two options:
 - A. Replace the complete latch assembly, including both inside and outside latch assemblies.
 - B. Replace just the inside latch assembly to be combined with current outside latch assembly.
3. If the bit does not fit, no action is required. Proceed to latch reassembly instructions.

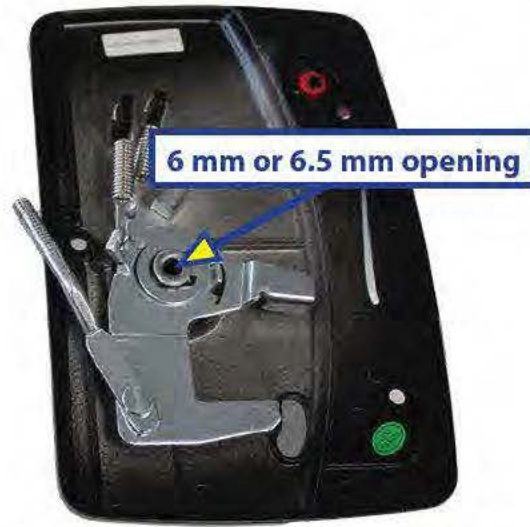
Replacement Not Needed
