TECHNICAL INSTRUCTIONS

SAFETY RECALL 23TA03 (Interim Notice 23TB03)

TONNEAU COVER MAY COME OFF WHILE DRIVING

CERTAIN 2022-2023 MODEL YEAR TUNDRA and TUNDRA HV

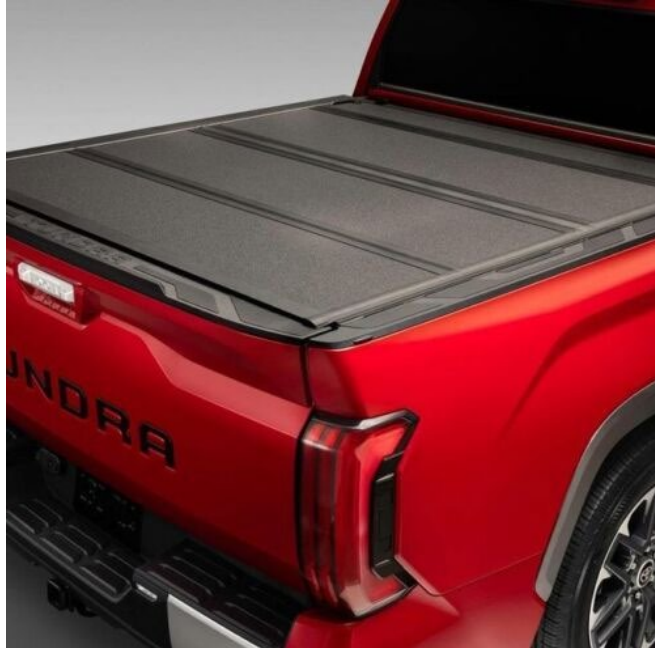
Some of the subject vehicles may be equipped with an optional Toyota genuine truck bed accessory tonneau cover that can detach from the vehicle while driving. A tonneau cover that detaches from a vehicle could increase the risk of a crash or injury.

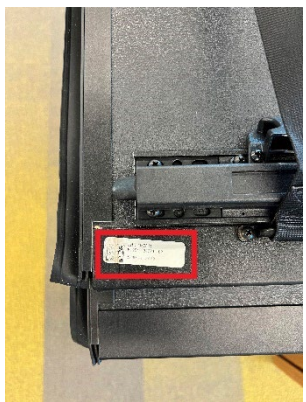
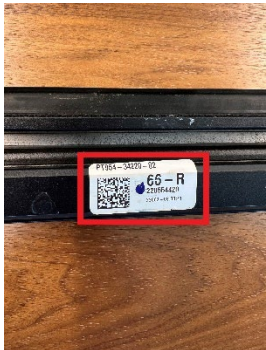
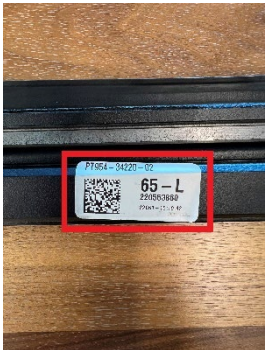
Affected Tonneau Covers

<p>Affected Tonneau Cover for 2022-2023 Tundra and Tundra HV</p> <ul style="list-style-type: none"> The affected tonneau cover has a Toyota decal on the top of panel closest to the tailgate. <p style="text-align: center;">OR</p> <ul style="list-style-type: none"> The affected tonneau cover has a decal underneath showing part number PT954-34220-02 or PT954-34221-02. <p style="text-align: center;">OR</p> <ul style="list-style-type: none"> The affected tonneau cover has a decal on either tonneau cover rail showing part number PT954-34220-02 or PT954-34221-02.
