TECHNICAL INSTRUCTIONS

SAFETY RECALL 23TA03

TONNEAU COVER MAY COME OFF WHILE DRIVING

CERTAIN 2022-2023 MODEL YEAR TUNDRA and TUNDRA HV

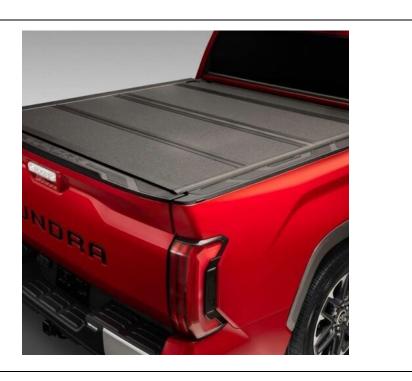
Some of the subject vehicles may be equipped with an optional Toyota genuine truck bed accessory tonneau cover that can detach from the vehicle while driving. A tonneau cover that detaches from a vehicle could increase the risk of a crash or injury.

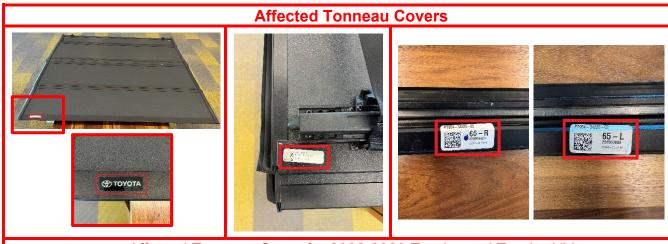
Affected Tonneau Cover for 2022-2023 Tundra and Tundra HV

The affected tonneau cover has a Toyota decal on the top of panel closest to the tailgate.

The affected tonneau cover has a decal underneath showing part number PT954-34220-02 or PT954-34221-02.

• The affected tonneau cover has a decal on either tonneau cover rail showing part number PT954-34220-02 or PT954-34221-02.

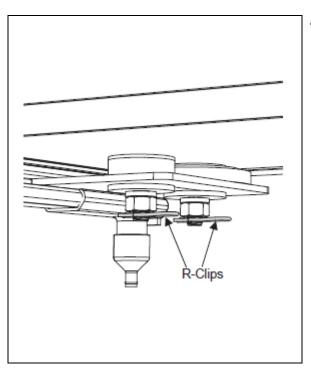
b. In some instances, after tightening the hex nut there may be slight gap on the elevator bolt. This does not affect the retention of the Tonneau Cover and is an acceptable condition. (See examples below)

a. Carefully fold the cover forward and tighten the four (4) hex nuts to 13Nm and ensure that the lock washers are completely flat.
