TECHNICAL INSTRUCTIONS

SAFETY RECALL 23TA03 (Interim Notice 23TB03)

TONNEAU COVER MAY COME OFF WHILE DRIVING

CERTAIN 2022-2023 MODEL YEAR TUNDRA and TUNDRA HV

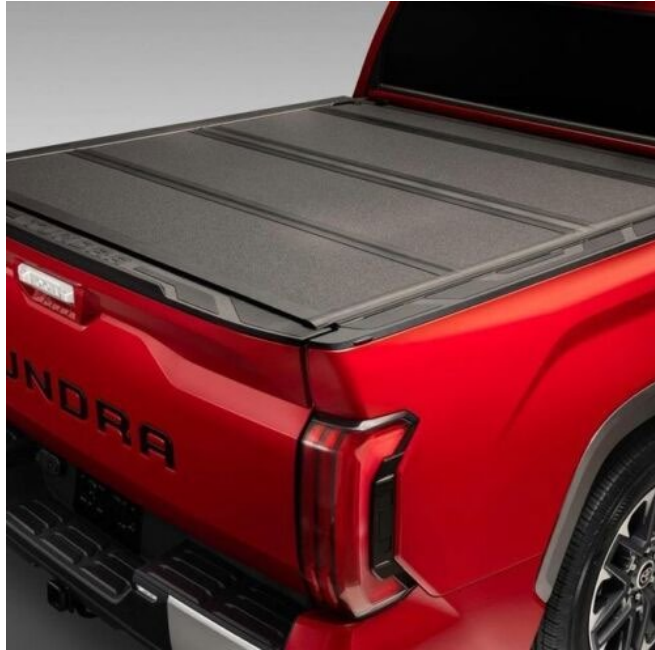
Some of the subject vehicles may be equipped with an optional Toyota genuine truck bed accessory tonneau cover that can detach from the vehicle while driving. A tonneau cover that detaches from a vehicle could increase the risk of a crash or injury.

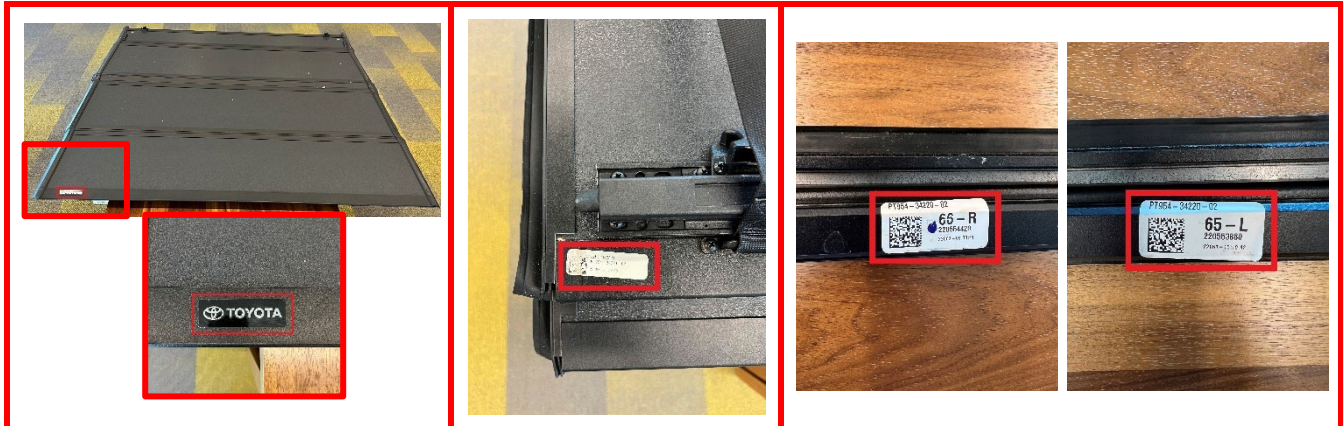
Affected Tonneau Cover for 2022-2023 Tundra and Tundra HV

- The affected tonneau cover has a Toyota decal on the top of panel closest to the tailgate.
- OR**
- The affected tonneau cover has a decal underneath showing part number PT954-34220-02 or PT954-34221-02.
- OR**
- The affected tonneau cover has a decal on either tonneau cover rail showing part number PT954-34220-02 or PT954-34221-02.
