***Important* REC-002-23 Driveshaft Separation Technical Instructions**

Xos Safety Recall REC-002-23

Driveshaft Separation

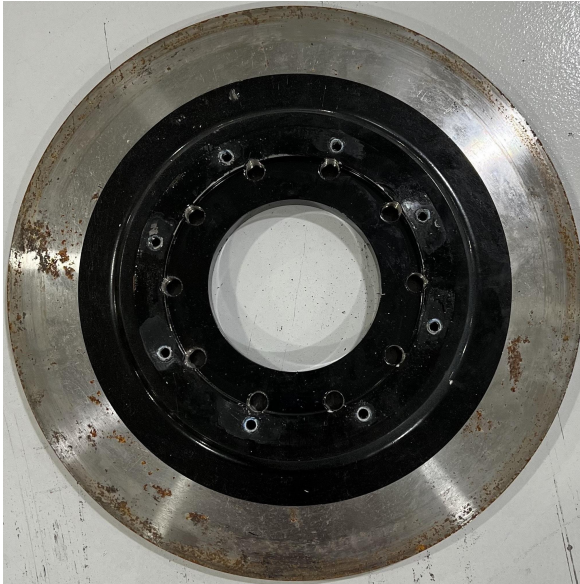
1. Visually inspect EPB Rotor.
2. Confirm all surfaces of the rotor to be completely unpainted.
 - a. If the surface is unpainted, the rotor will be reused after cleaning and tapping.
 - b. If the surface is painted, the rotor must be discarded and replaced with an unpainted one (**RM01-MB-M0044**).

Figure 1 - Painted Rotor (Incorrect)

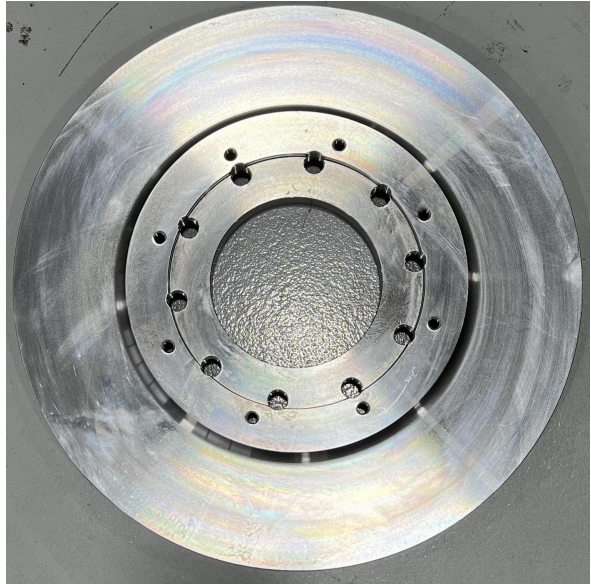
Figure 2 - Unpainted Rotor (Correct)
